Hazard Assessment of Lithium Ion Battery Energy Storage Systems

FINAL REPORT

Andrew F. Blum, P.E., CFEI
R. Thomas Long Jr., P.E., CFEI
Exponent, Inc.
17000 Science Drive, Suite 200
Bowie, MD 20715

**Fire Hazard Assessment of
Lithium Ion Battery
Energy Storage Systems**

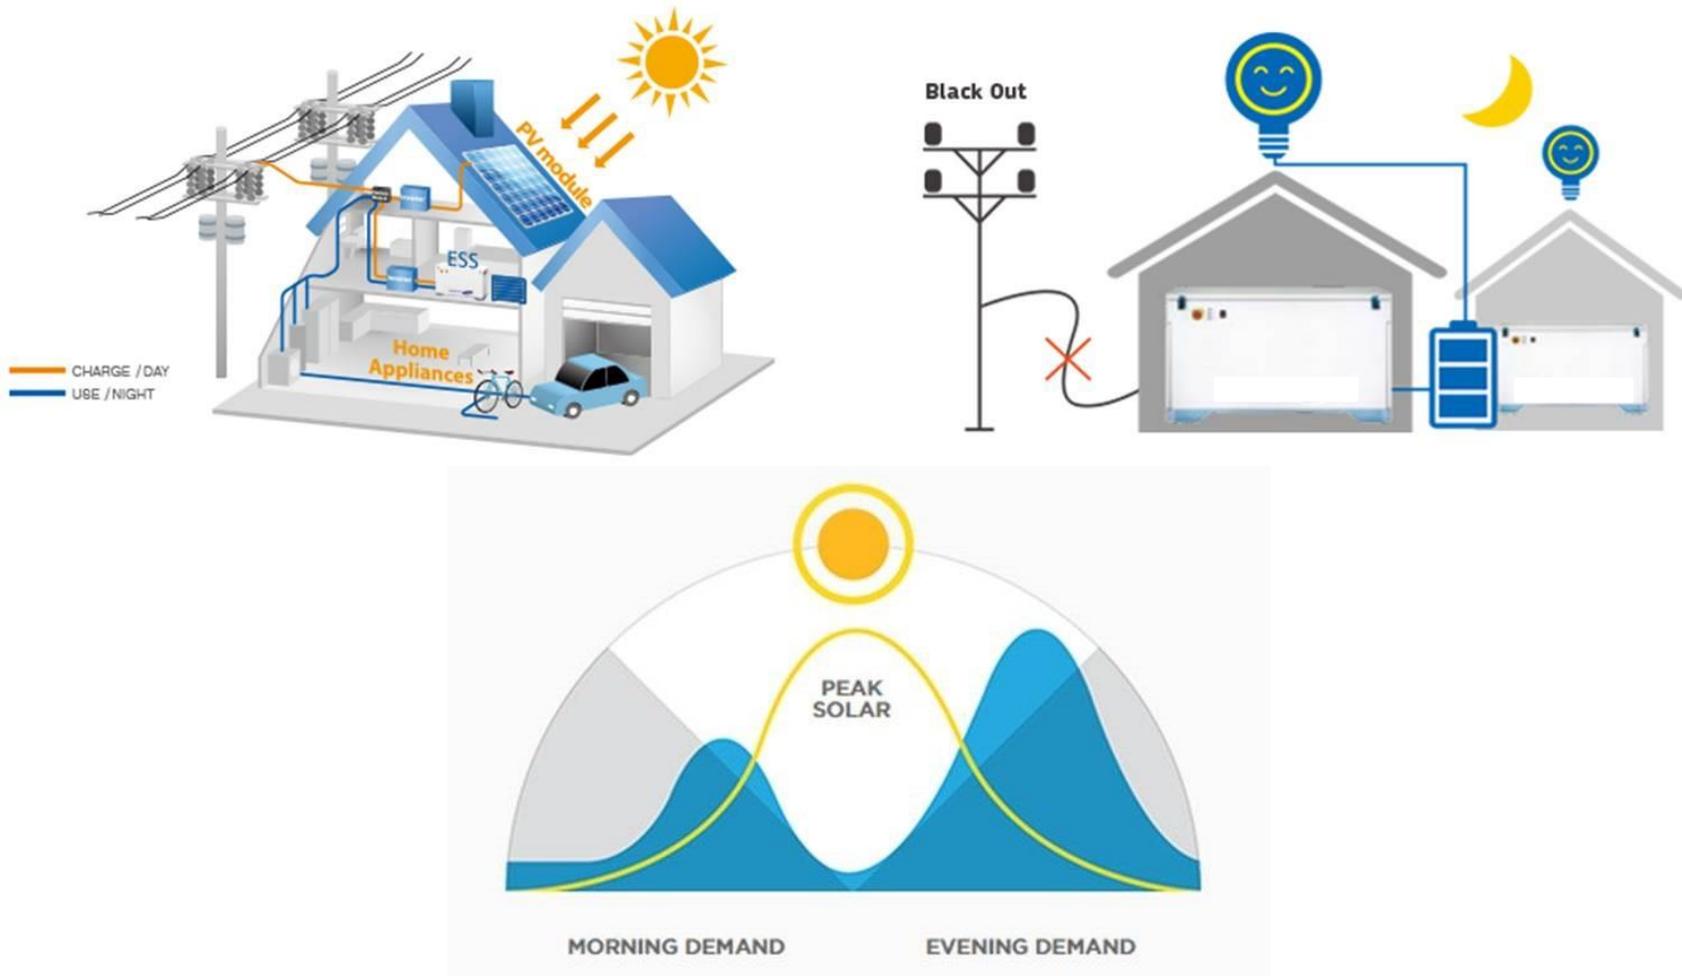
Figure 1 Illustration of energy storage during off peak hours (top left); use of energy storage during peak hours or power interruptions (top right); and the typical energy consumption curve (bottom)¹²

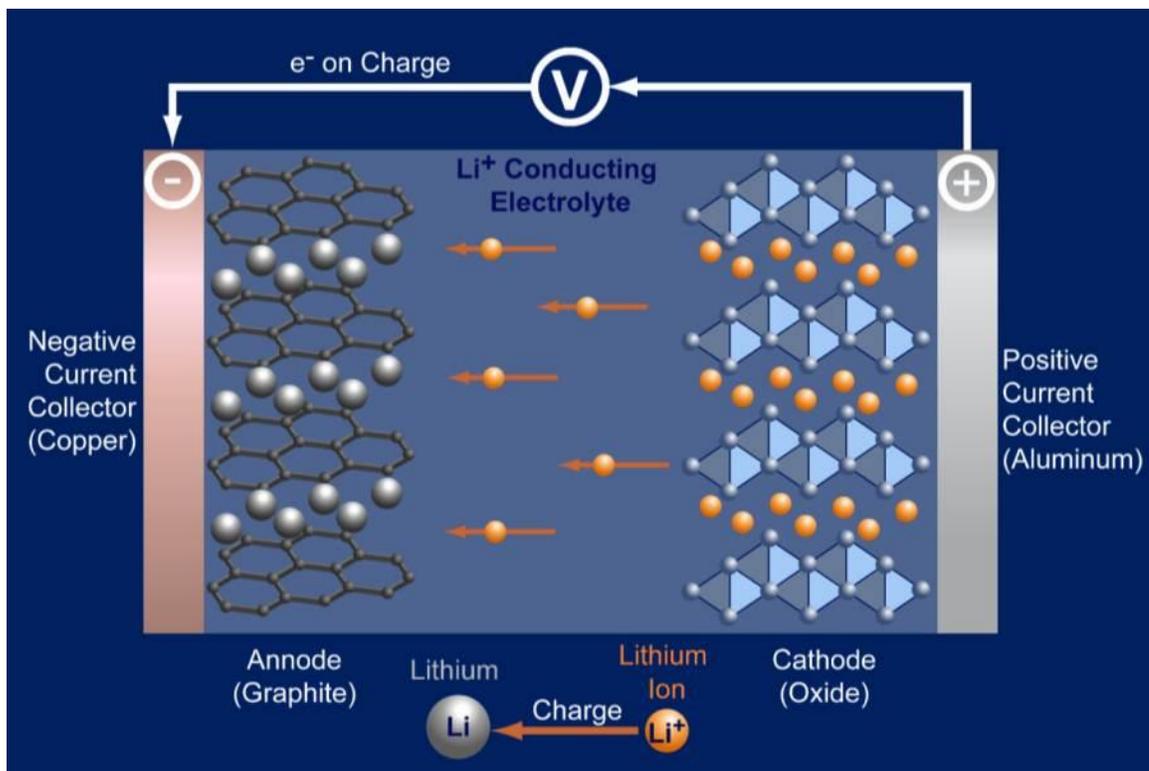
Figure 2 Li-ion cell operation: During charging, lithium ions intercalate into the anode, the reverse occurs during discharge

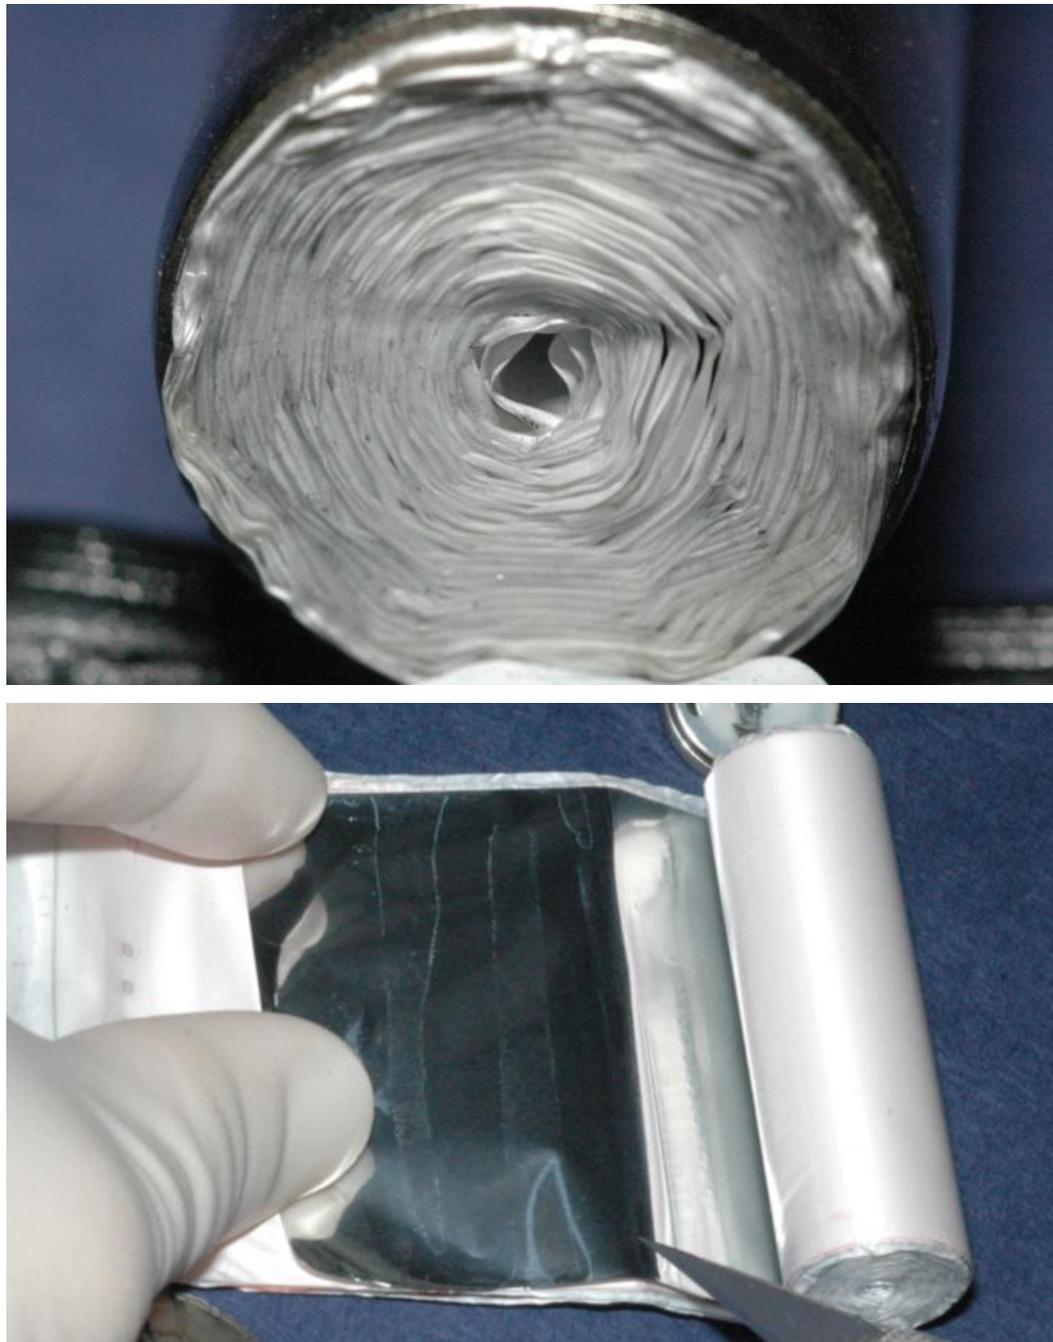
Figure 3 Base of a cylindrical Li-ion cell showing wound structure (top); Cell being unwound revealing multiple layers: separator is white, aluminum current collector (part of cathode) appears shiny (bottom)

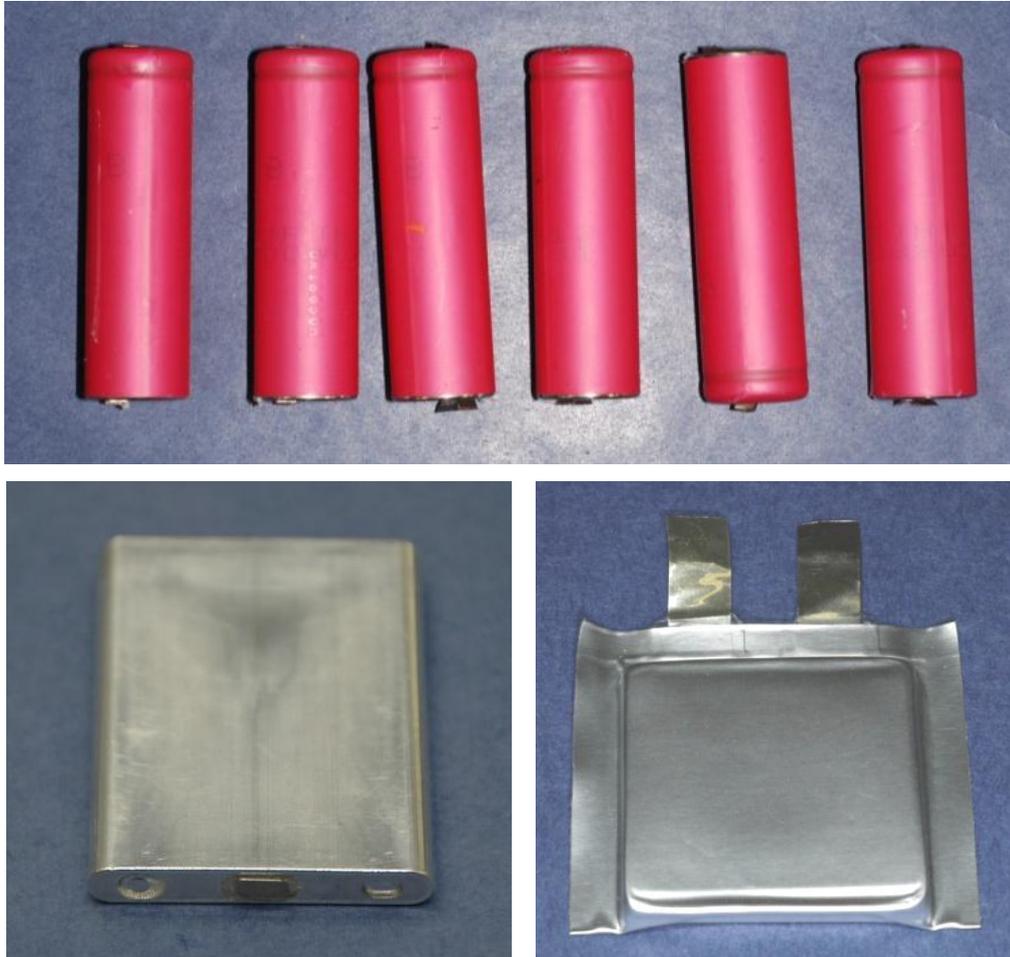
Figure 4 Example of 18650 cylindrical cells; these are the most common consumer electronics Li-ion cell form factor (top); hard case prismatic cell (bottom left); and soft pouch polymer cell (bottom right)

sealed seams (commonly referred to as Li-ion polymer cells²¹), as shown in Figure 4. A variety of safety mechanisms might also be included in the mechanical design of a cell, such as charge interrupt devices and positive temperature coefficient switches.^{22,23}

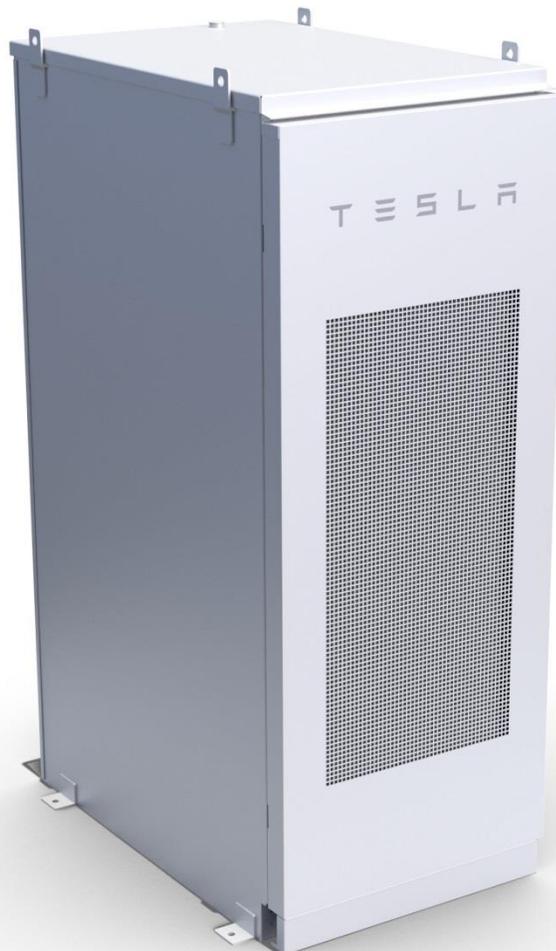
Figure 5 Single standalone Powerpack (100 kWh commercial ESS)

This section provides an overview of the Powerpack (a 100 kWh commercial ESS) utilized for this testing program. The Powerpack can be a single standalone unit, as shown in Figure 5, or installed side by side with multiple Powerpacks if additional storage capacity is desired, as shown in Figure 6.

The Powerpack was positioned on a noncombustible surface similar to its intended end use for an outdoor installation on a concrete pad, as shown in Figure 5. The test instrumentation, including thermocouples (TCs), heat flux gauges (HFGs), pressure transducers, gas sampling, data acquisition, weather meter, and cameras were positioned around the Powerpack as illustrated in Figure 11. In addition, a propane burner, further described in Section 5.1.2, was placed to the right side of the Powerpack, allowing for direct flame impingement on the exterior of the Powerpack cabinet.

The Powerpack was positioned on a noncombustible surface similar to its intended end use installation on a concrete pad, as shown in Figure 5. The test instrumentation, including thermocouples (TCs), pressure transducers, gas sampling, data acquisition, weather meter, and cameras were positioned around the Powerpack as illustrated in Figure 16. In addition, heater cartridges utilized to force the individual batteries into thermal runaway, further described in Section 5.2.2, were positioned inside pod 6 (the initiator pod).

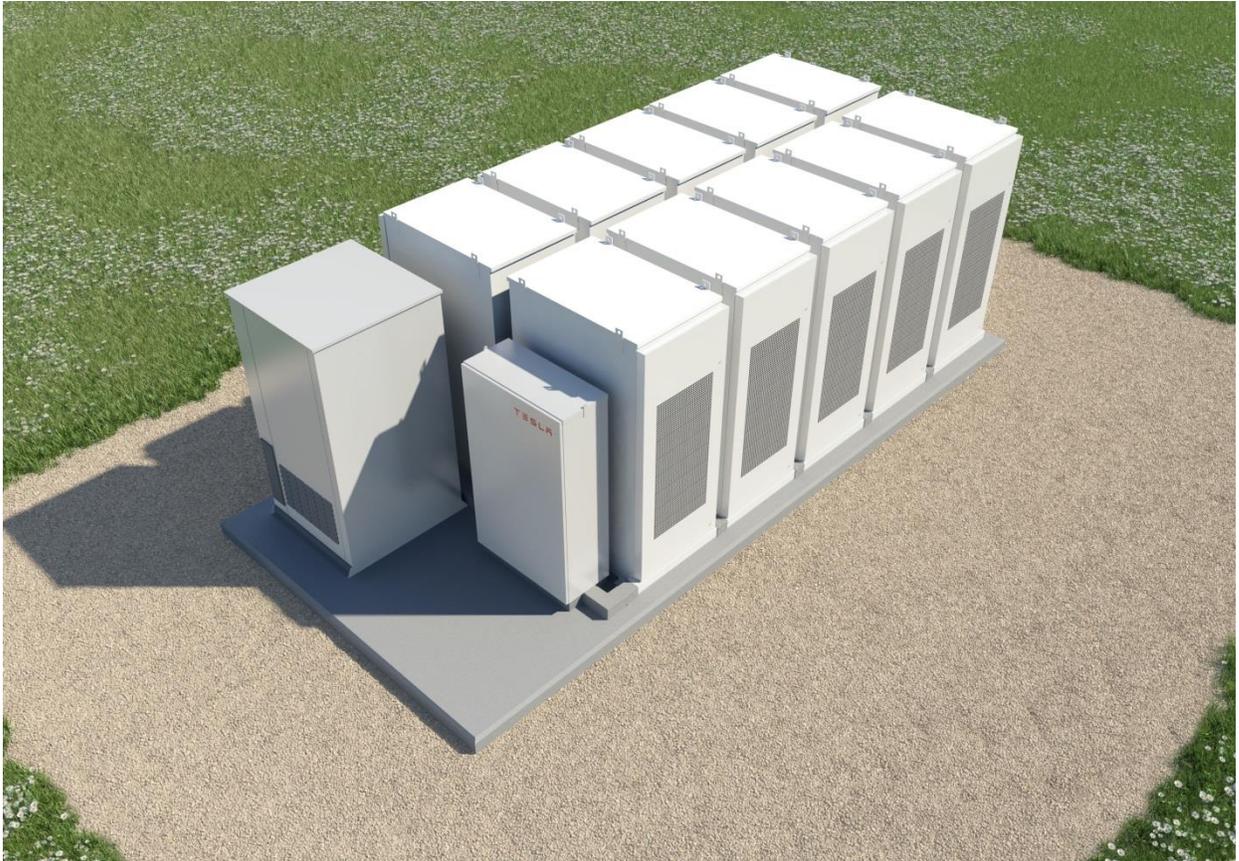
Figure 6 Multiple Powerpacks installed side by side in an array

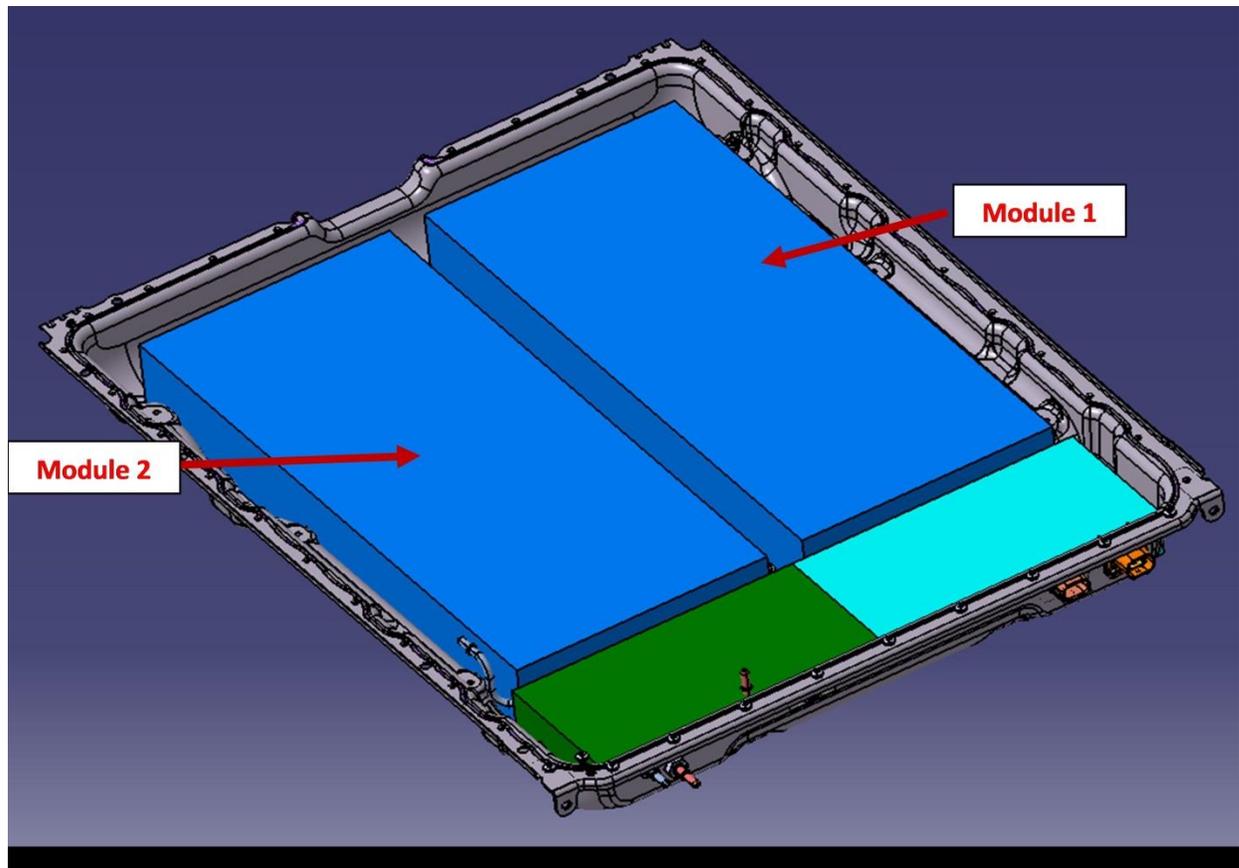
Figure 7 Illustration of a pod with two modules (blue); each module contains approximately 450 cylindrical Li-ion battery cells totaling 900 battery cells for each pod

The cells utilized within the Powerpack are 3.6 volt, 2.4 amp hour cylindrical 18650 cells. Two modules, each consisting of approximately 450 cells, are connected and enclosed inside a steel cover to form one energy storage pod, as shown in Figure 7. As such, one energy storage pod contains a total of two modules, or approximately 900 battery cells. Sixteen (16) energy storage pods are contained within the Powerpack cabinet for a total of approximately 14,400 battery cells within the Powerpack.

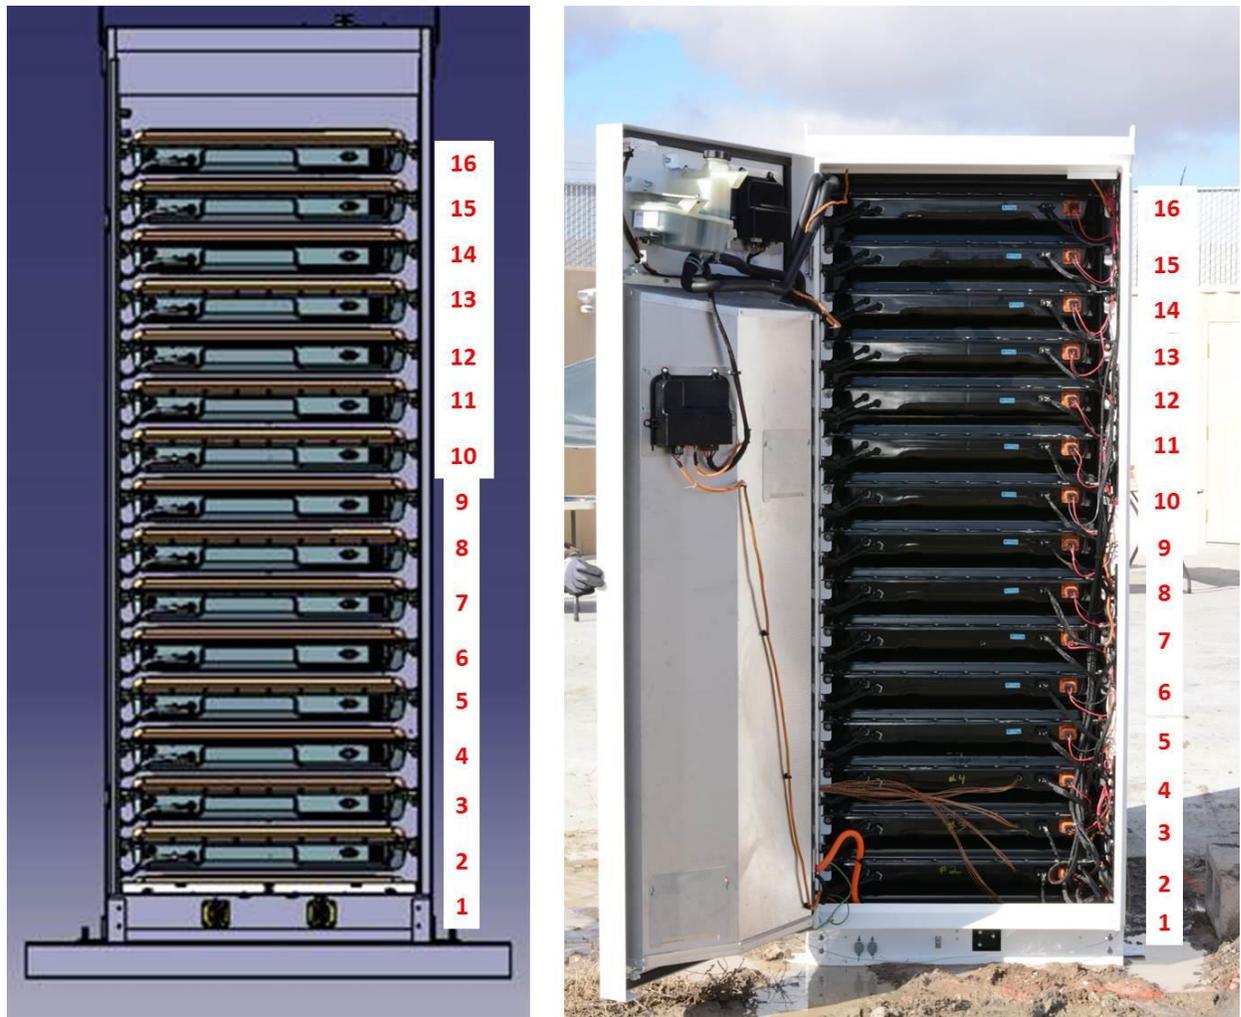
Figure 8 Powerpack illustration (left) and image (right); depicting the sixteen (16) energy storage pods installed within the cabinet and instrumented for testing

The Powerpack was designed for commercial installations. Within the Powerpack, Li-ion cells are contained within energy storage pods. The energy storage pods are housed inside a 52-inch long by 38-inch wide by 86-inch high steel cabinet. The total weight is 3,970 pounds. The front door of the Powerpack cabinet provides access to each of the 16 energy storage pods, as shown in Figure 8, and contains equipment designed to thermally cool the pods. The liquid cooling system pumps a 50% water / 50% ethylene glycol mixture to each of the 16 energy storage pods, as shown in Figure 9. The coolant pumps, reservoirs, and associated fans and radiators are mounted and contained within the front door of the Powerpack. A refrigerant system using 400 grams of R134a further cools the ethylene glycol and is also mounted on the front door of the Powerpack. The back of the energy storage pods connect to an exhaust manifold at the rear of the Powerpack that has a vent at the top, as shown in Figure 10.

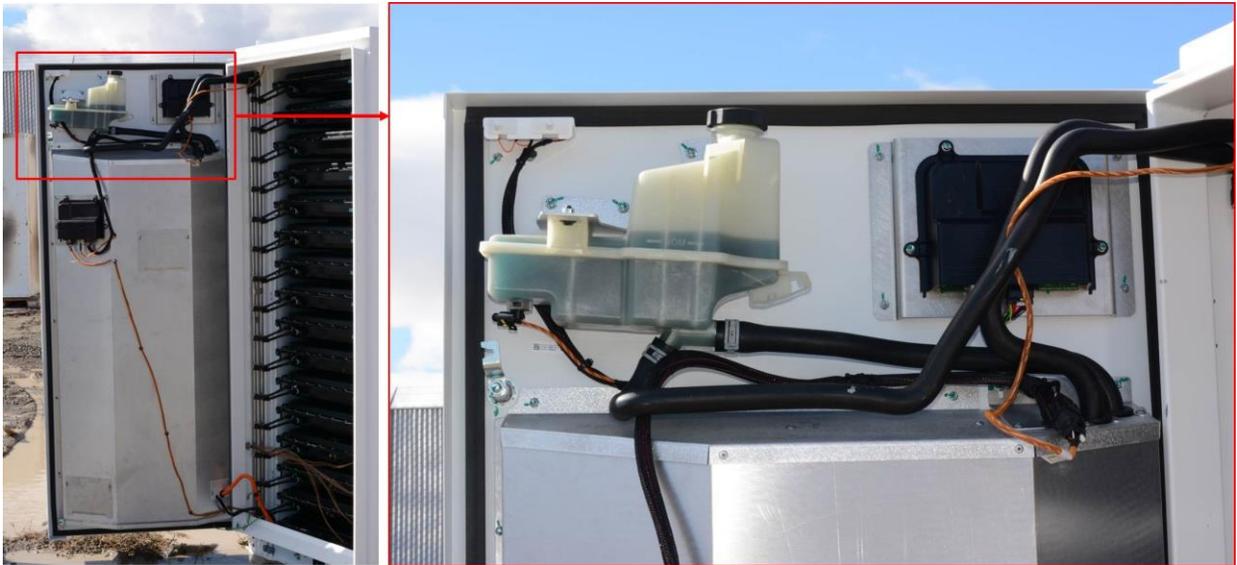
Figure 9 Powerpack thermal door (left) and close up of the refrigerant (right)

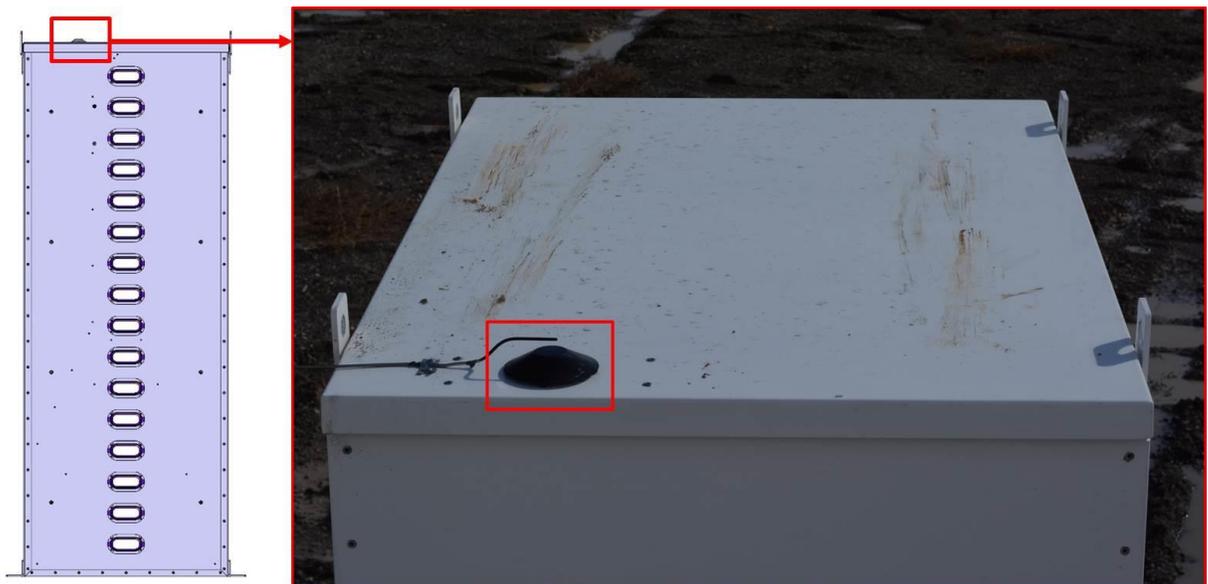
Figure 10 Illustration of the Powerpack exhaust vent (left) and an image of the vent at the top of the Powerpack (right)

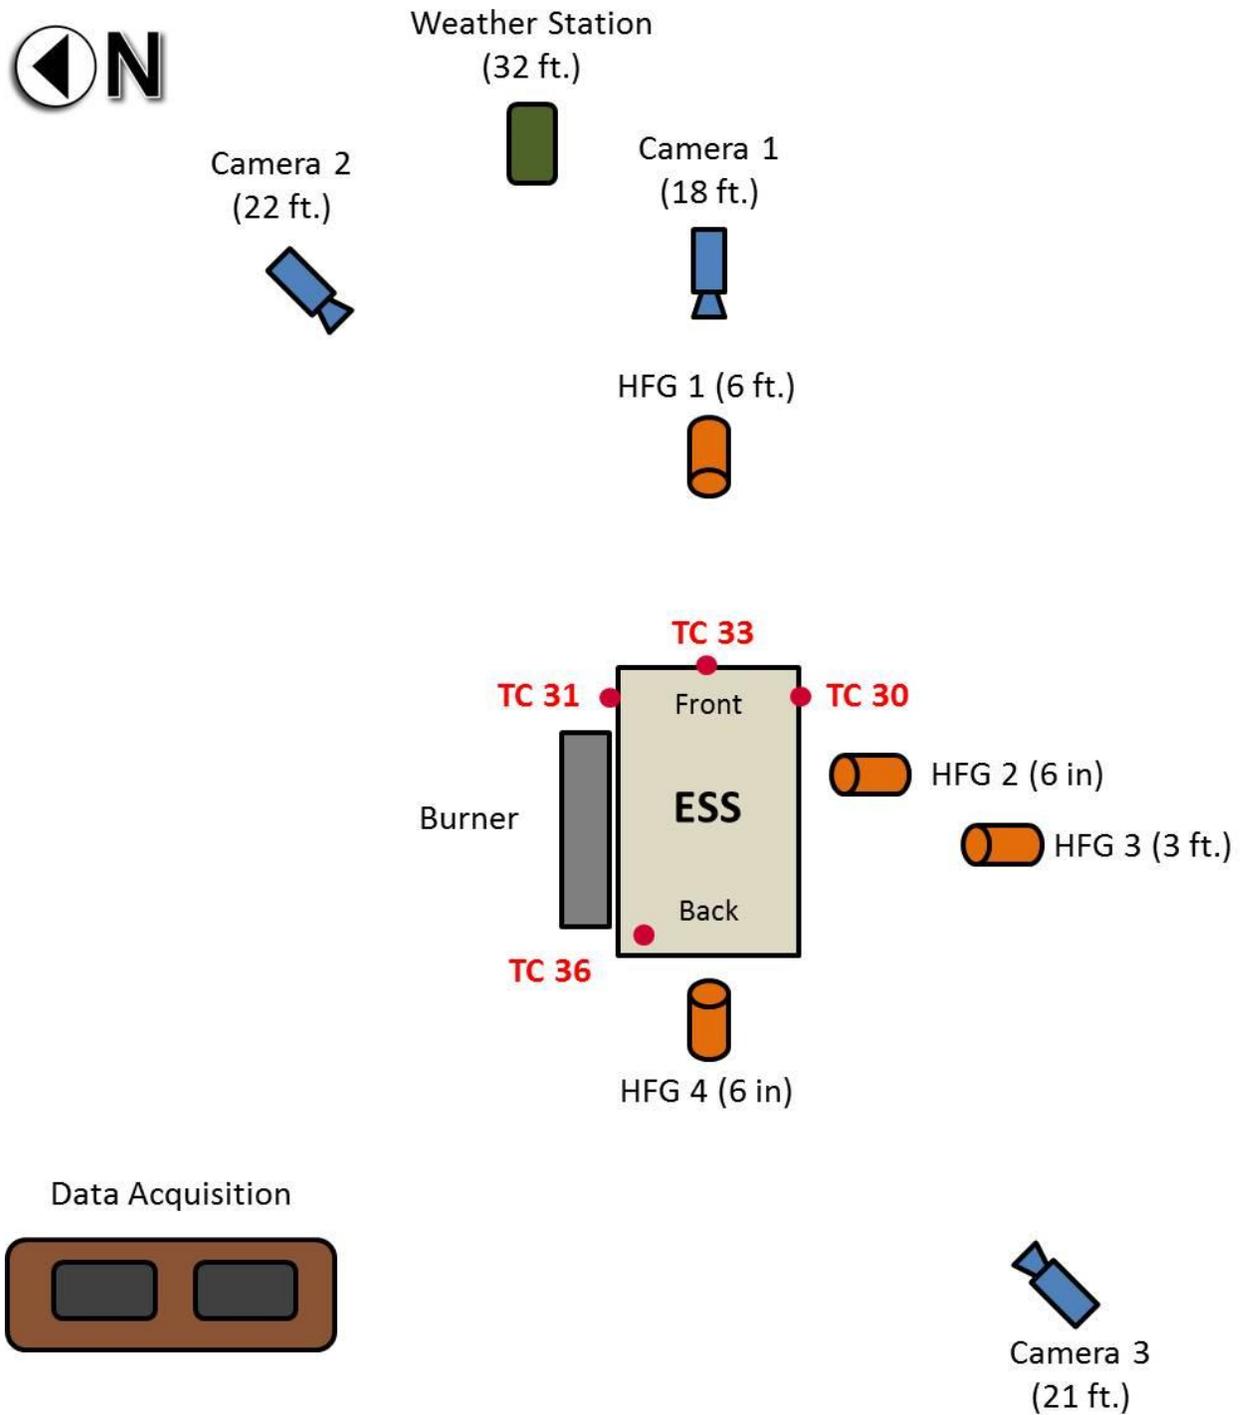
Figure 11 External fire test setup and instrumentation

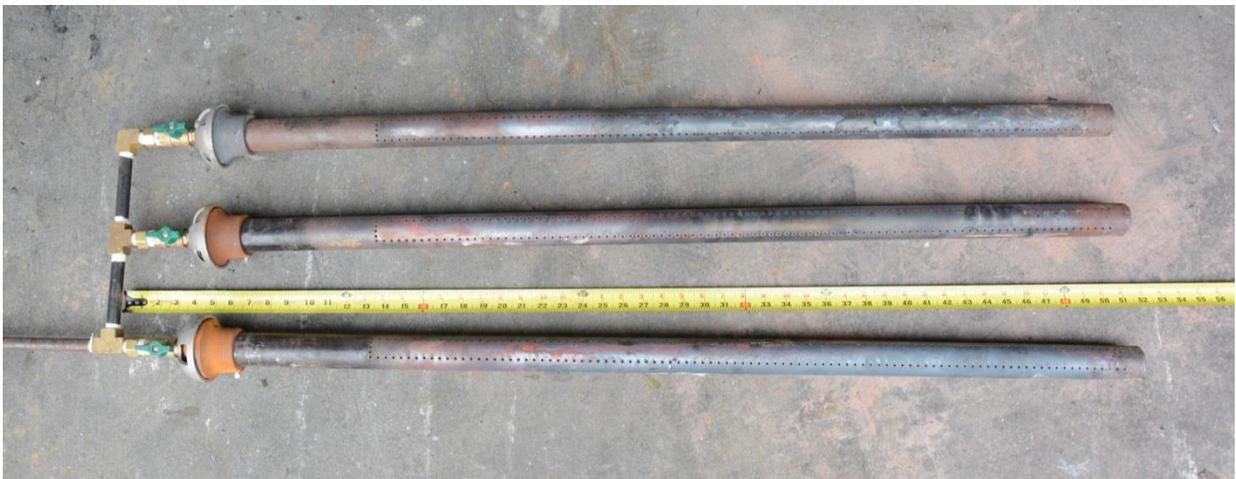
Figure 12 Burners utilized for testing

Each burner was 1.25 inches in diameter and 49 inches long and consisted of two rows of 2 mm orifices drilled at an angle 45 degrees apart. The orifices extended for 36 inches, spaced approximately 5 mm apart. The three burners were installed inside a five sided, 36 by 36 inch by 8 inch steel shell, with a steel mesh covering the opening to increase the amount of radiative heat load from the burner assembly to the exterior wall of the Powerpack enclosure. The burner assembly was positioned against the right side of the Powerpack cabinet to allow for direct flame impingement on the exterior of the unit, as shown in Figure 13. .

The flow of propane was monitored by a calibrated Omega FMA1845A mass flow meter, capable of measuring up to 1,000 liters per minute (lpm). The flow rate of propane was adjusted to provide an output of approximately 400 kW during the test.⁸¹

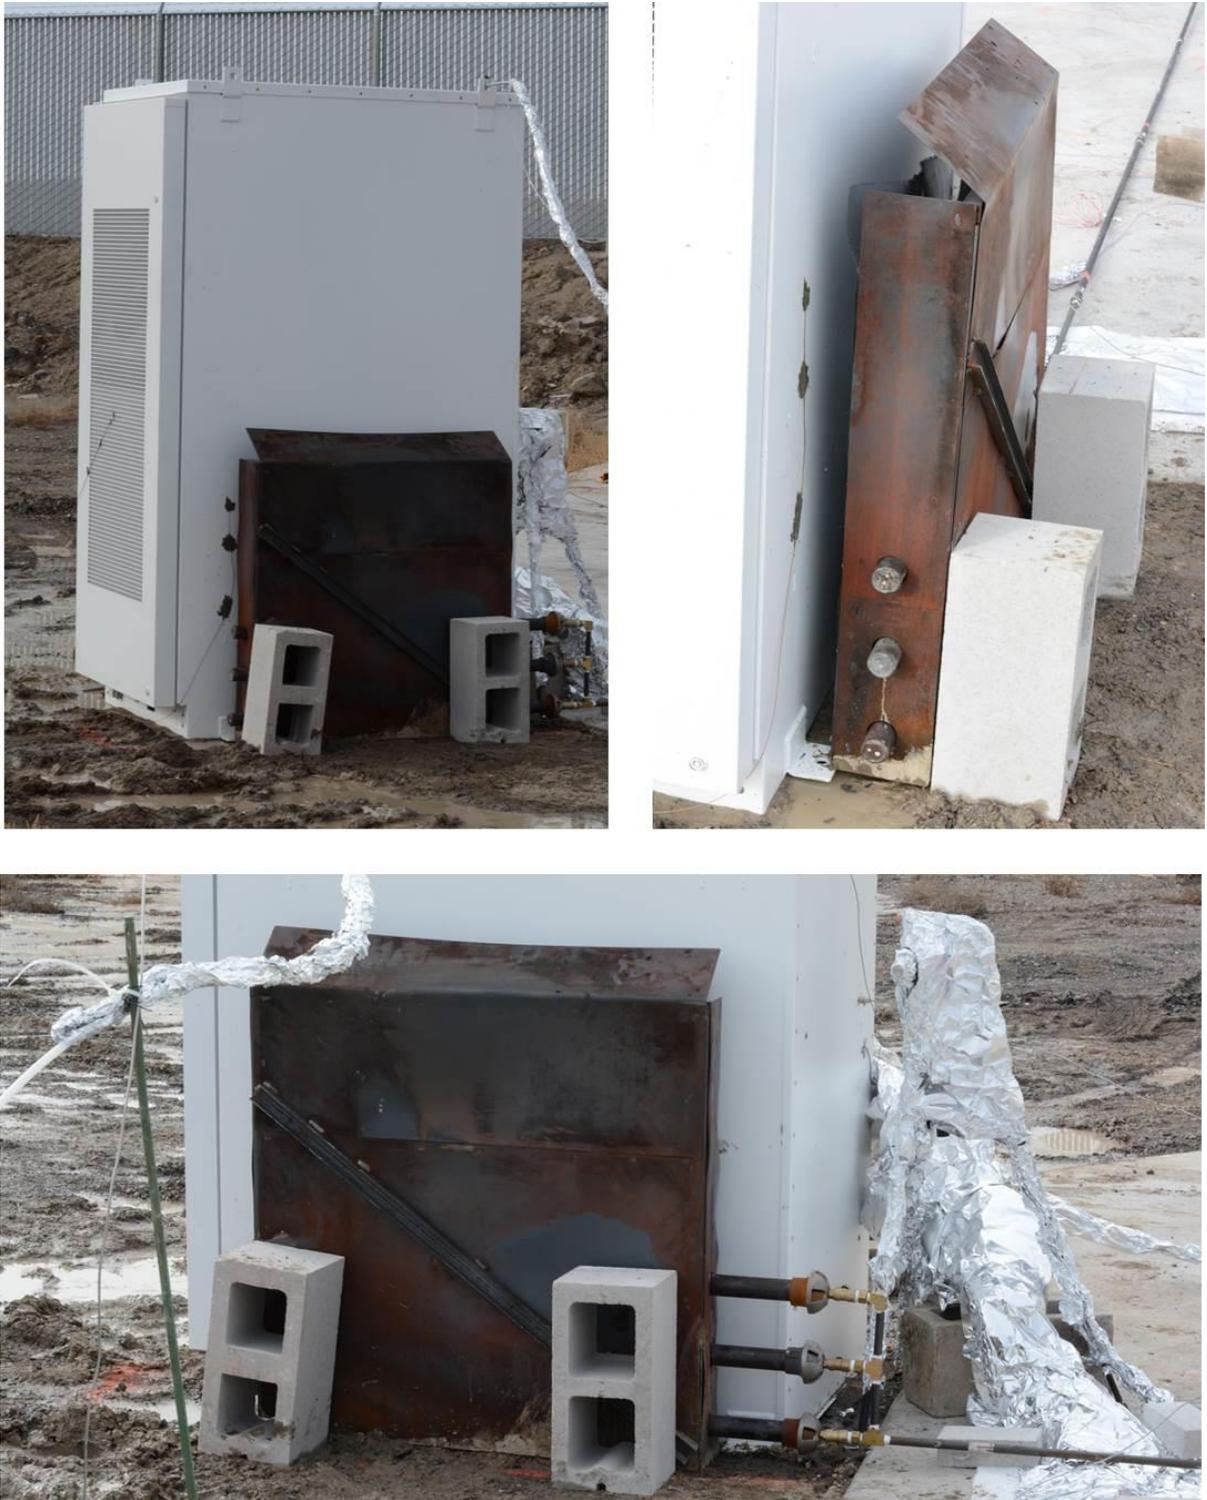
Figure 13 Burner assembly and positioning

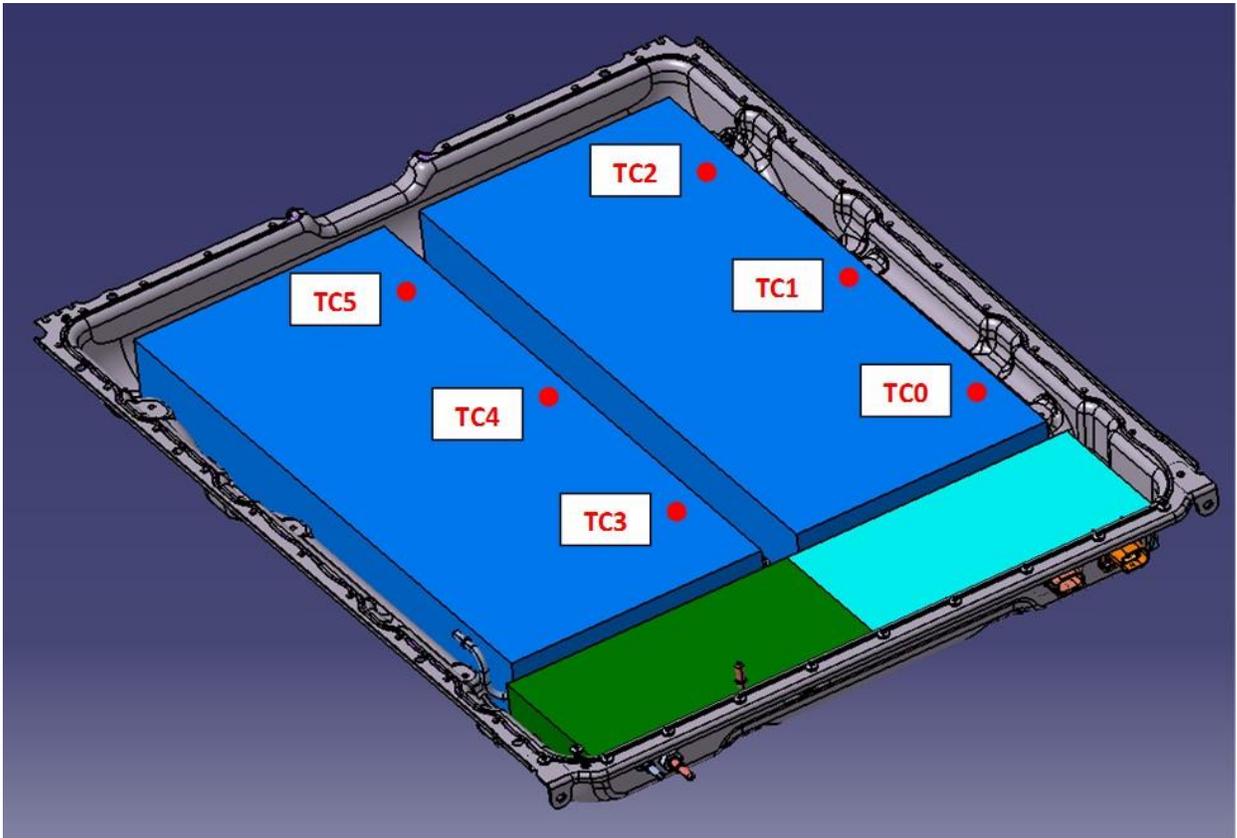
Figure 14 TC measurement locations within Pod 1; Pods 2 through 4 are similarly instrumented and labeled in the same numerical order

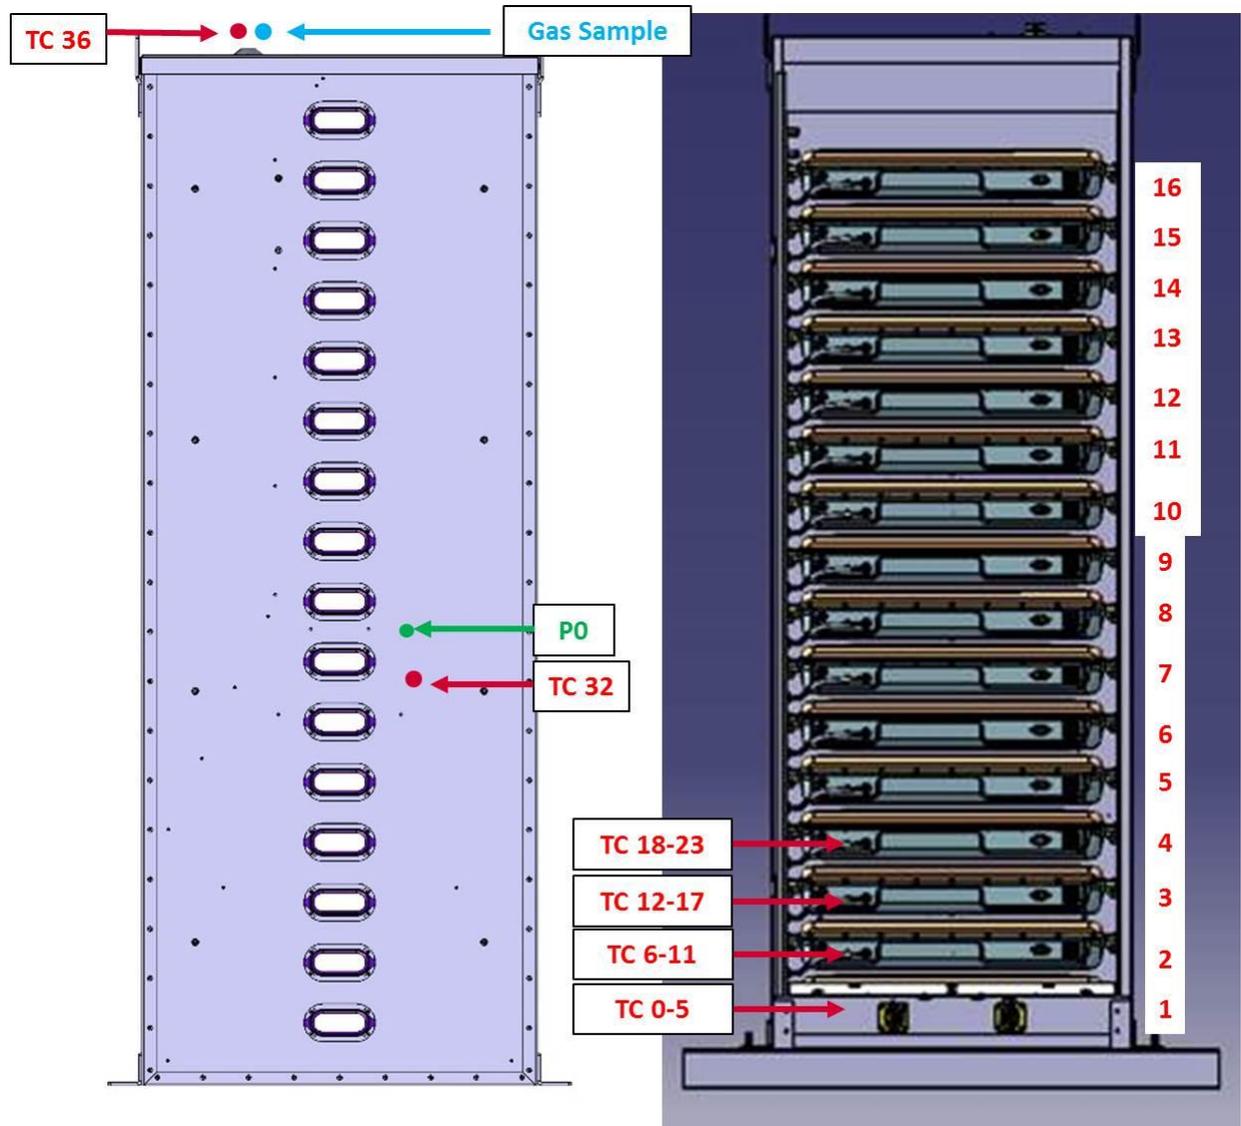
Figure 15 TC, gas sampling, and pressure measurement locations inside the Powerpack cabinet

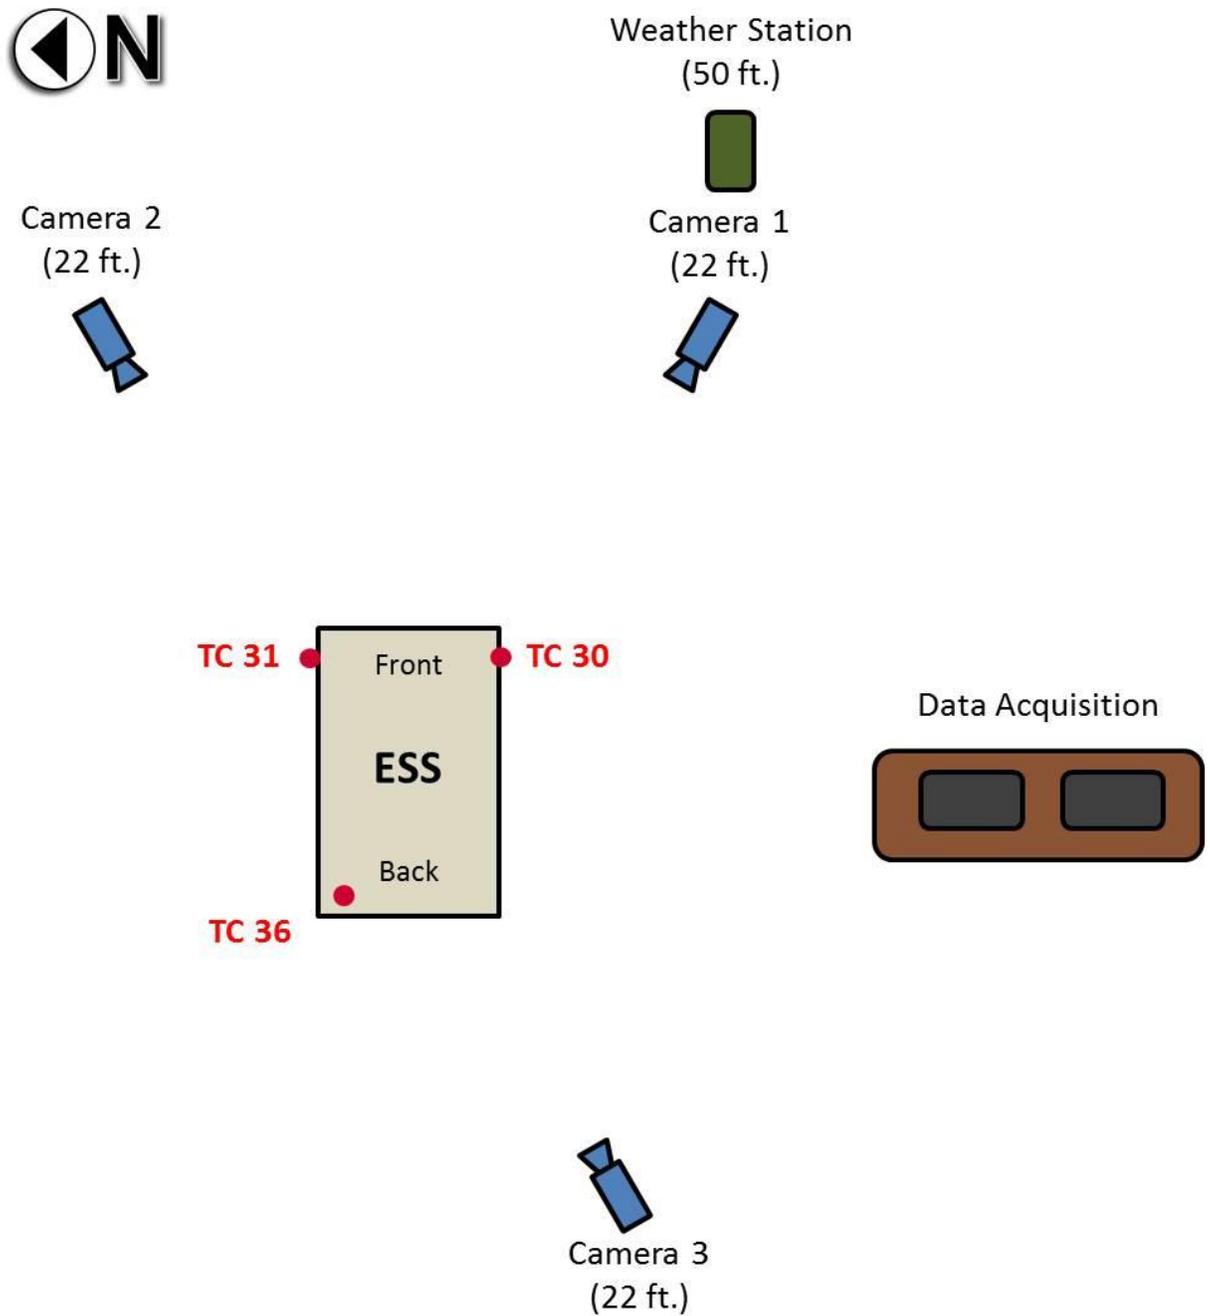
Figure 16 Internal ignition test setup and instrumentation

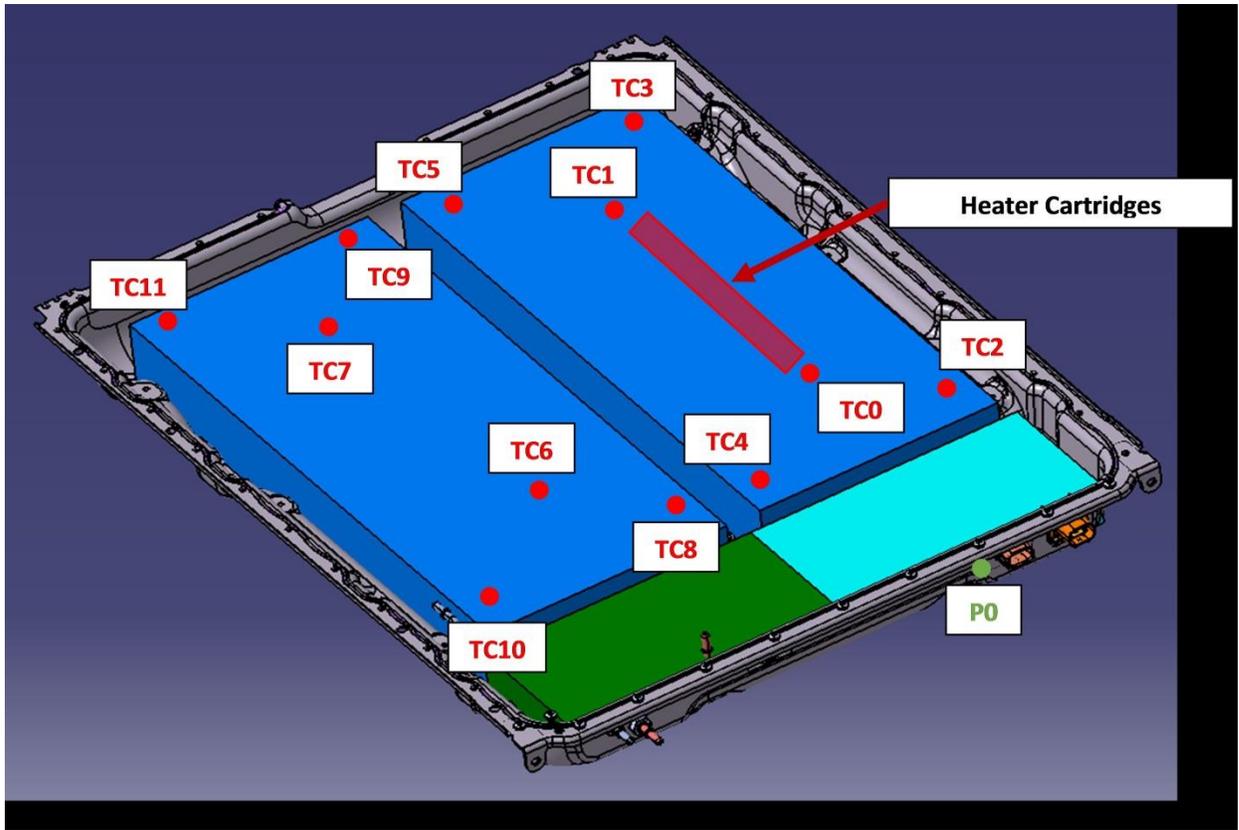
Figure 17 TC, pressure measurement and heater cartridge locations within Pod 6

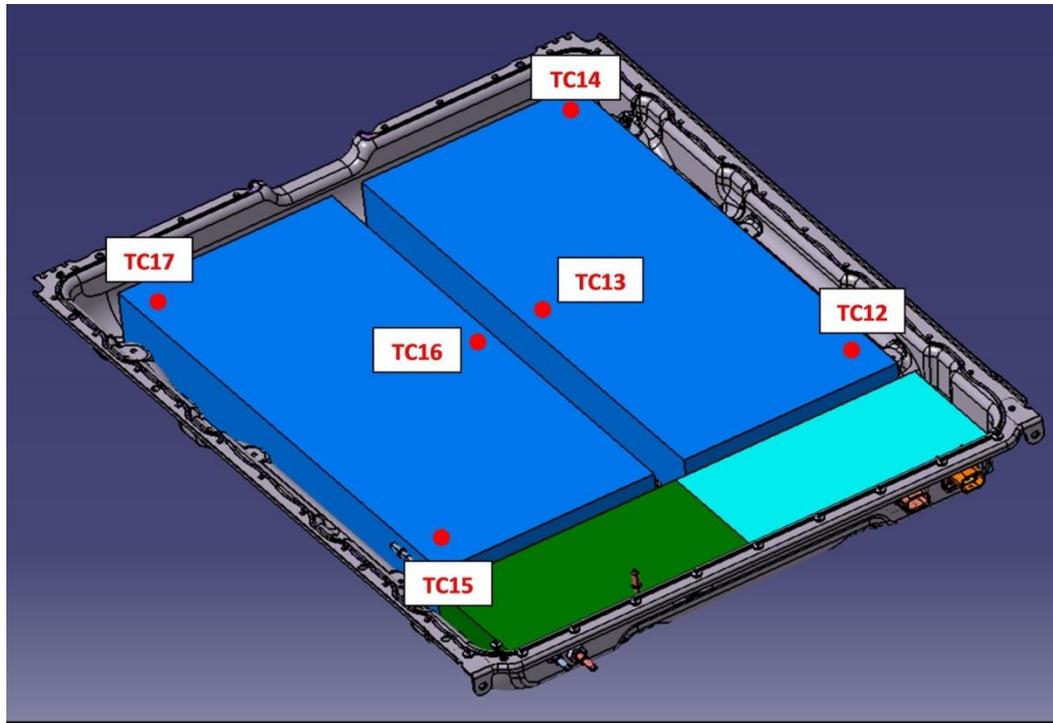
Figure 18 TC measurement locations within Pod 5

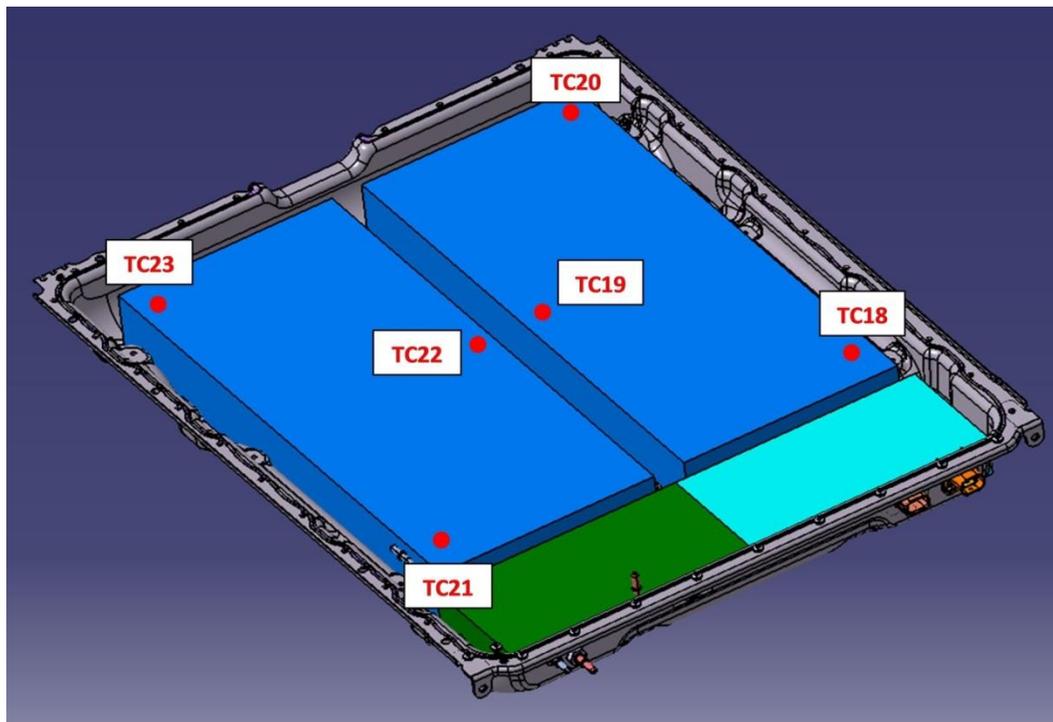
Figure 19 TC measurement locations within Pod 7
