Hazard Assessment of Lithium Ion Battery Energy Storage Systems

FINAL REPORT

Andrew F. Blum, P.E., CFEI
R. Thomas Long Jr., P.E., CFEI
Exponent, Inc.
17000 Science Drive, Suite 200
Bowie, MD 20715

**Fire Hazard Assessment of
Lithium Ion Battery
Energy Storage Systems**

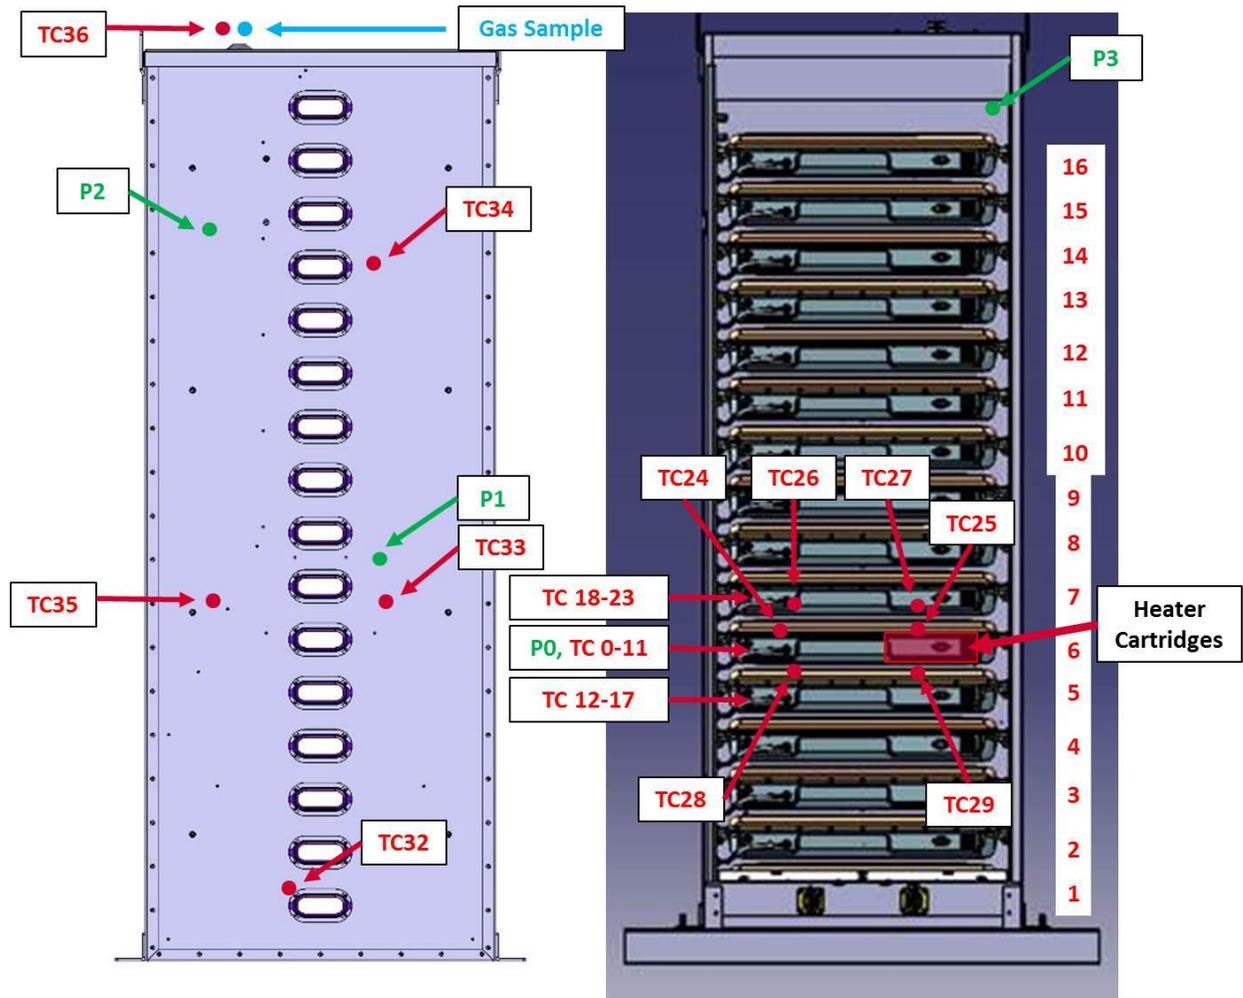
Figure 20 TC, gas sampling, and pressure measurement locations inside the Powerpack cabinet

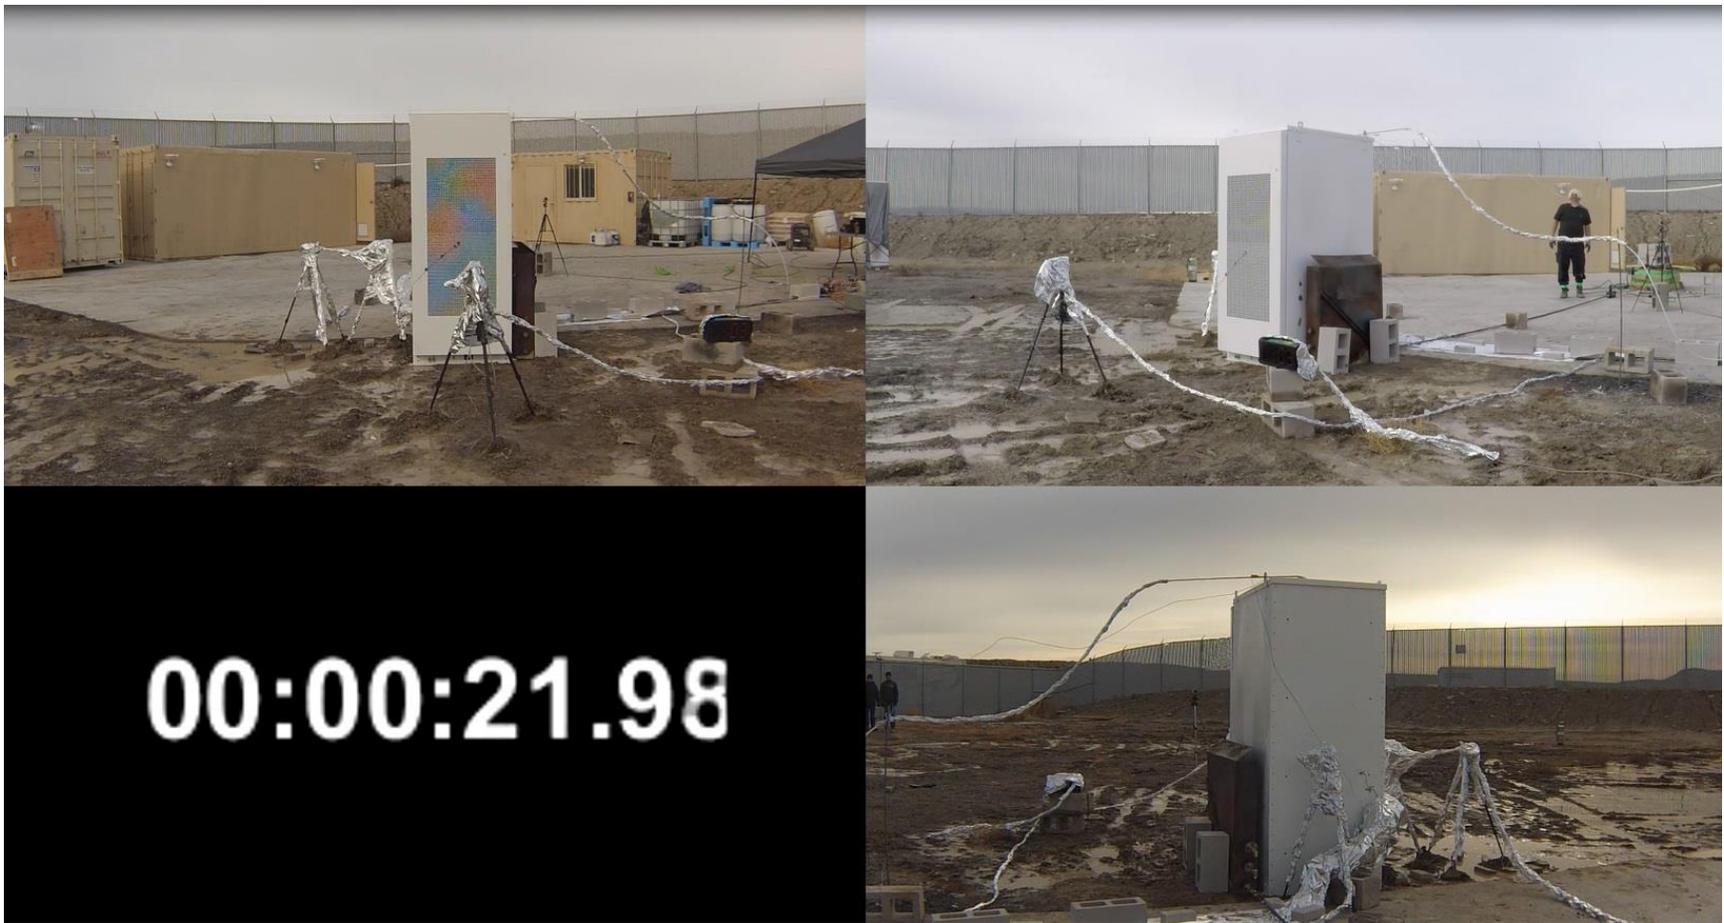
Figure 21 External test screenshot: start of test, burners "ON"

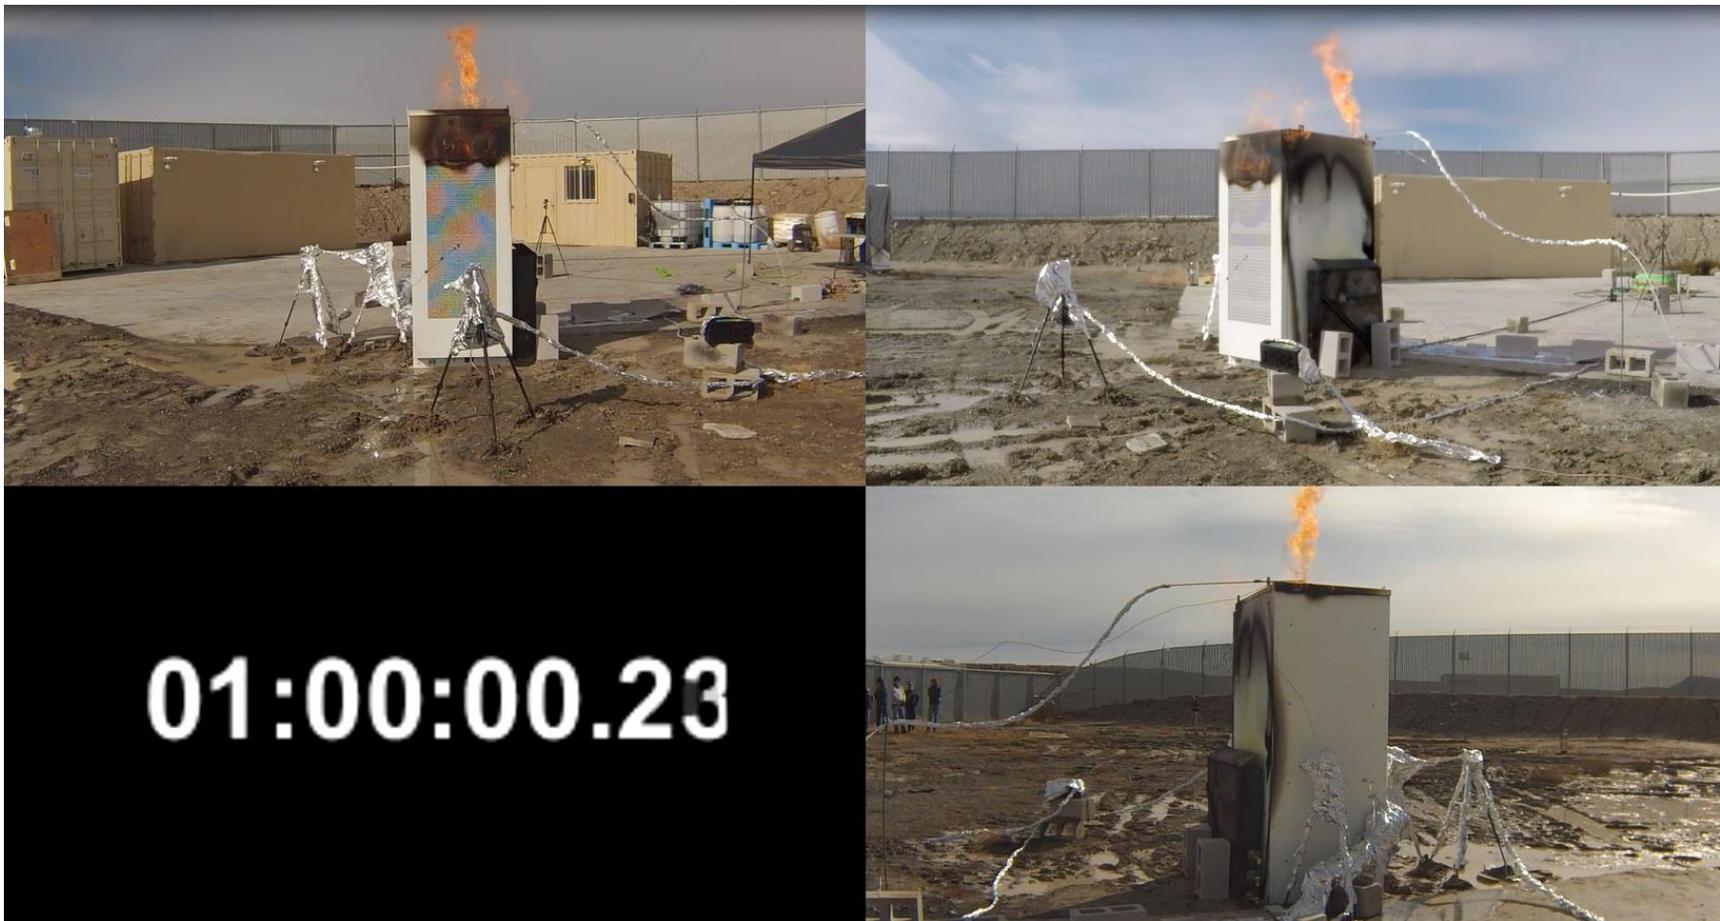
Figure 22 External test screenshot: test time = 1 hour, fire emanating from the front door and exhaust vent, pops consistent with battery cell thermal runaway heard steadily, burners turned "OFF"

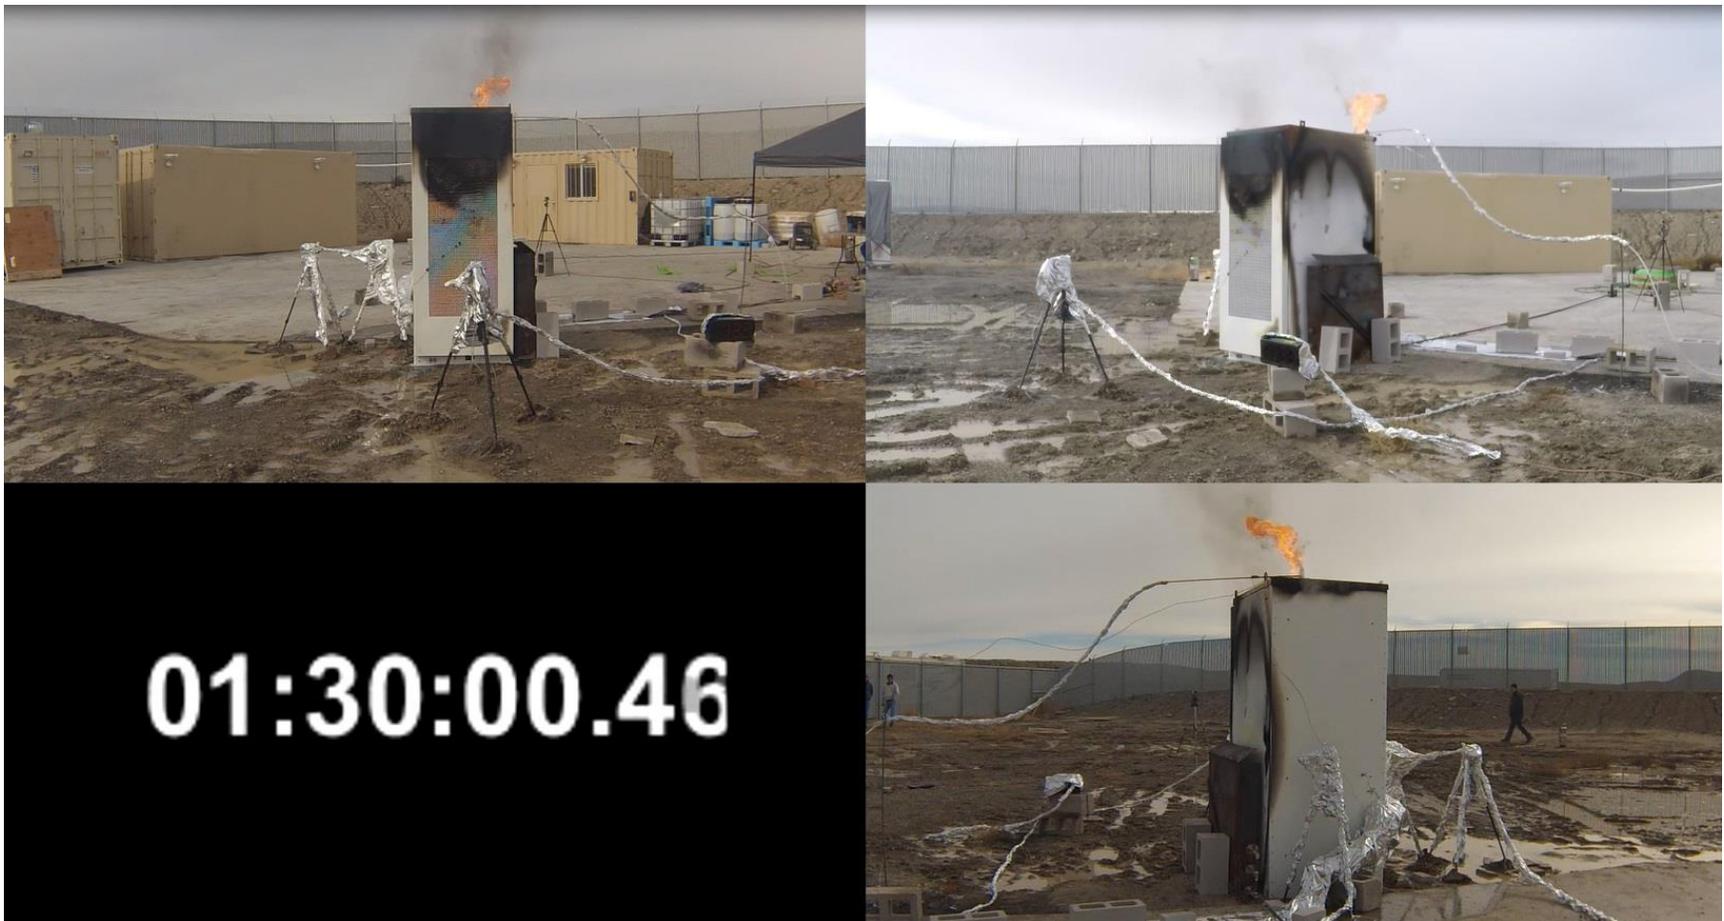
Figure 23 External test screenshot: test time = 1 hour 30 minutes, flames at front door and exhaust vent intermittently decreasing in intensity

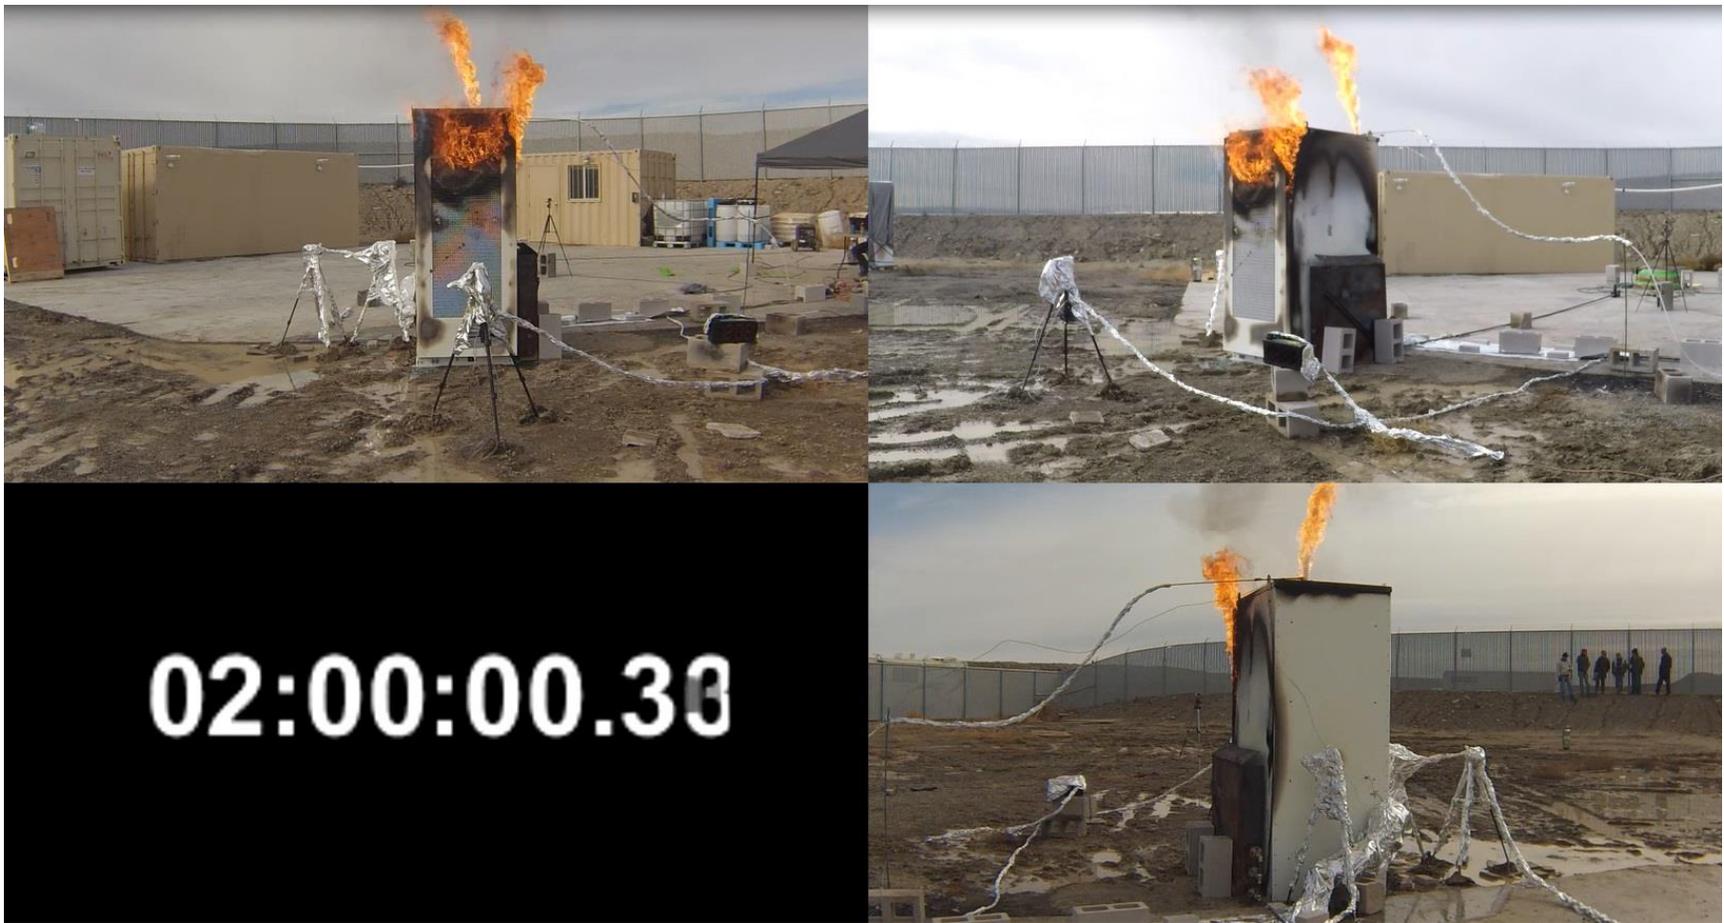
Figure 24 External test screenshot: test time = 2 hours, fire inside the Powerpack intensifying

2:00:00	Fire inside Powerpack intensifying
2:30:00	Fire inside Powerpack steady
2:33:30	Fire inside Powerpack decreasing in intensity
3:00:00	Fire insides subsiding, weak flames observed out the front door and exhaust vent

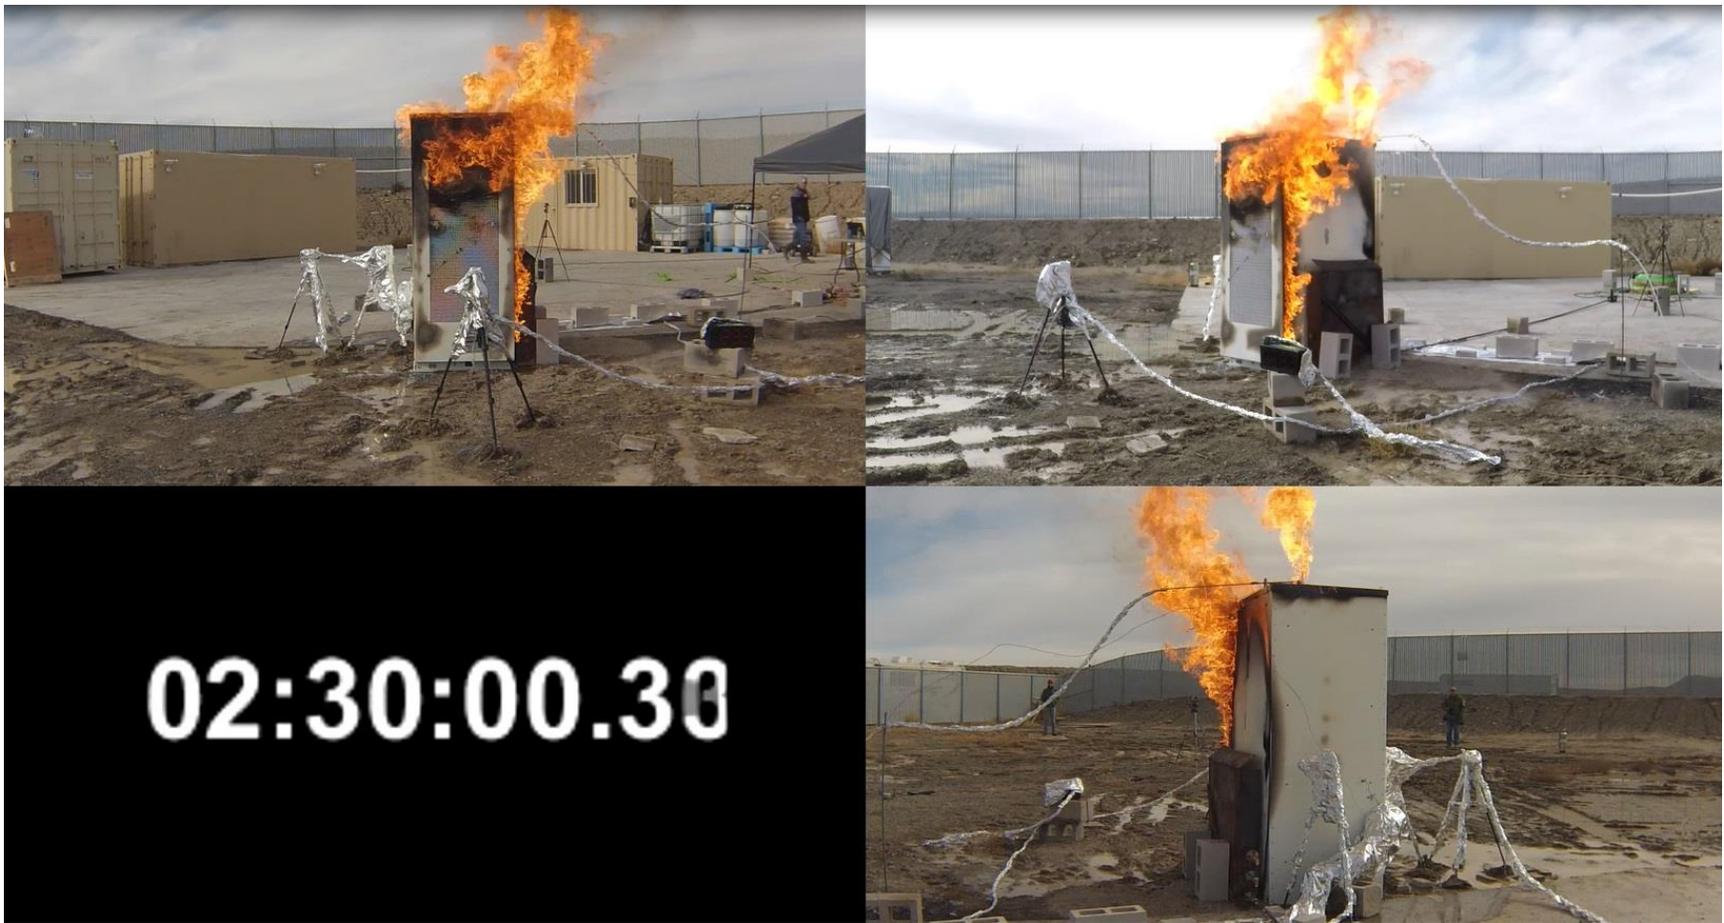
Figure 25 External test screenshot: test time = 2 hours 30 minutes, fire inside the Powerpack intensifying

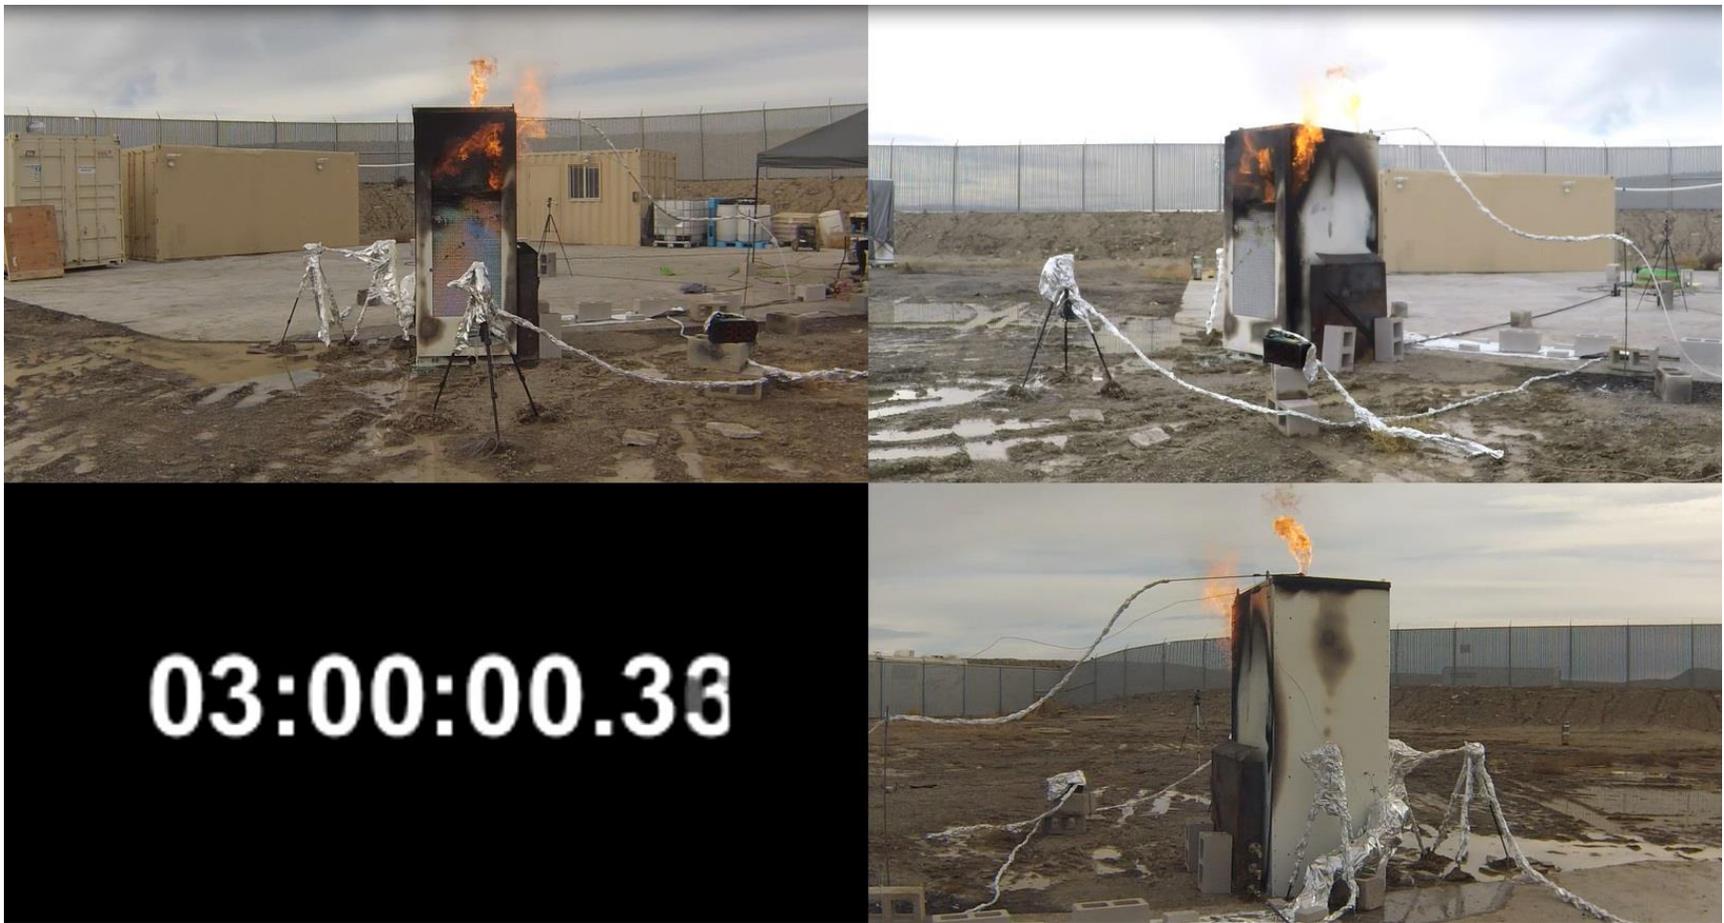
Figure 26 External test screenshot: test time = 3 hours, fire inside the Powerpack subsiding

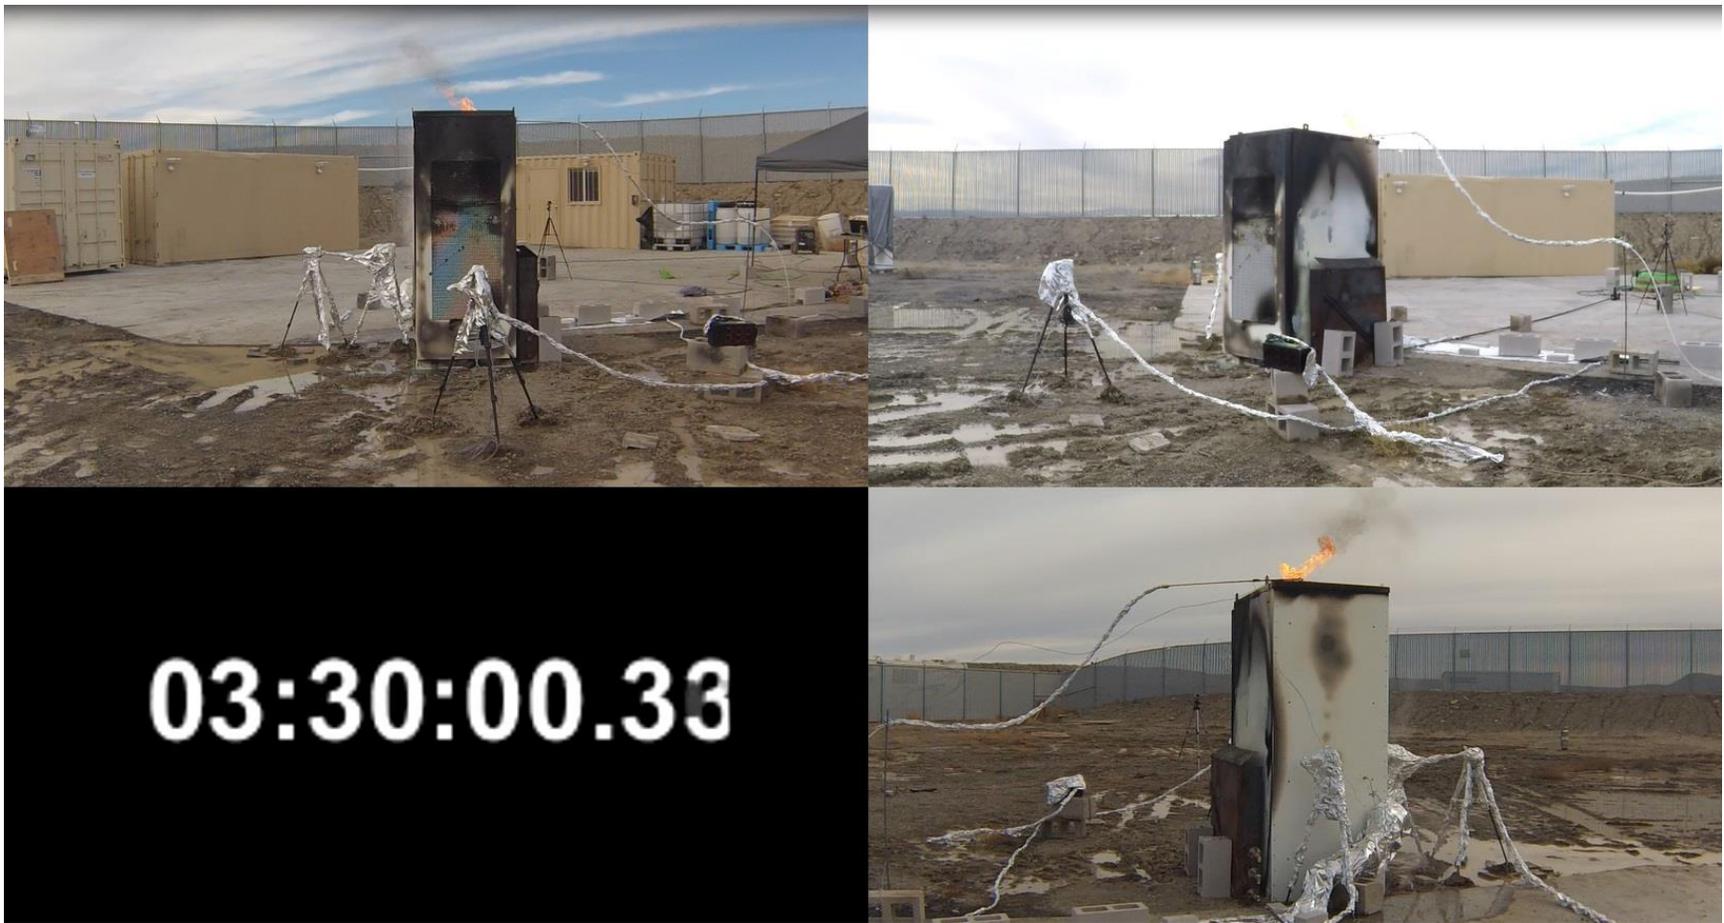
Figure 27 External test screenshot: test time = 3 hours 30 minutes, fire inside the Powerpack burning itself out

3:10:50	Last pop heard from Powerpack
3:30:00	Fire continues to decrease in intensity
3:41:10	Last visible flame out
3:45:00	Cameras and data acquisition off

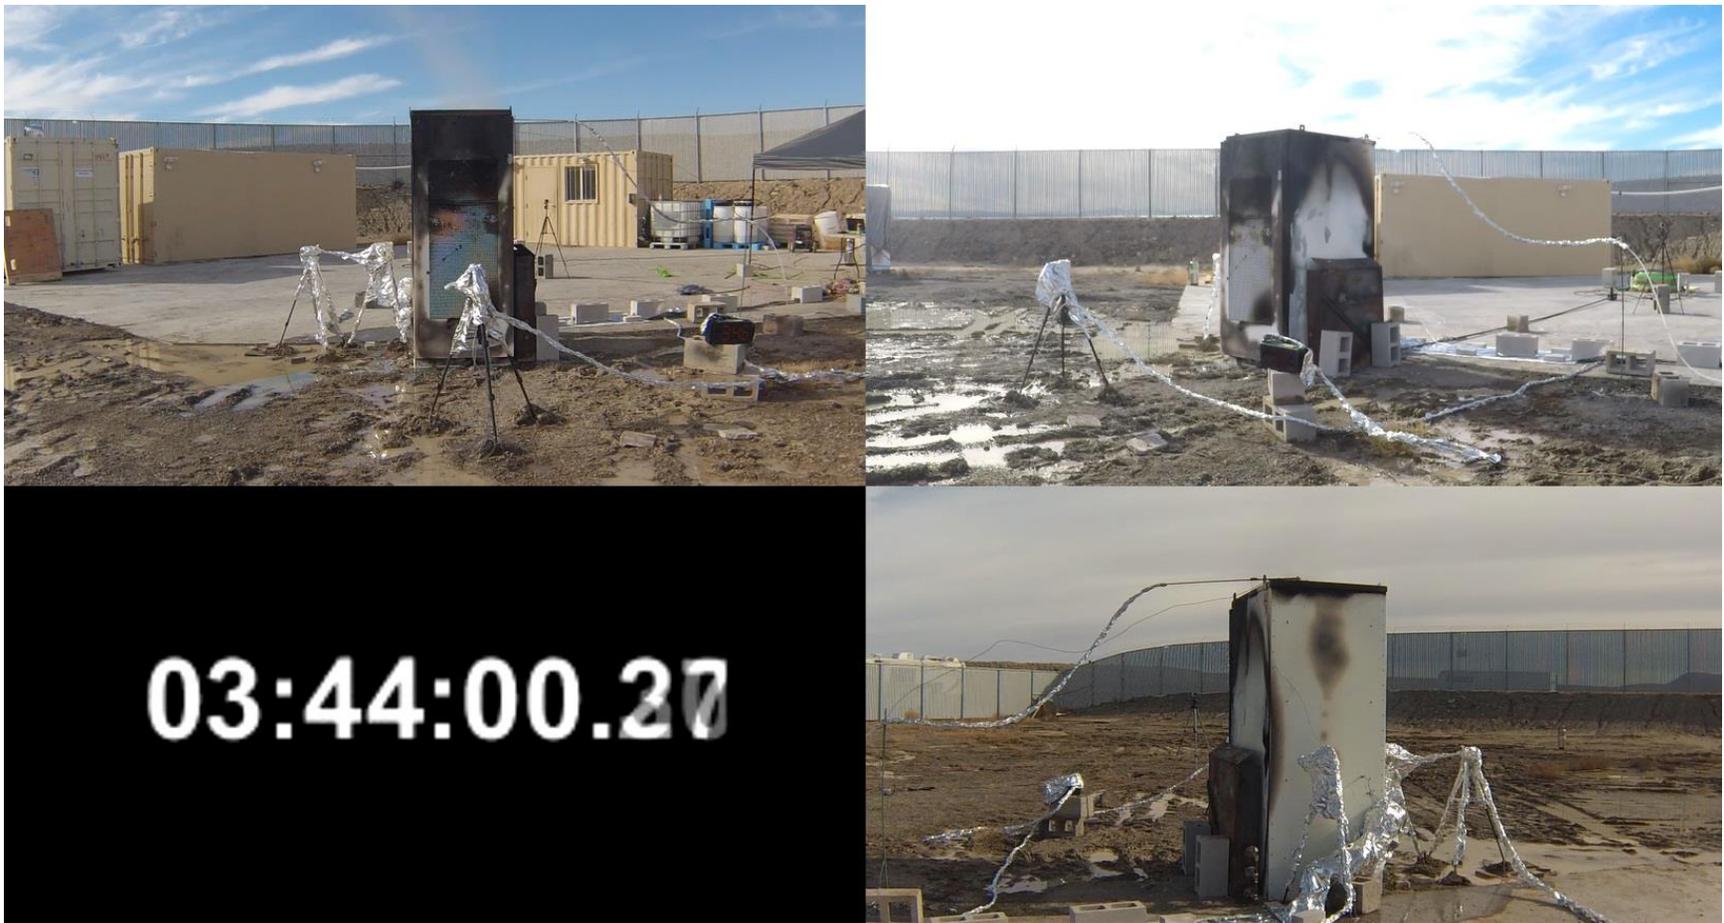
Figure 28 External test screenshot: end of test, fire is out.

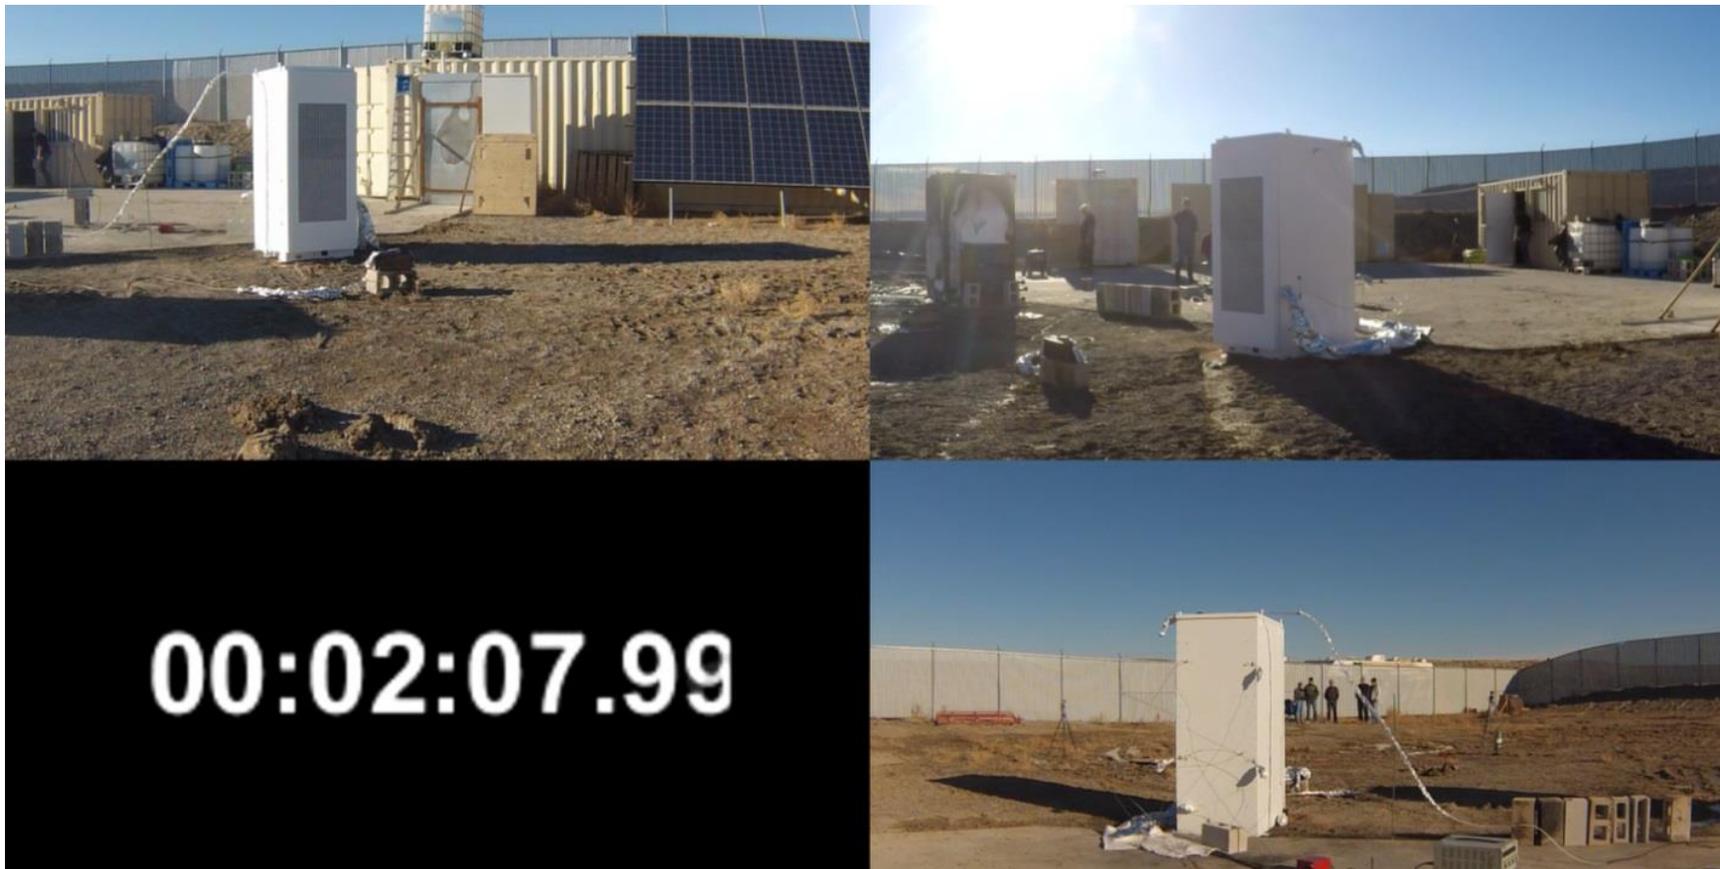
Figure 29 Internal test screenshot: start of test, heater cartridges "ON"

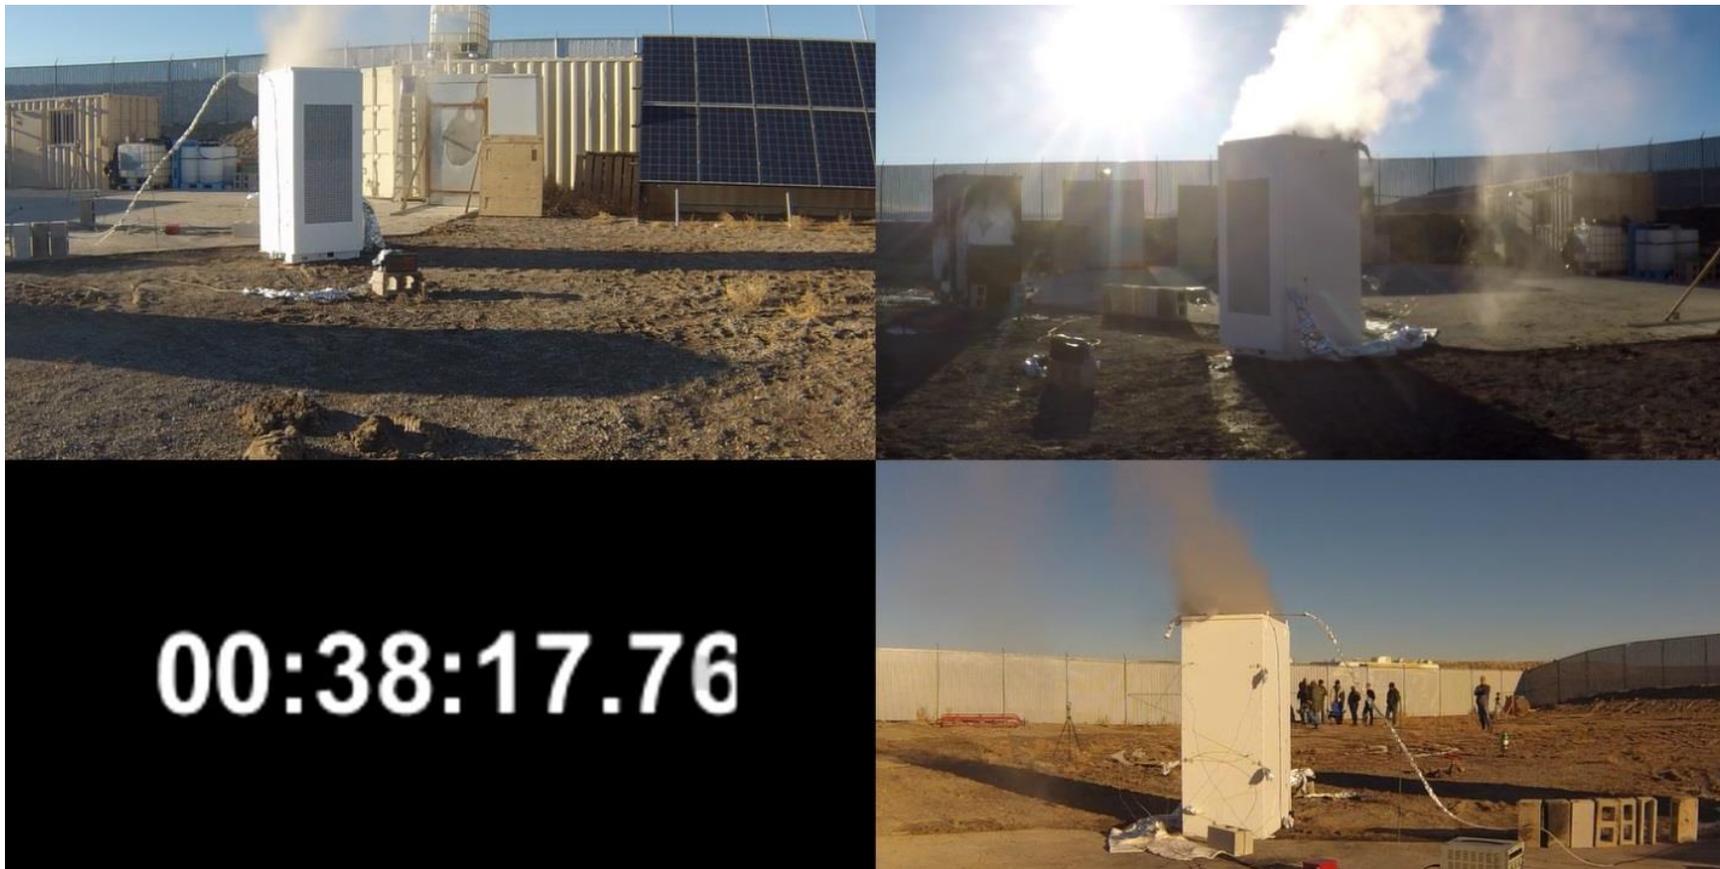
Figure 30 Internal test screenshot: peak smoke production approximately 35 to 40 minutes after the heater cartridges were turned "ON"

0:36:22	Steady pops heard from Powerpack starting at this time until 0:45:01 consistent with cell thermal runaway
0:38:34	Heater cartridges turned off.
0:45:01	Last pop heard from Powerpack

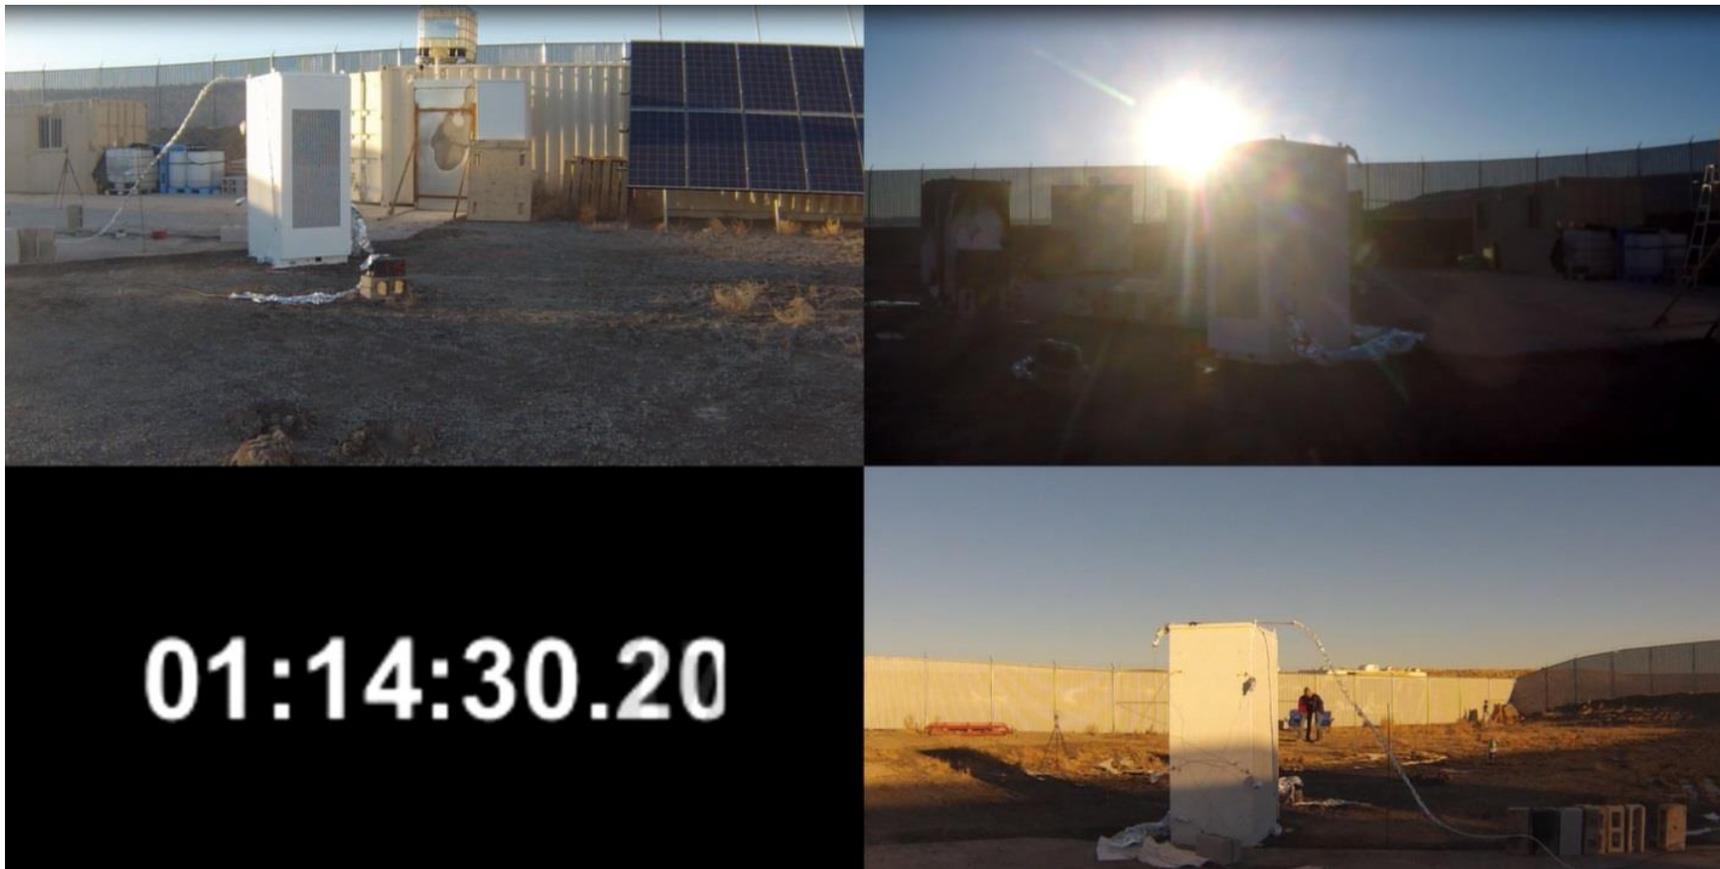
Figure 31 Internal test screenshot: end of test

0:49:30	Smoke production at exhaust vent subsiding
1:00:00	Smoke production at exhaust vent subsiding
1:15:00	Smoke production at exhaust vent subsiding
1:30:00	Smoke production at exhaust vent barely visible, cameras and data acquisition turned off, test terminated

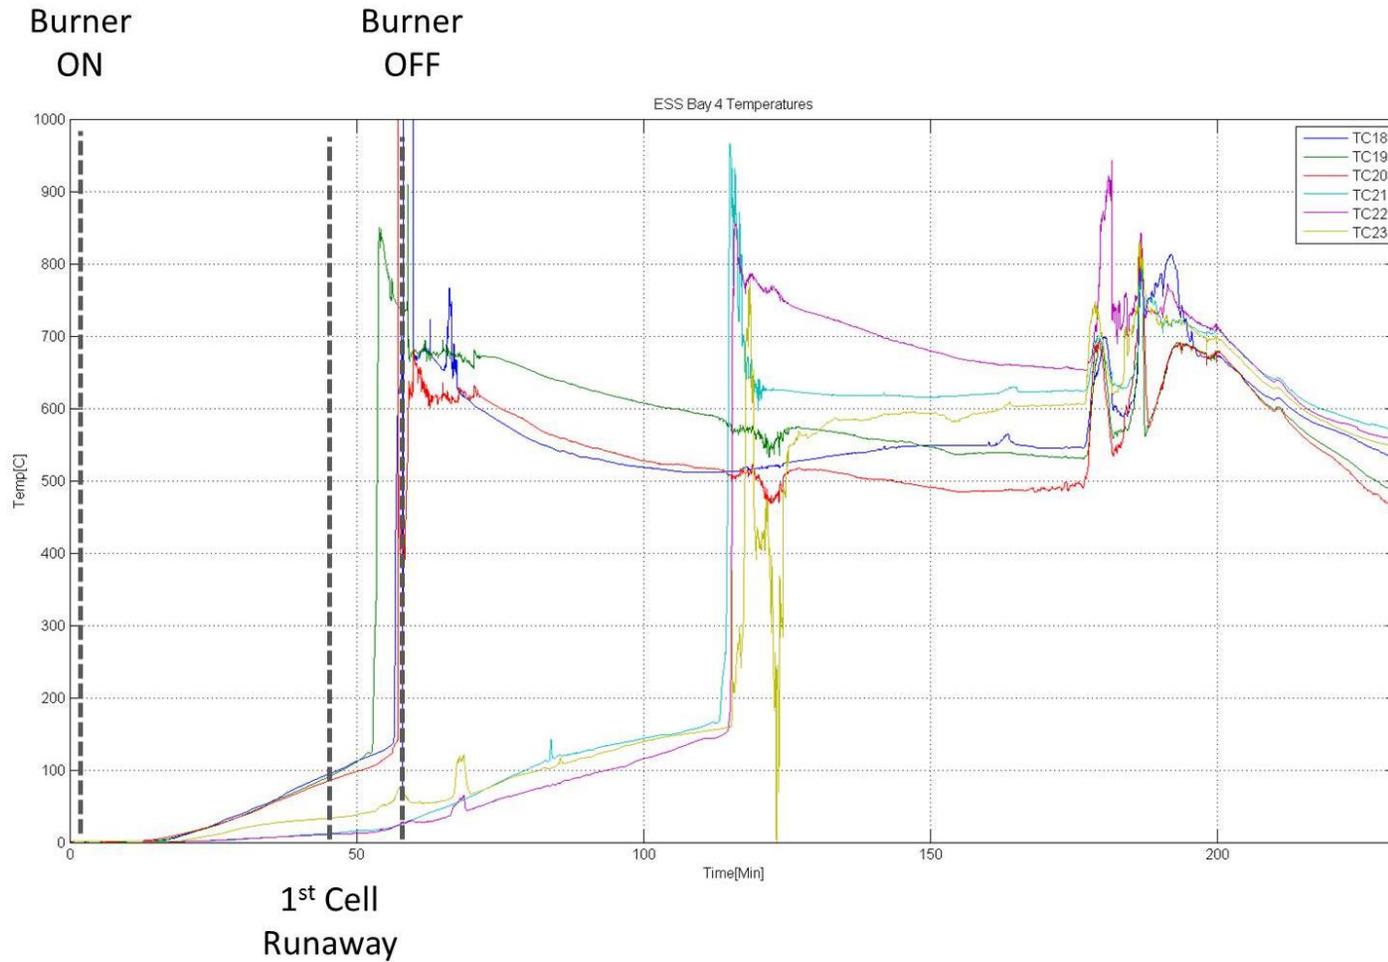
Figure 32 Powerpack Pod 4 temperatures (noise observed in the data is consistent with electrical interference that occurs during voltage leakage from the damaged batteries after thermal runaway)

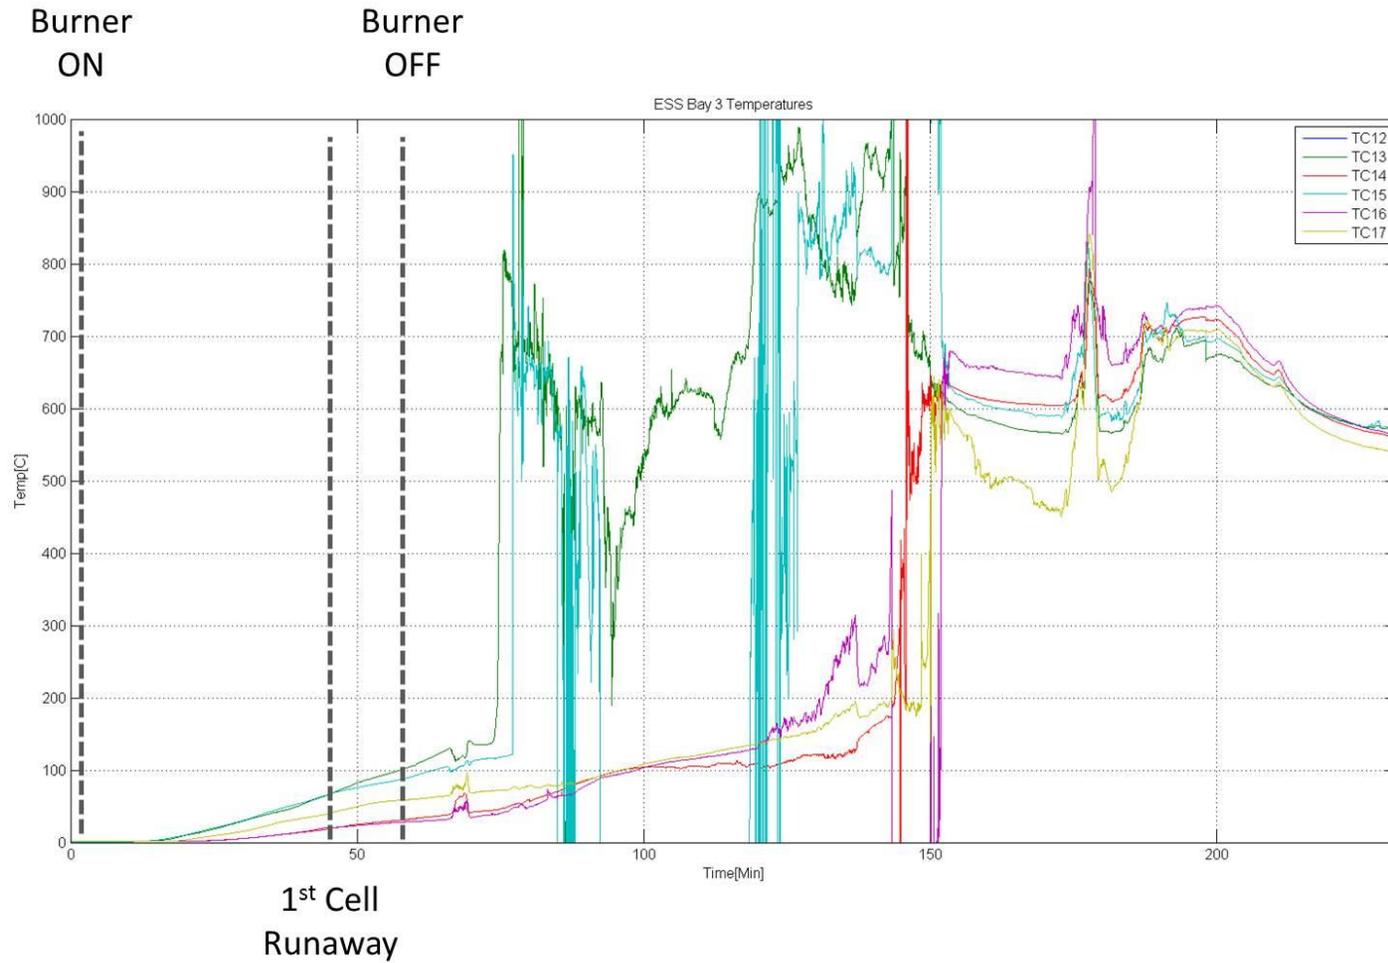
Figure 33 Powerpack Pod 3 temperatures (noise observed in the data is consistent with electrical interference that occurs during voltage leakage from the damaged batteries after thermal runaway)

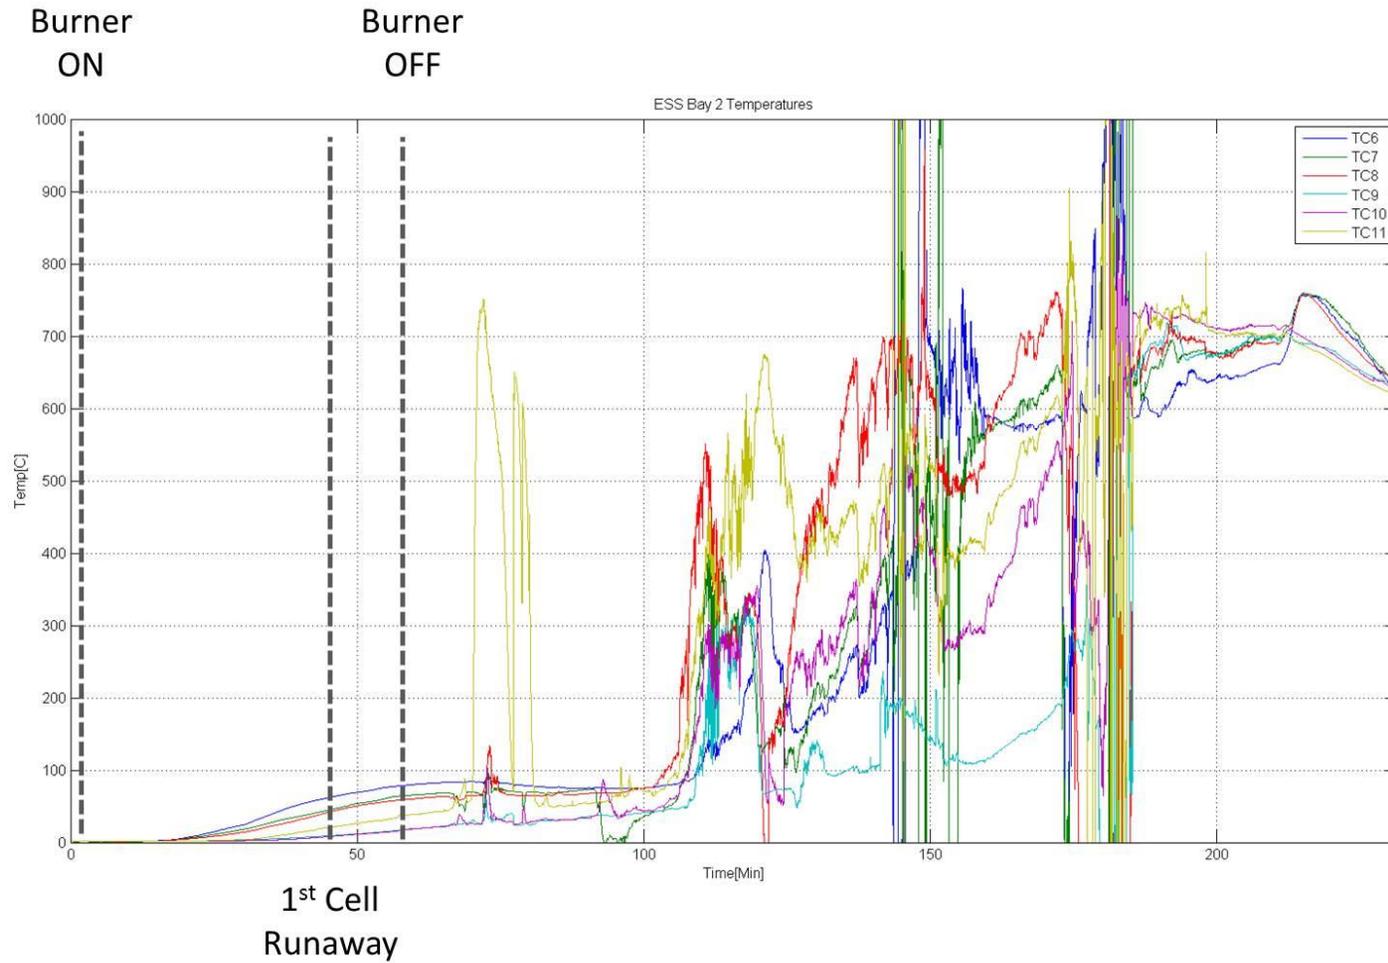
Figure 34 Powerpack Pod 2 temperatures (noise observed in the data is consistent with electrical interference that occurs during voltage leakage from the damaged batteries after thermal runaway)
