Hazard Assessment of Lithium Ion Battery Energy Storage Systems

FINAL REPORT

Andrew F. Blum, P.E., CFEI
R. Thomas Long Jr., P.E., CFEI
Exponent, Inc.
17000 Science Drive, Suite 200
Bowie, MD 20715

**Fire Hazard Assessment of
Lithium Ion Battery
Energy Storage Systems**

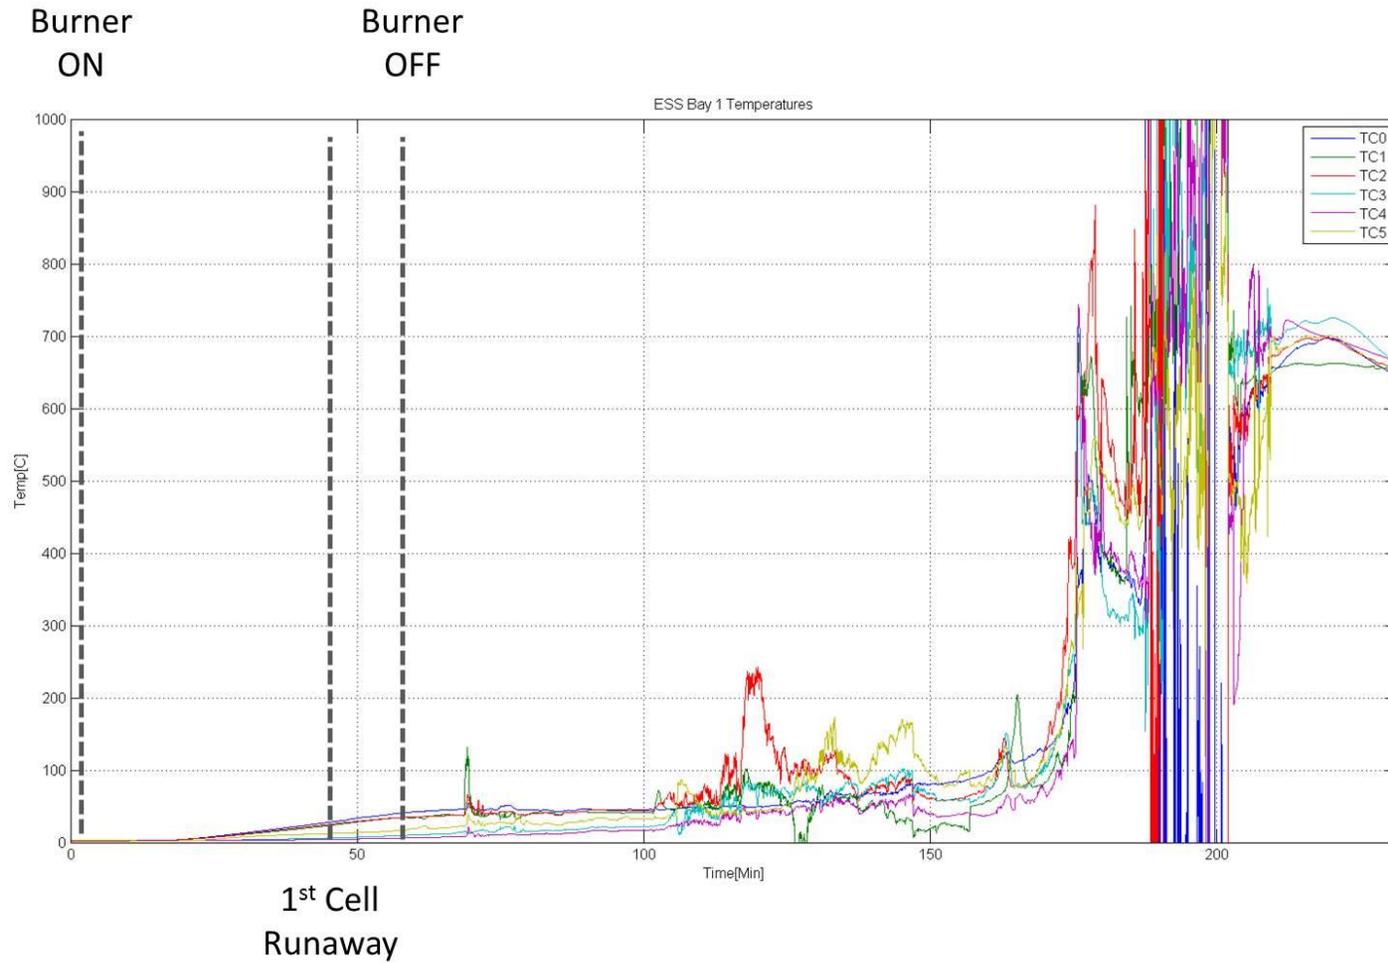
Figure 35 Powerpack Pod 1 temperatures (noise observed in the data is consistent with electrical interference that occurs during voltage leakage from the damaged batteries after thermal runaway)

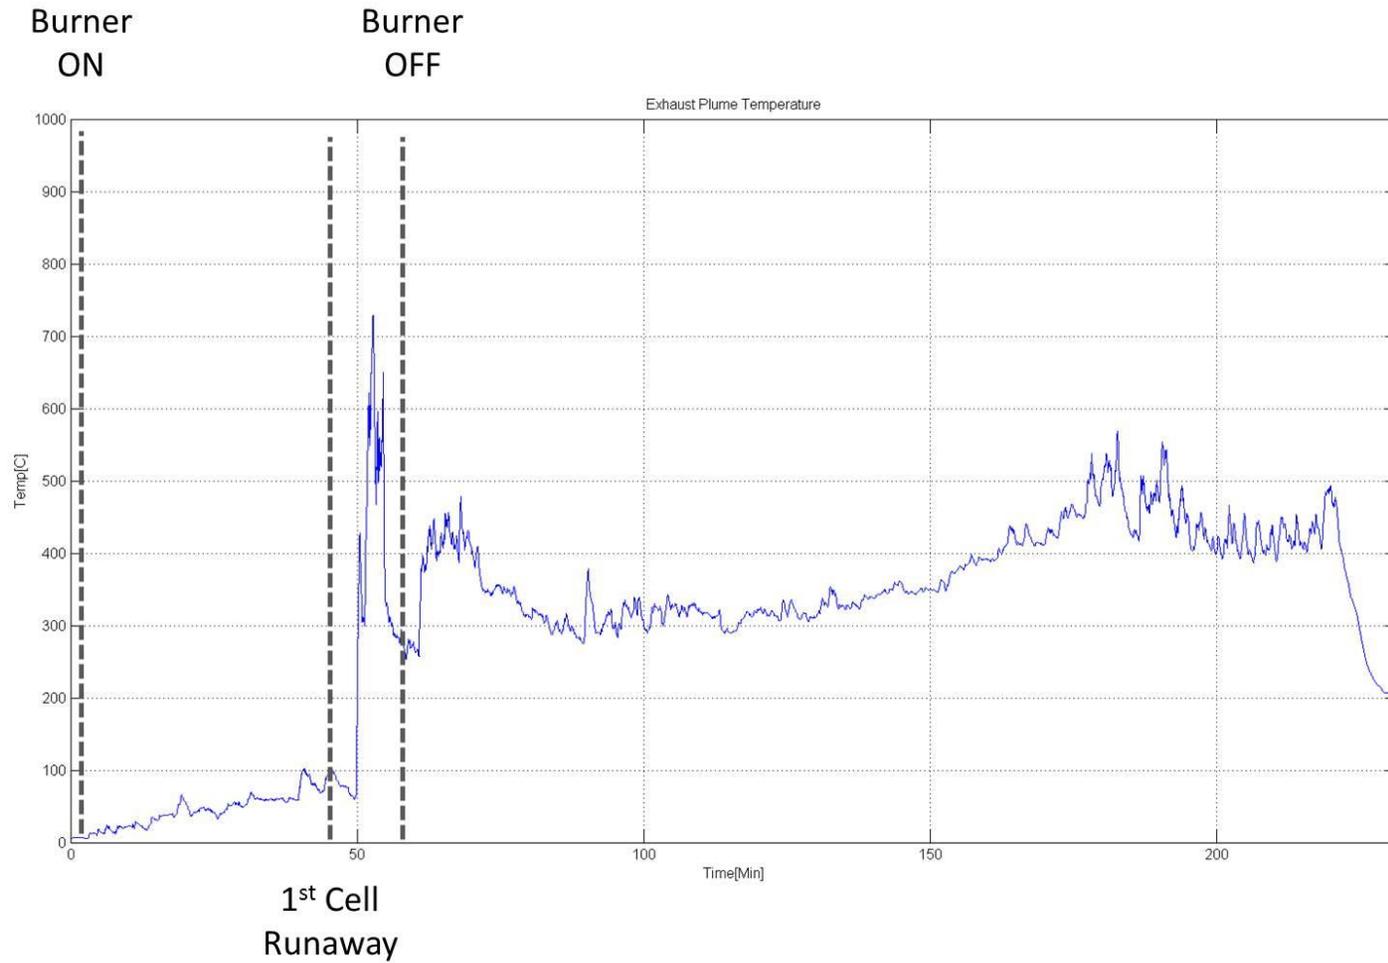
Figure 36 Powerpack exhaust vent temperature

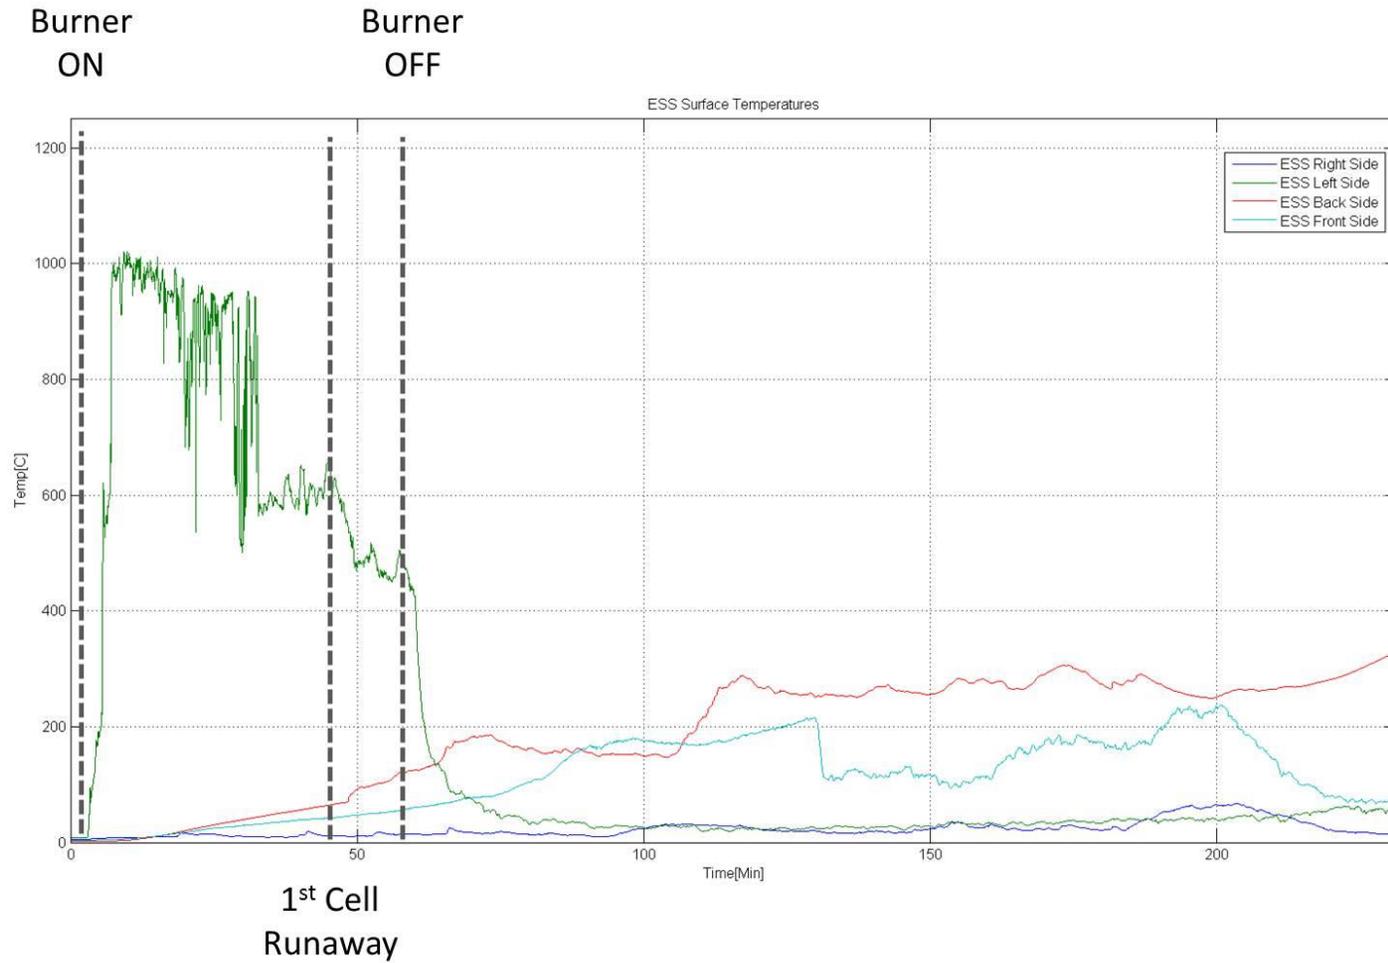
Figure 37 Powerpack external surface temperatures

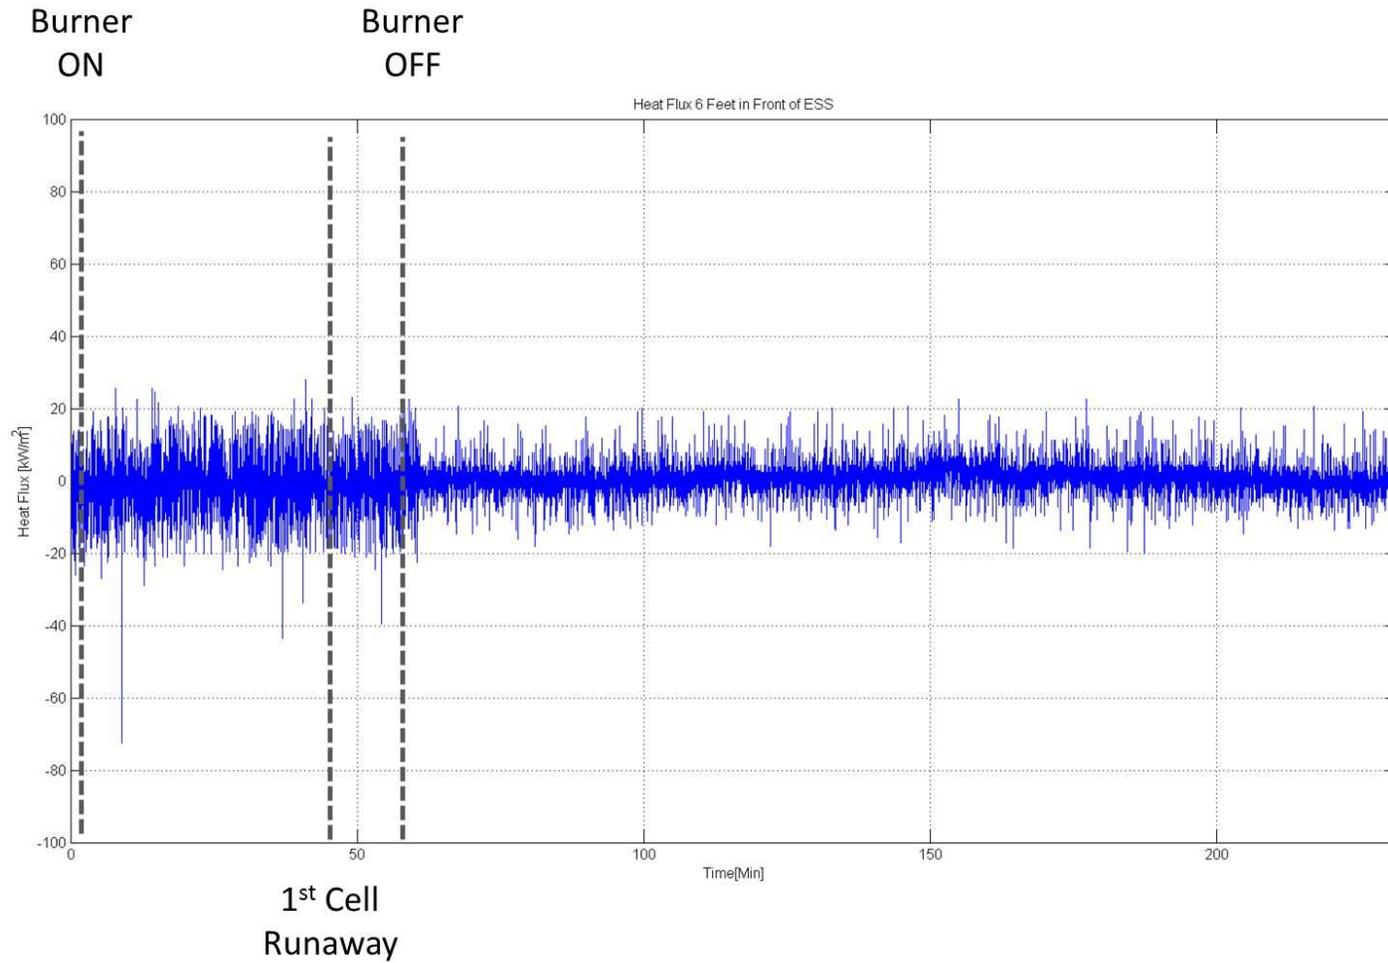
Figure 38 Heat flux measurements at HFG1, 6 feet from the front of the Powerpack

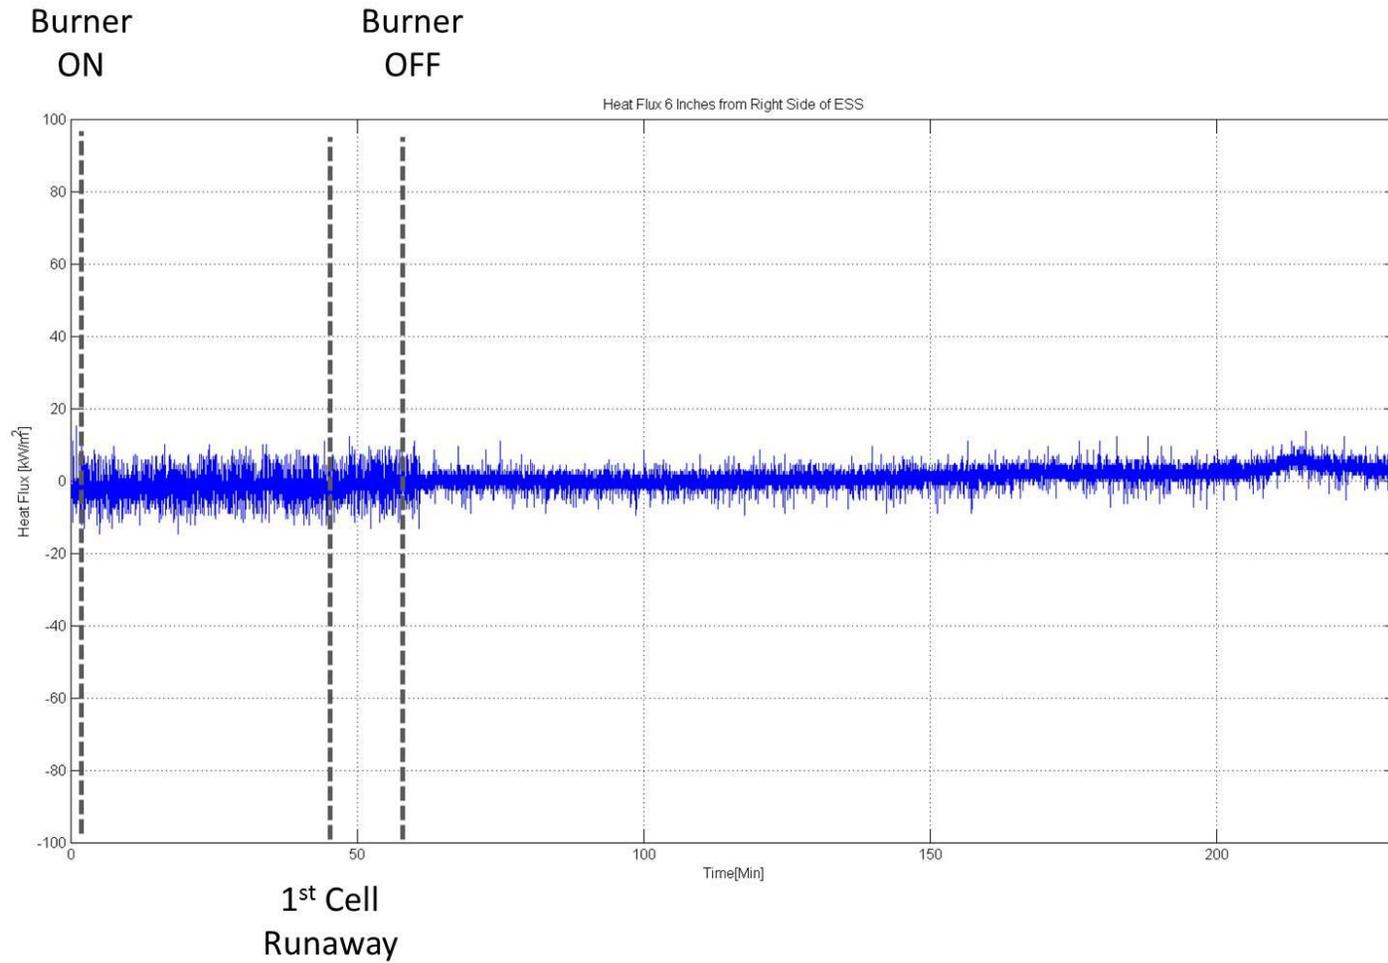
Figure 39 Heat flux measurements at HFG2, 6 inches from the side of the Powerpack

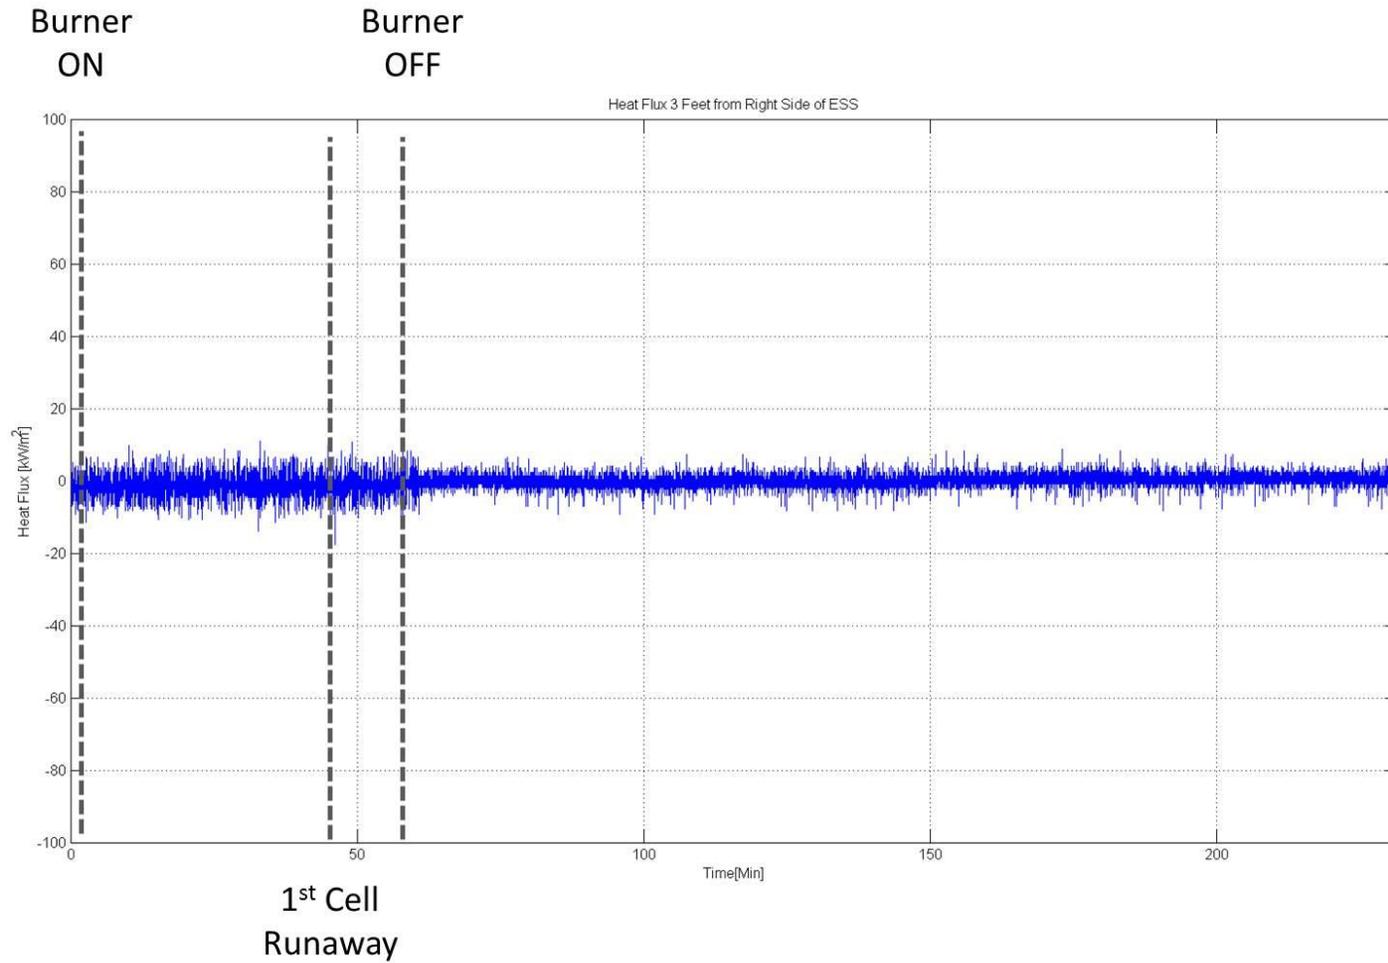
Figure 40 Heat flux measurements at HFG3, 3 feet from the back of the Powerpack

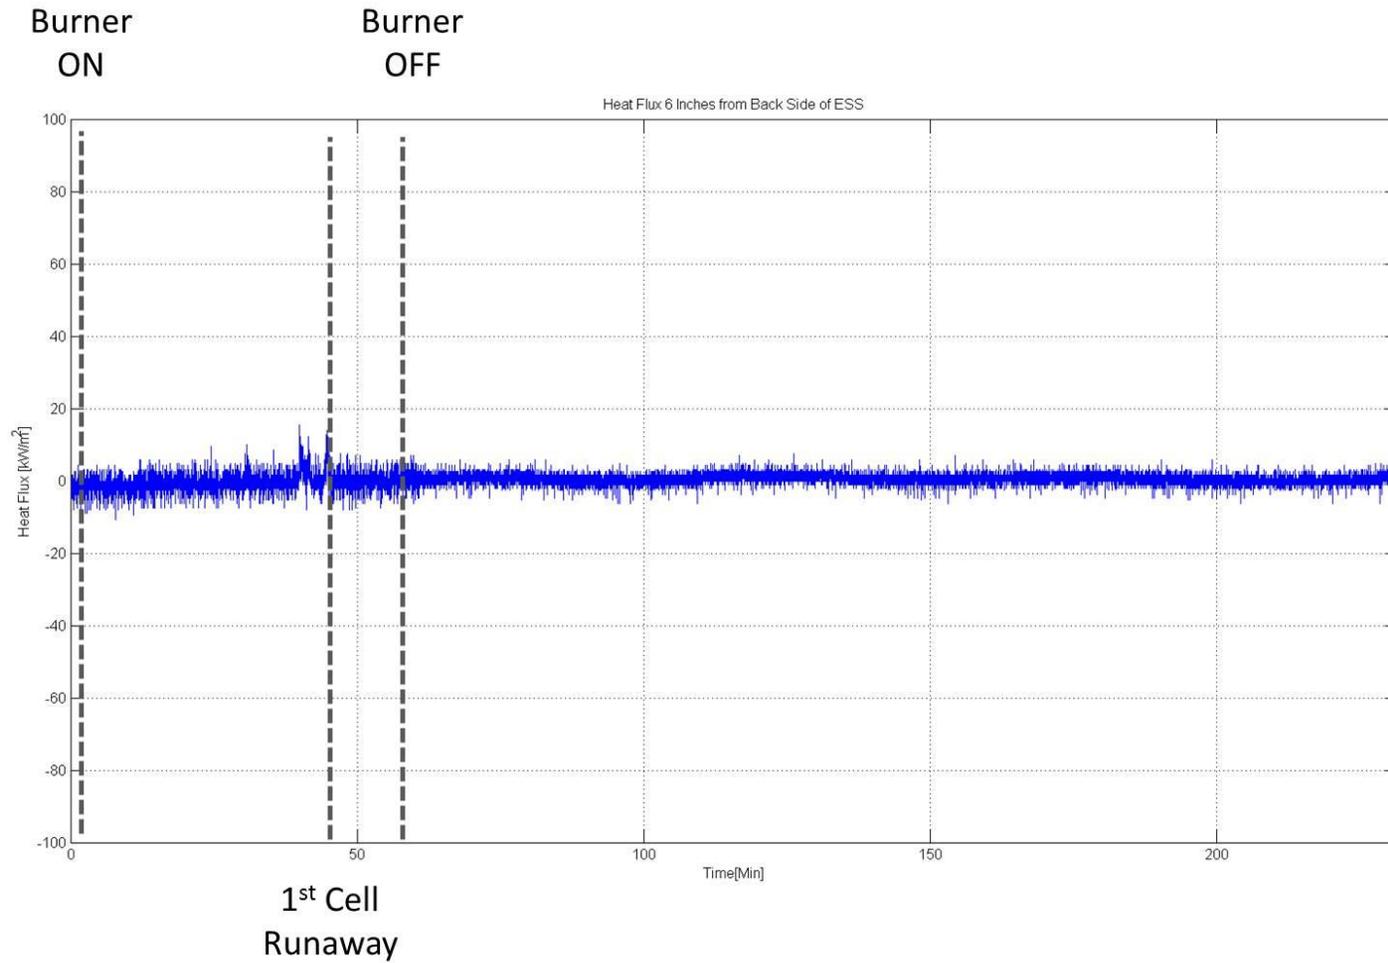
Figure 41 Heat flux measurements at HFG4, 6 inches from the side of the Powerpack

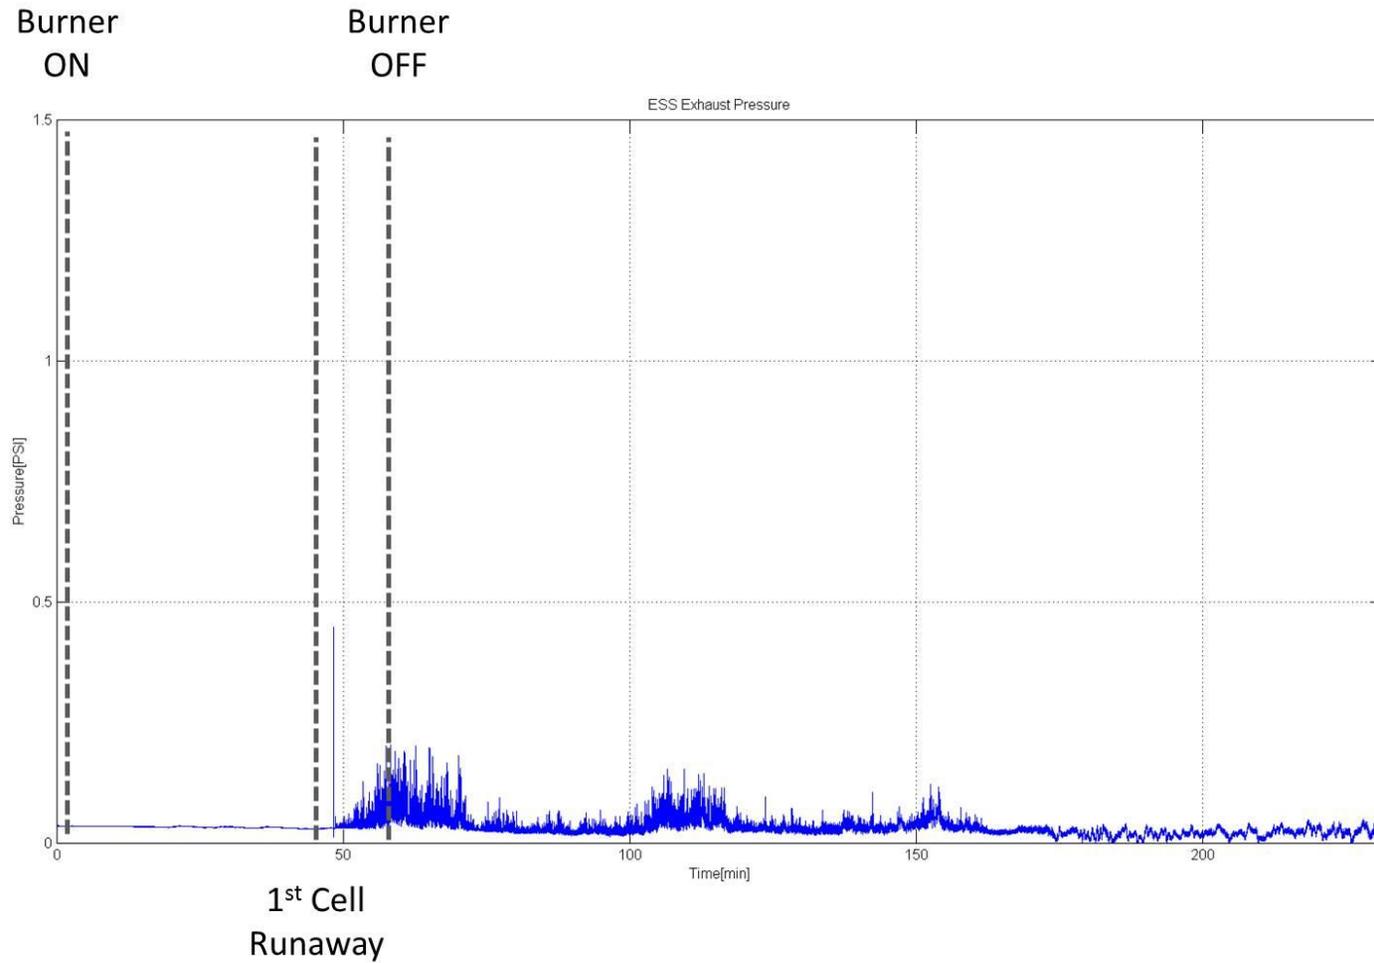
Figure 42 Exhaust manifold pressure

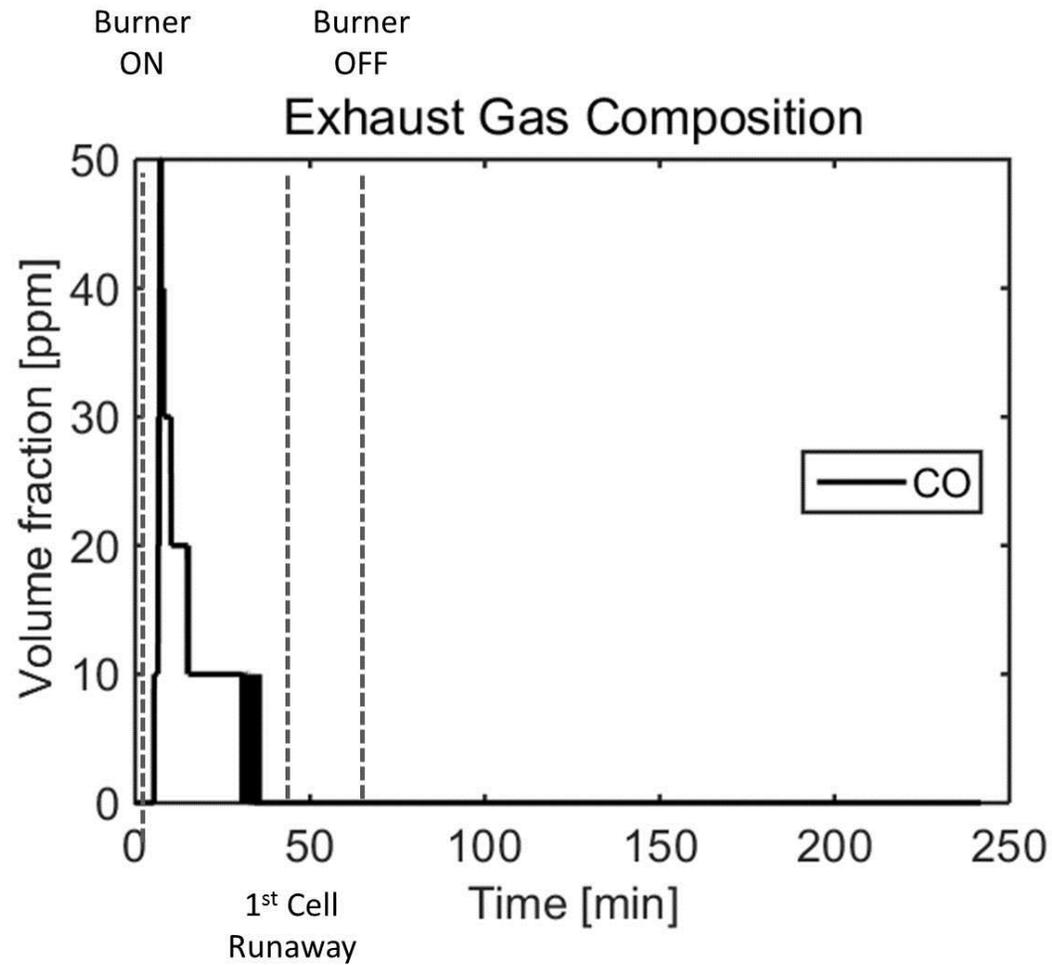
Figure 43 CO detected at the exhaust vent

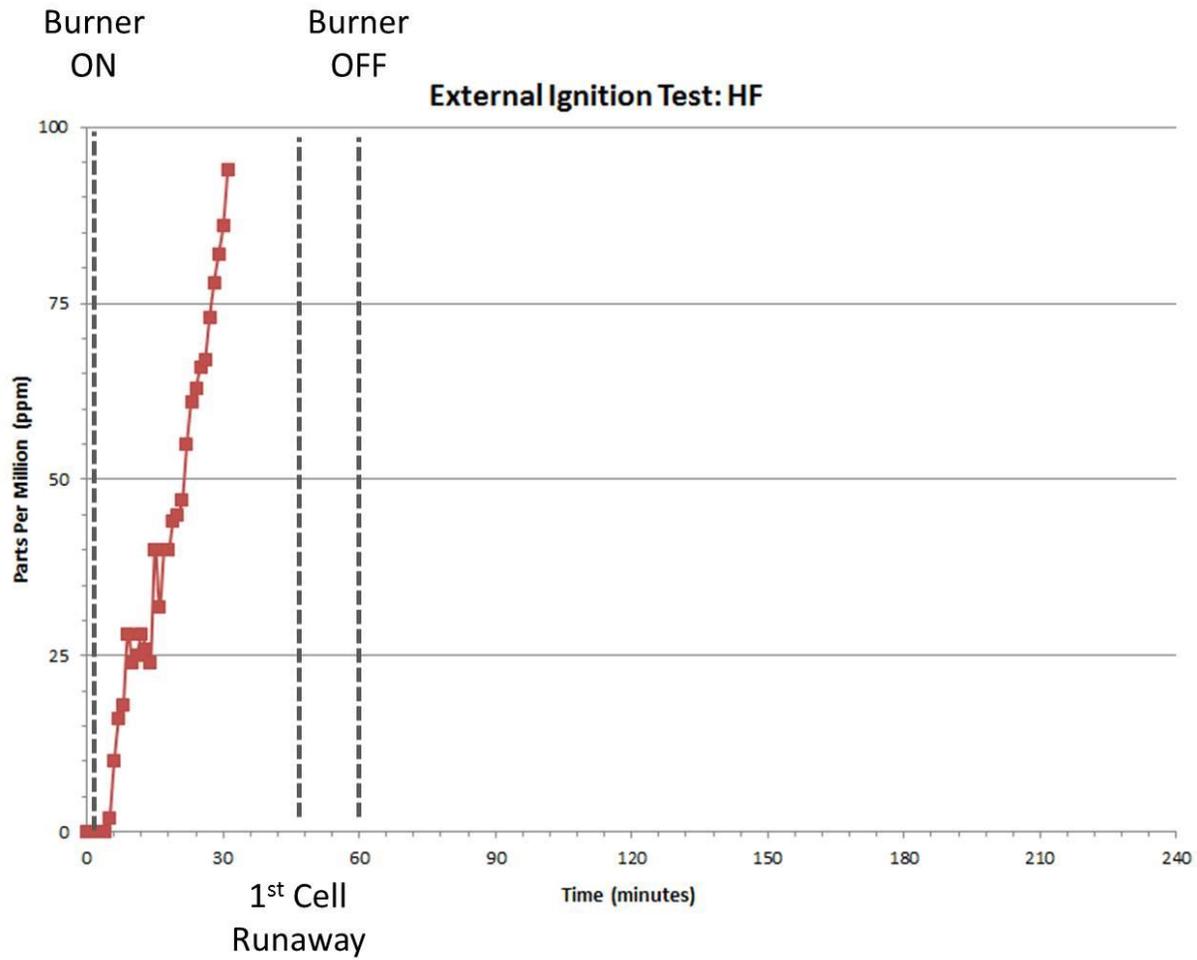
Figure 44 HF detected at the exhaust vent (detector maximum range was 100 ppm; all measurements after minute 30 were “over range,” indicating the HF values were greater than 100 ppm for the remainder of the test

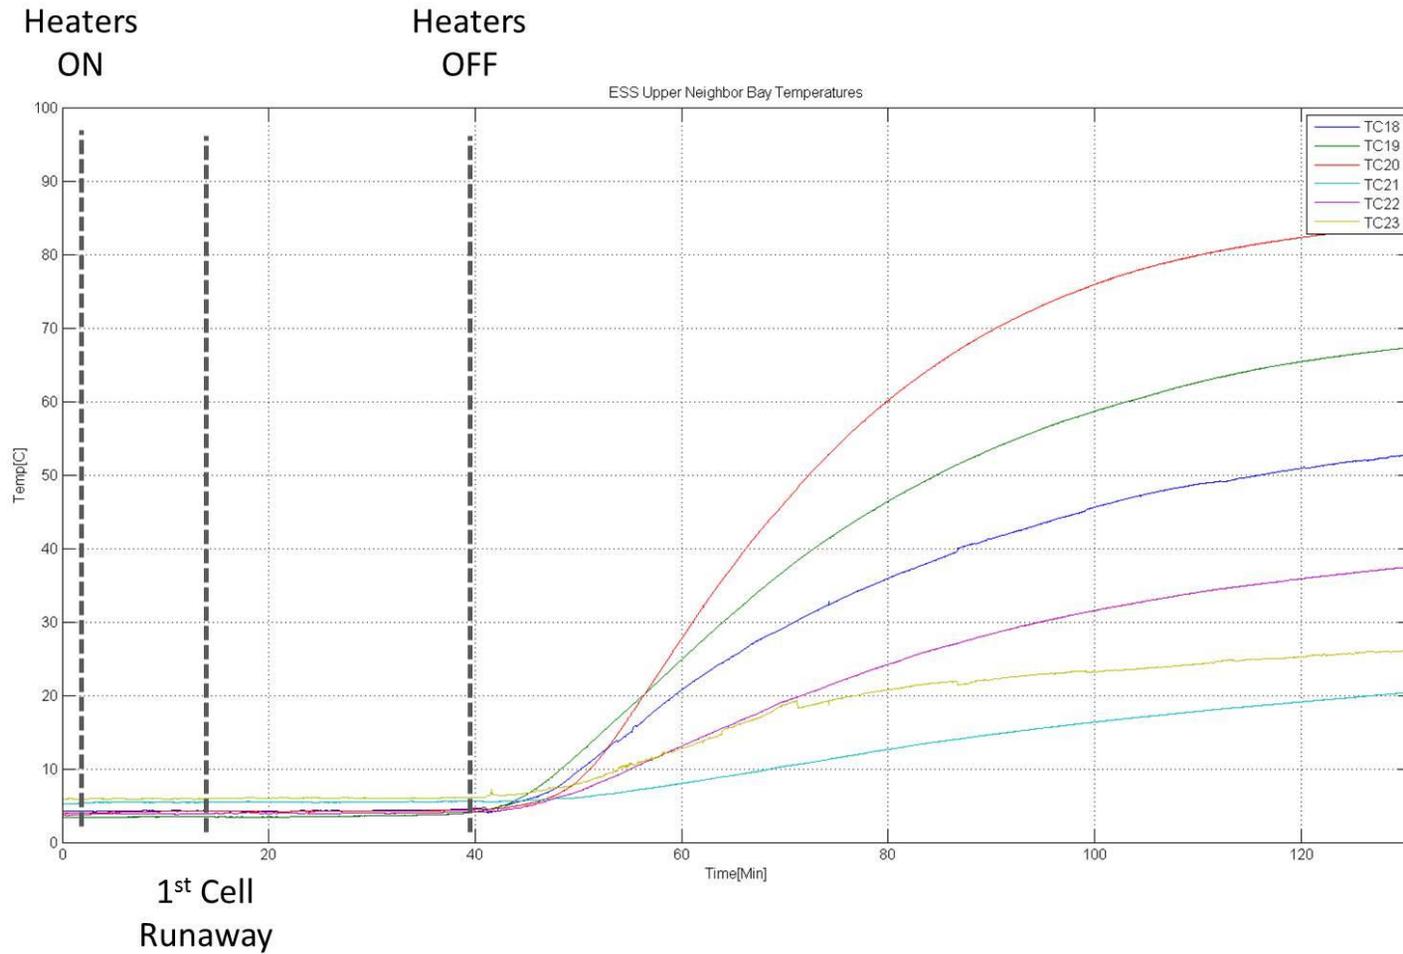
Figure 45 Pod 7 temperatures

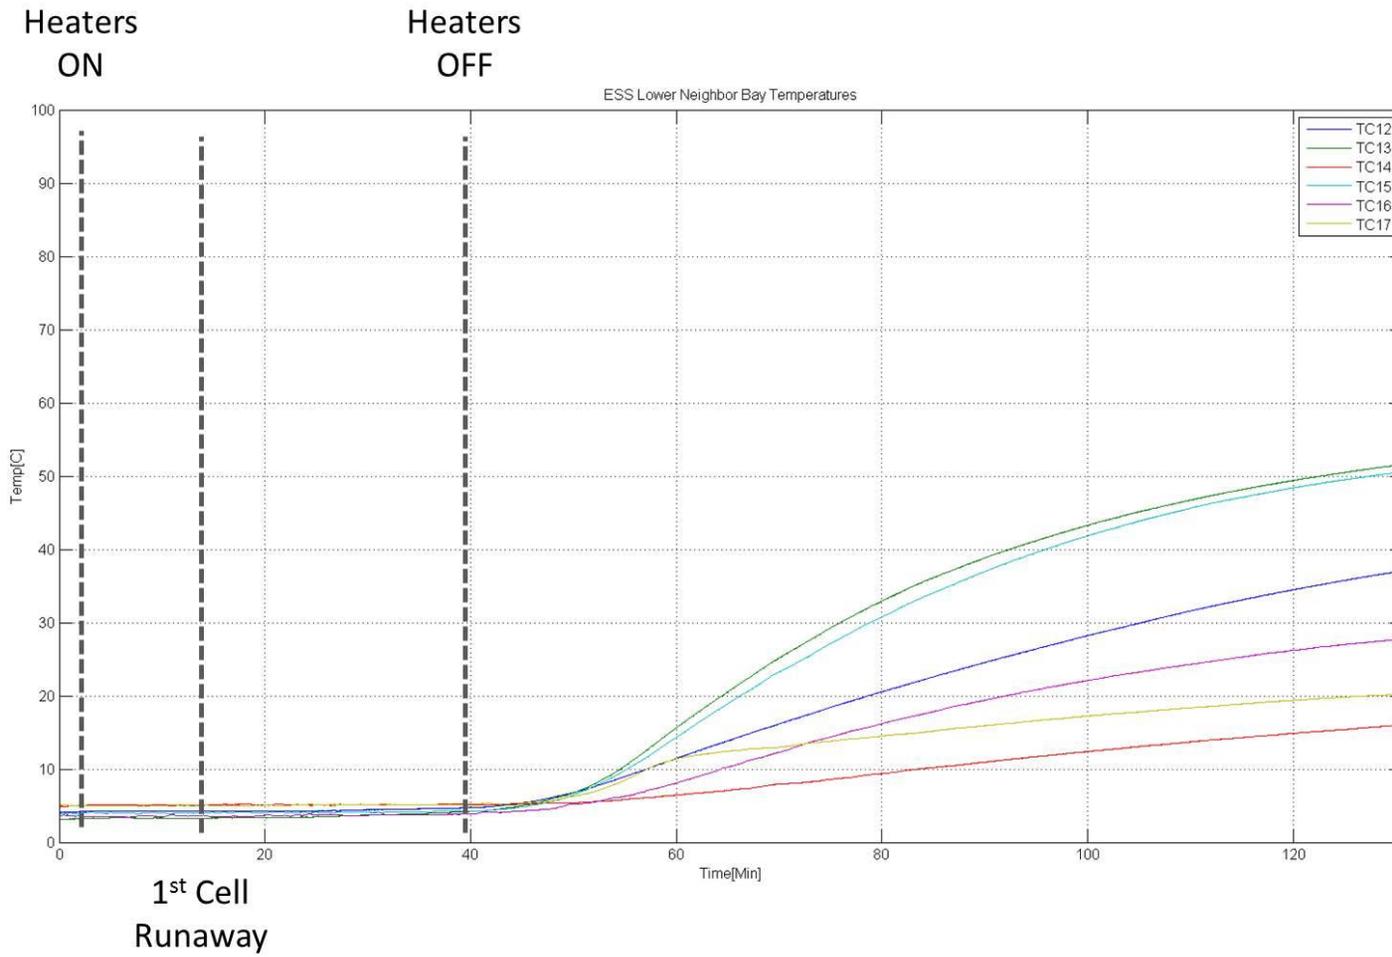
Figure 46 Pod 5 temperatures

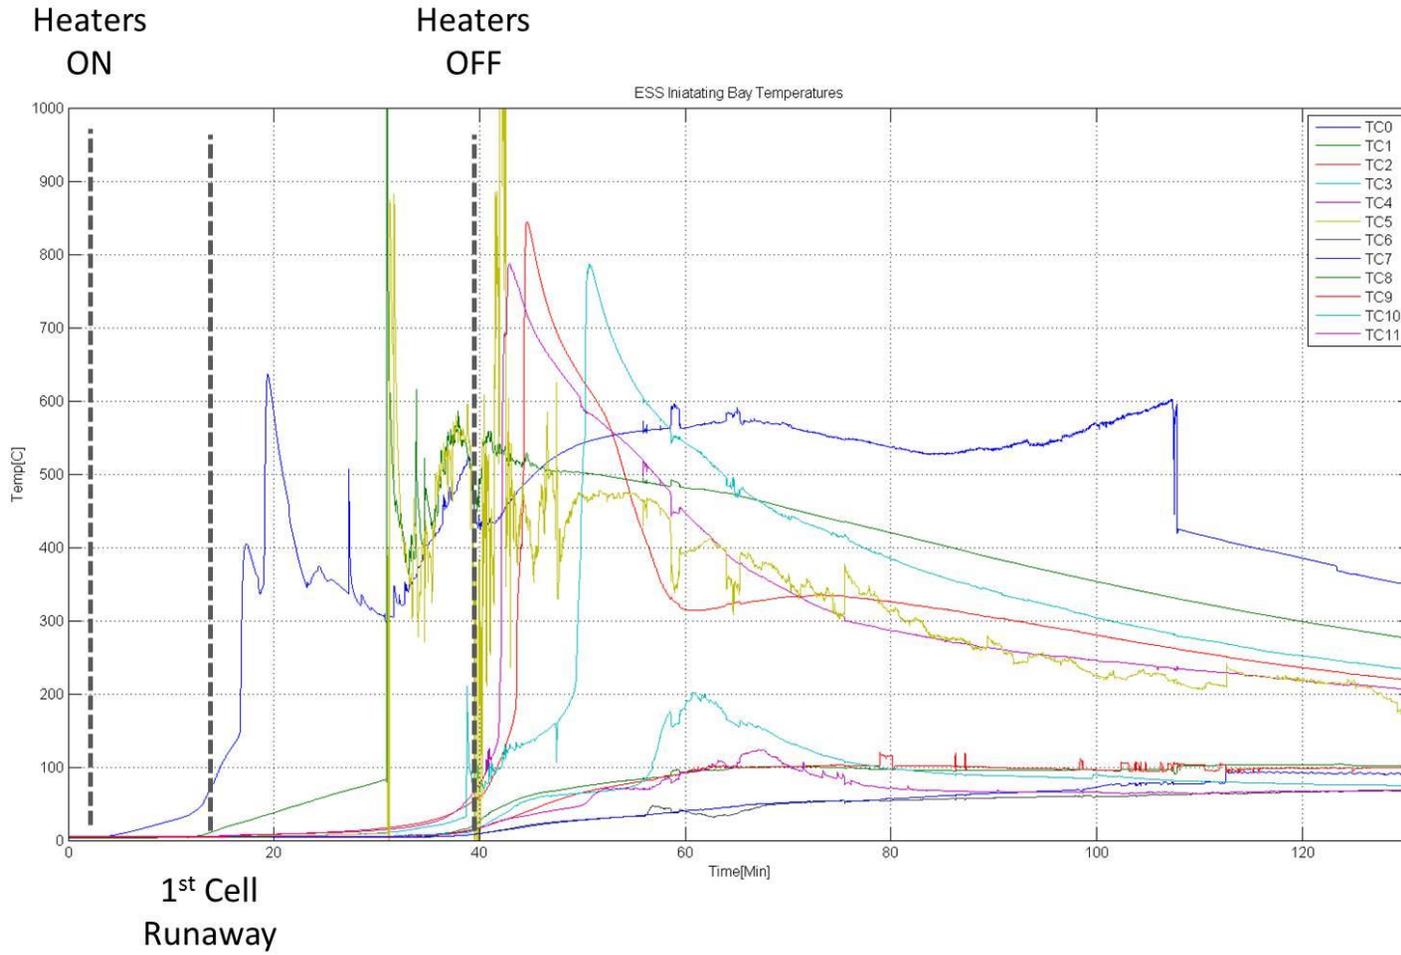
Figure 47 Pod 6 (initiator pod) temperatures (noise observed in the data is consistent with electrical interference that occurs during voltage leakage from the damaged batteries after thermal runaway)

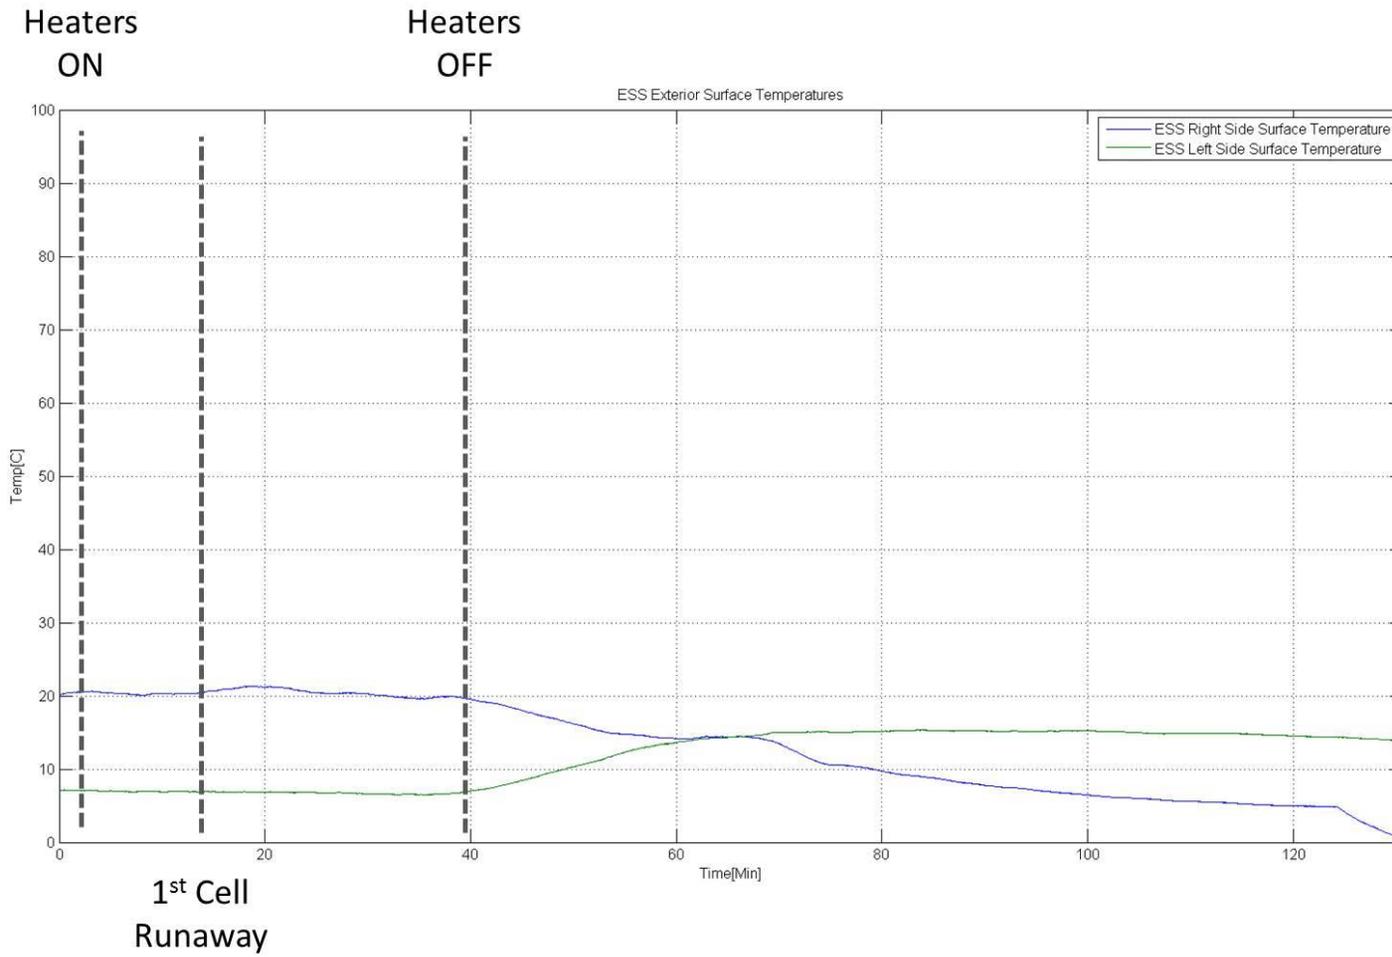
Figure 48 Exterior Powerpack surface temperatures

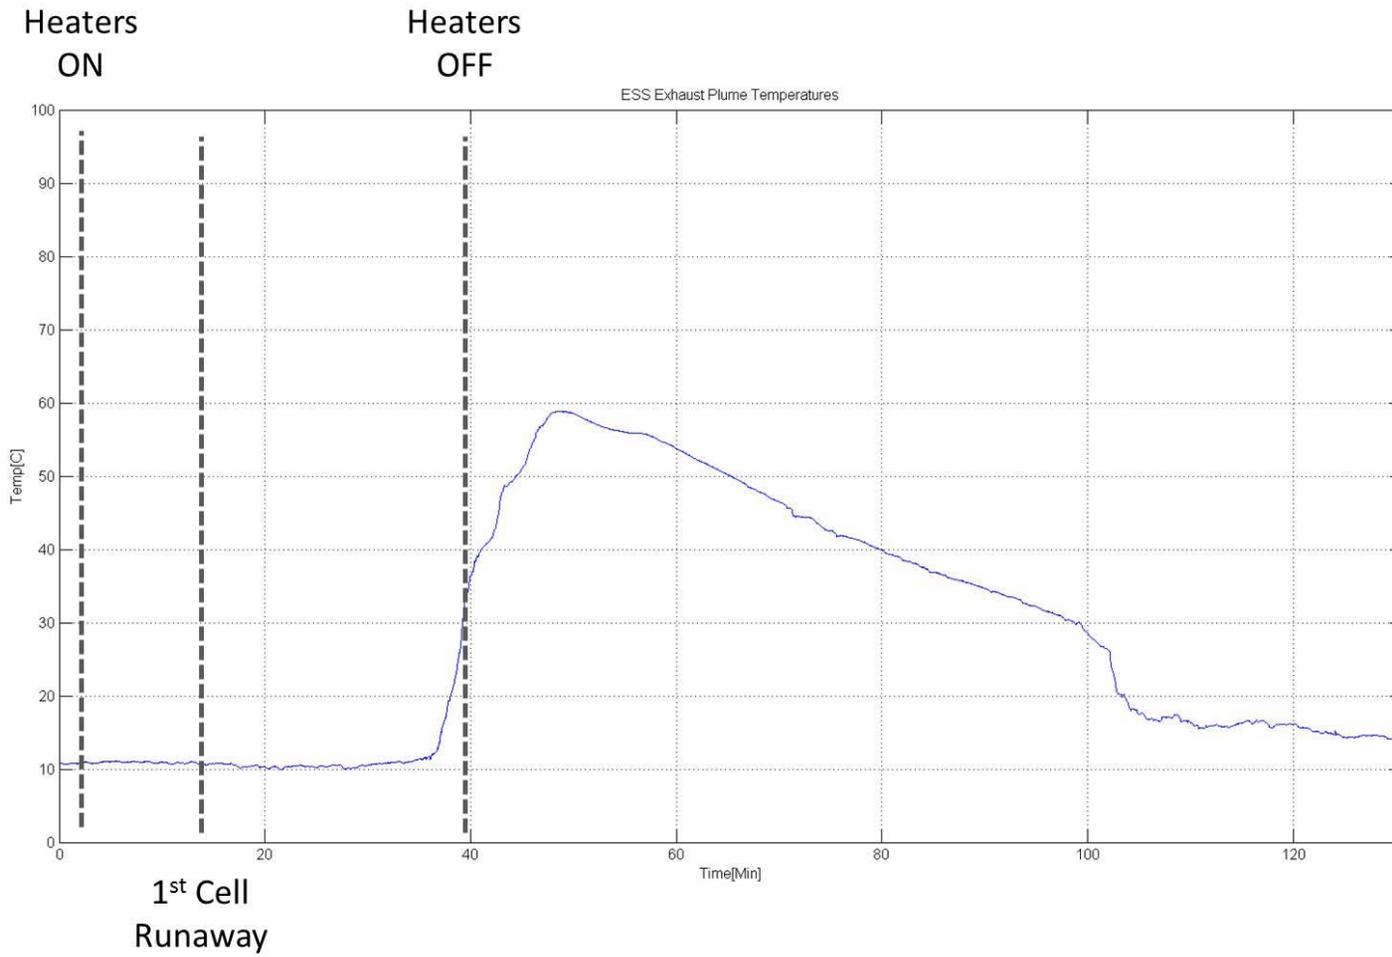
Figure 49 Exhaust vent temperature

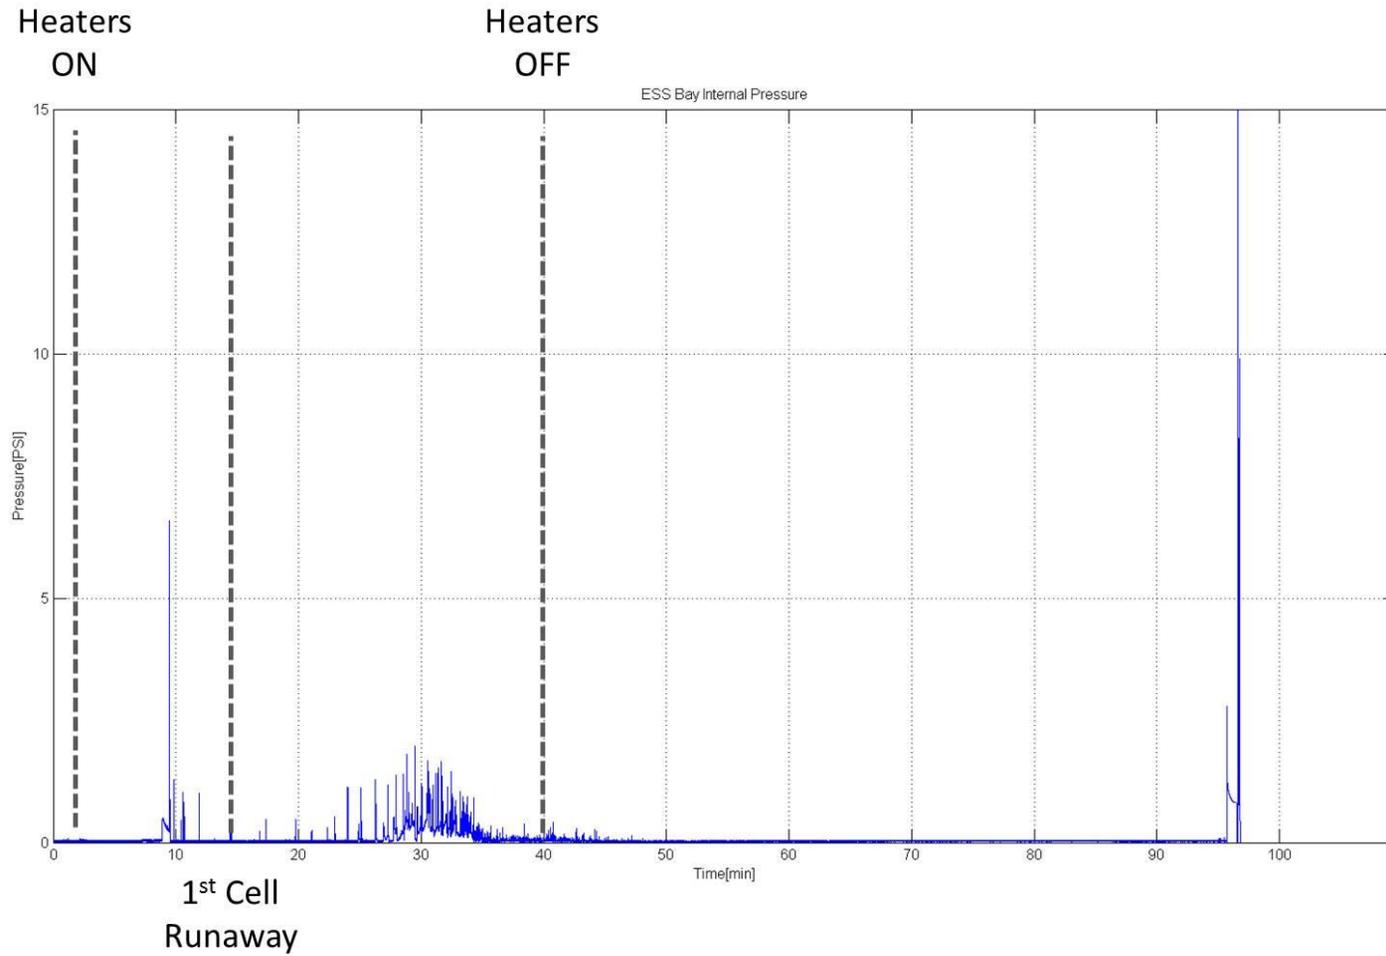
Figure 50 Pod 6 (initiator pod) pressure

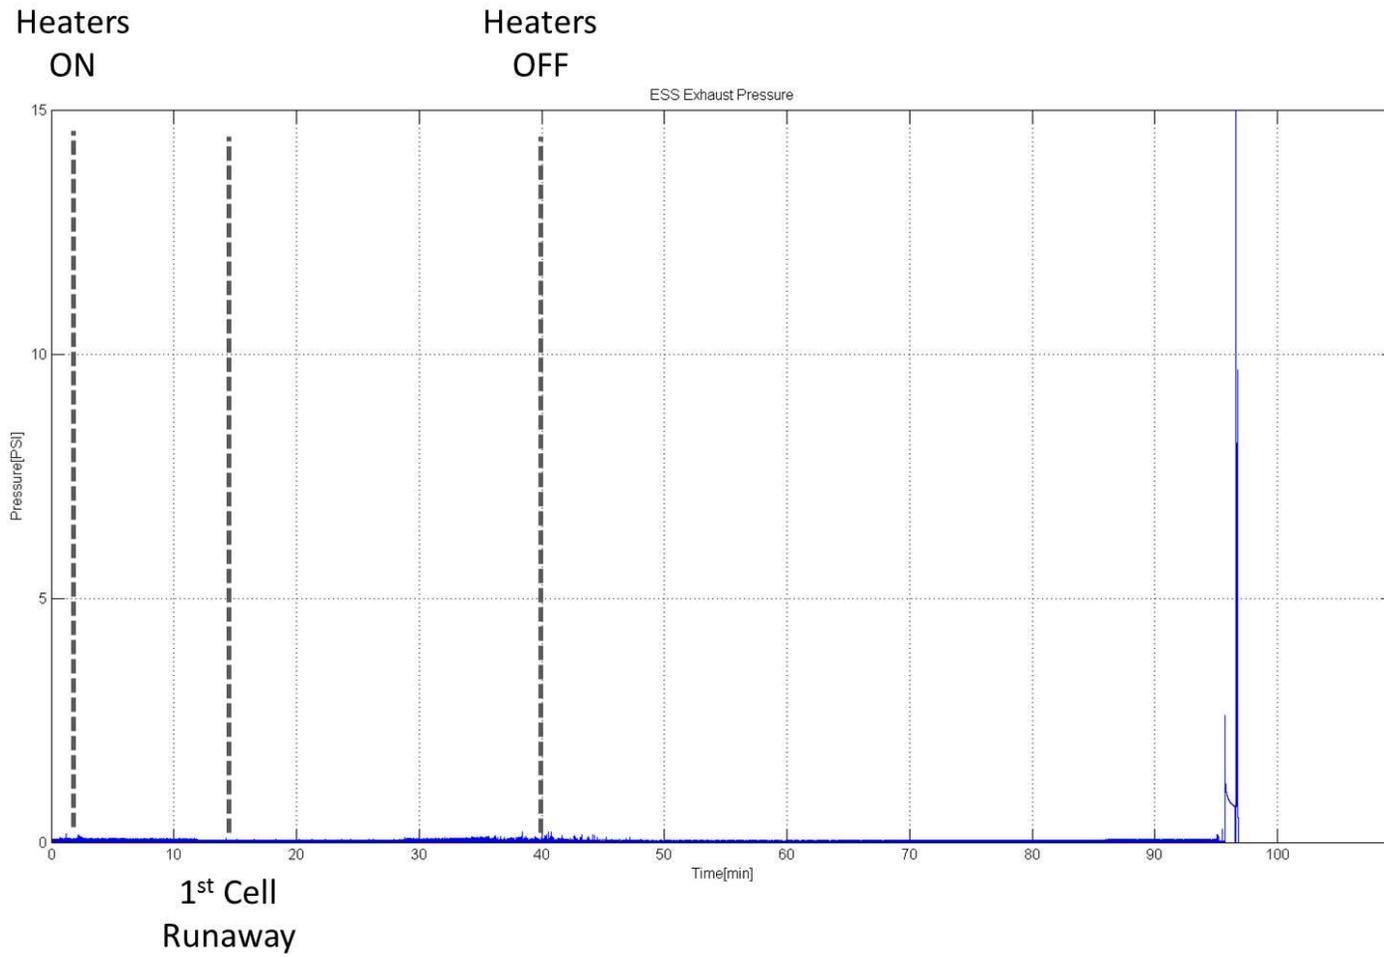
Figure 51 Powerpack exhaust manifold pressure
