Hazard Assessment of Lithium Ion Battery Energy Storage Systems

FINAL REPORT

Andrew F. Blum, P.E., CFEI
R. Thomas Long Jr., P.E., CFEI
Exponent, Inc.
17000 Science Drive, Suite 200
Bowie, MD 20715

**Fire Hazard Assessment of
Lithium Ion Battery
Energy Storage Systems**

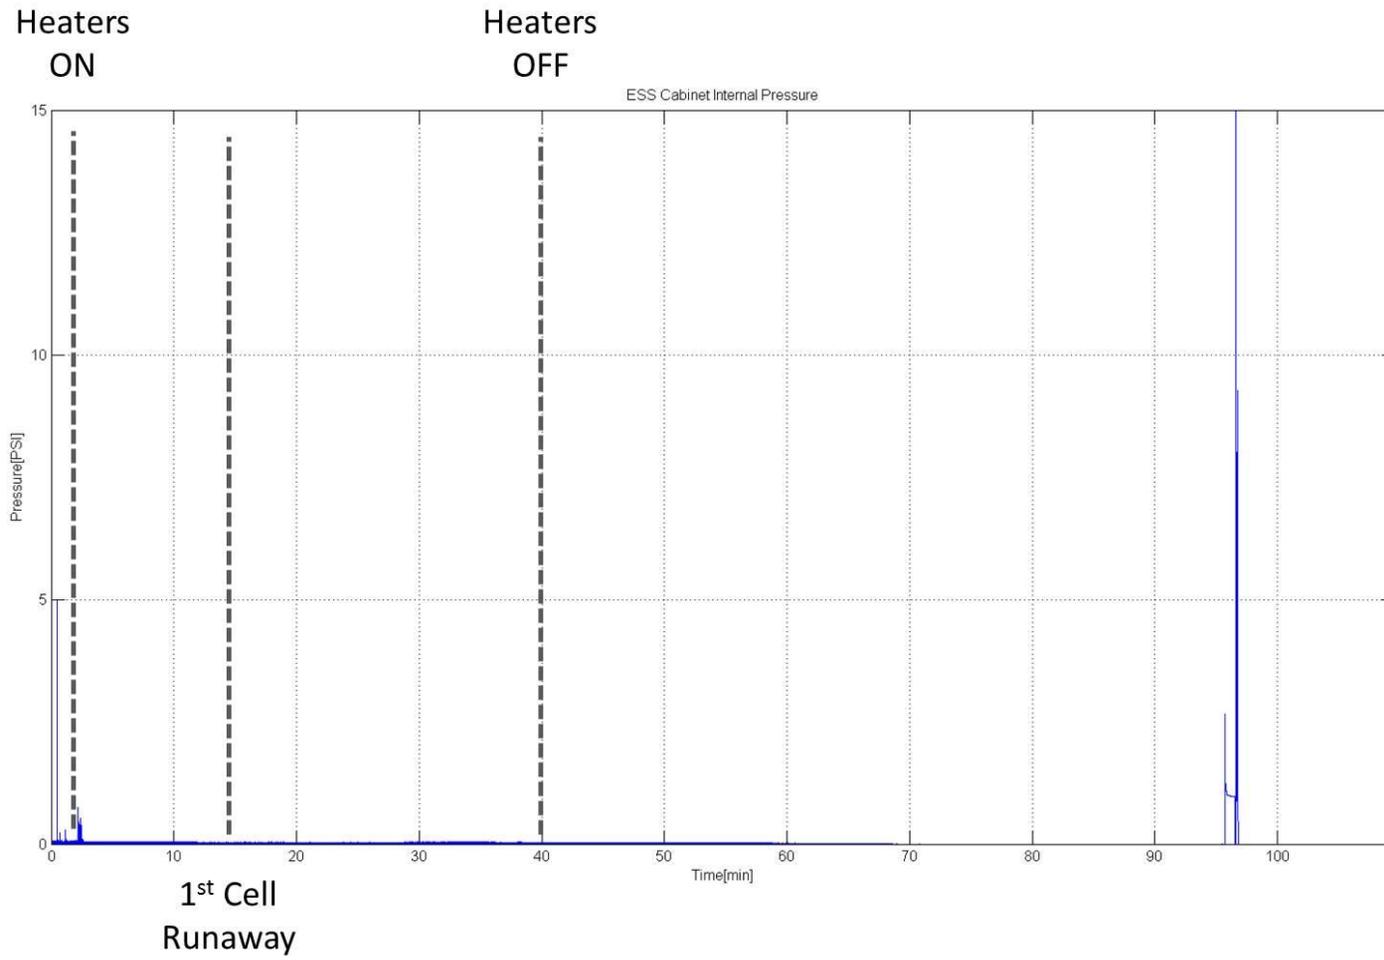
Figure 52 Powerpack cabinet pressure

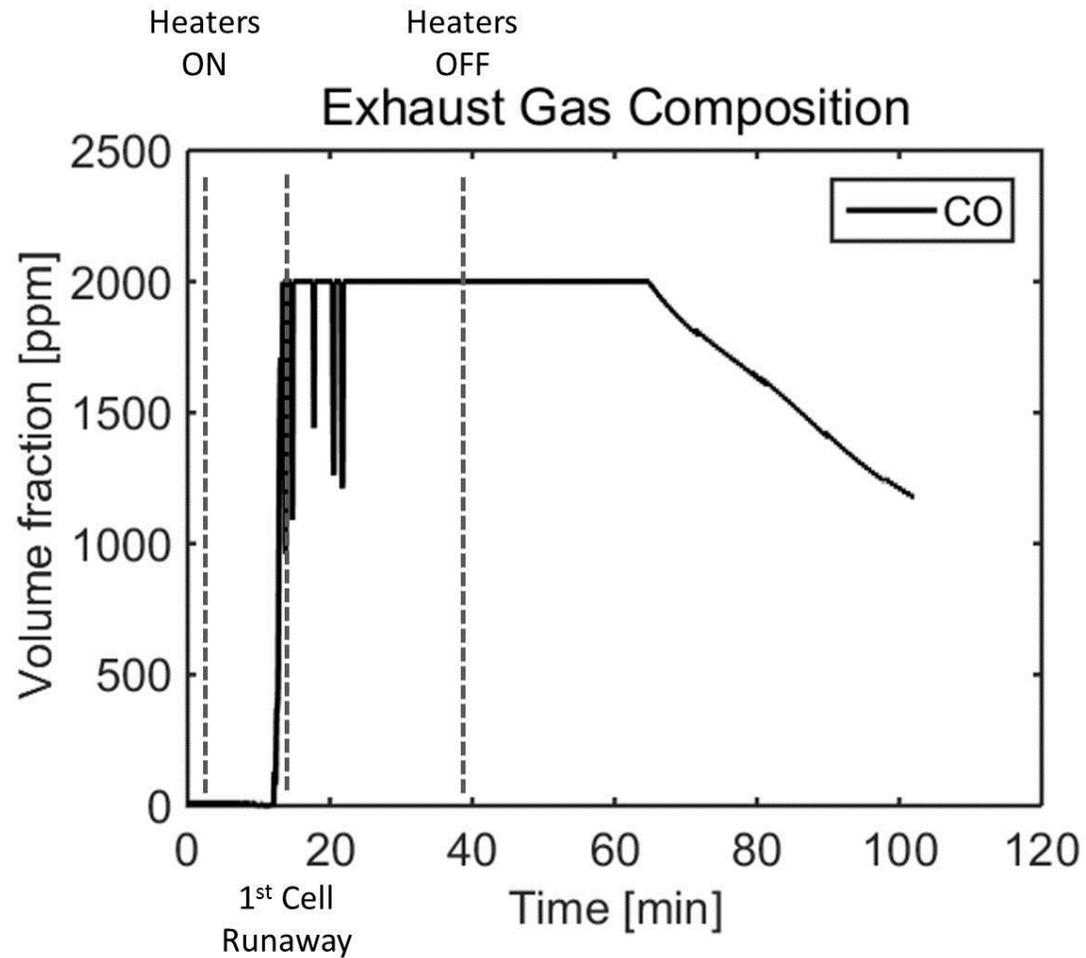
Figure 53 CO detected at exhaust vent

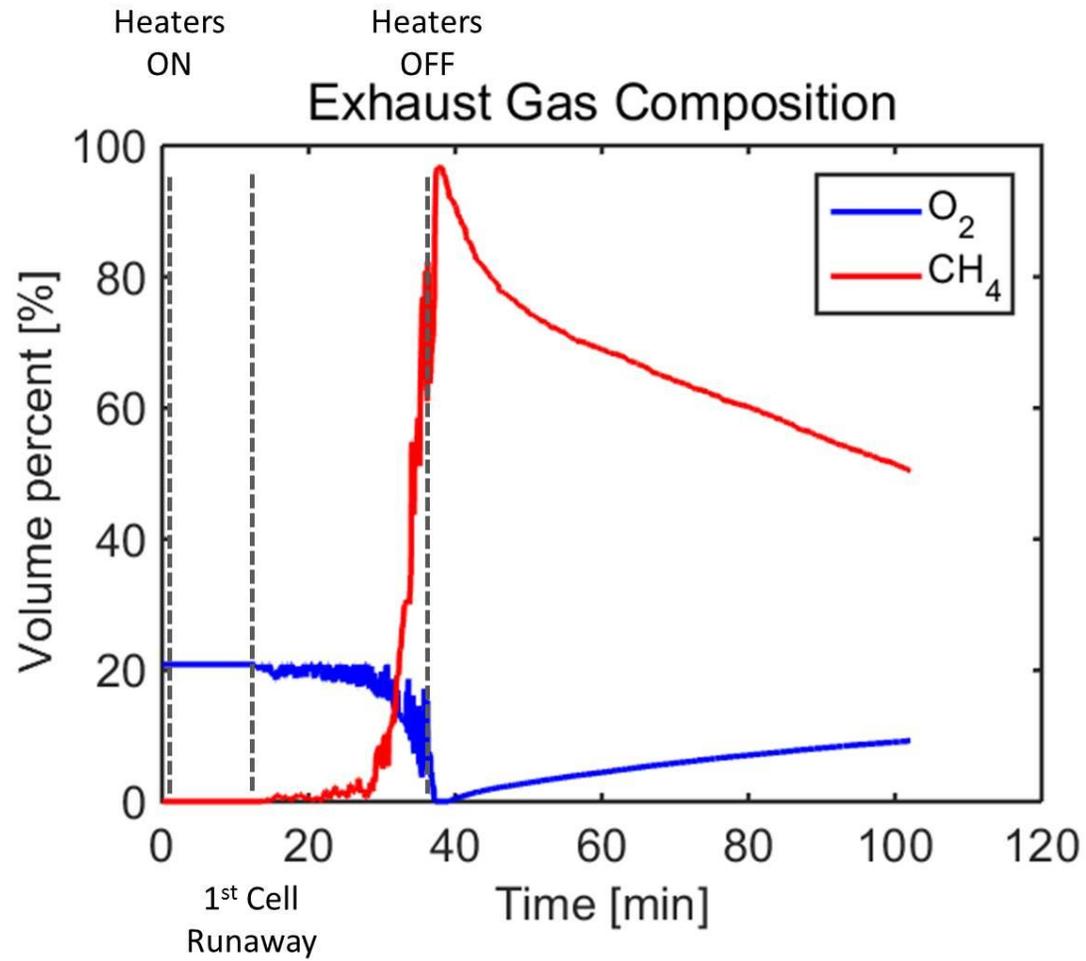
Figure 54 CH₄ detected at exhaust vent

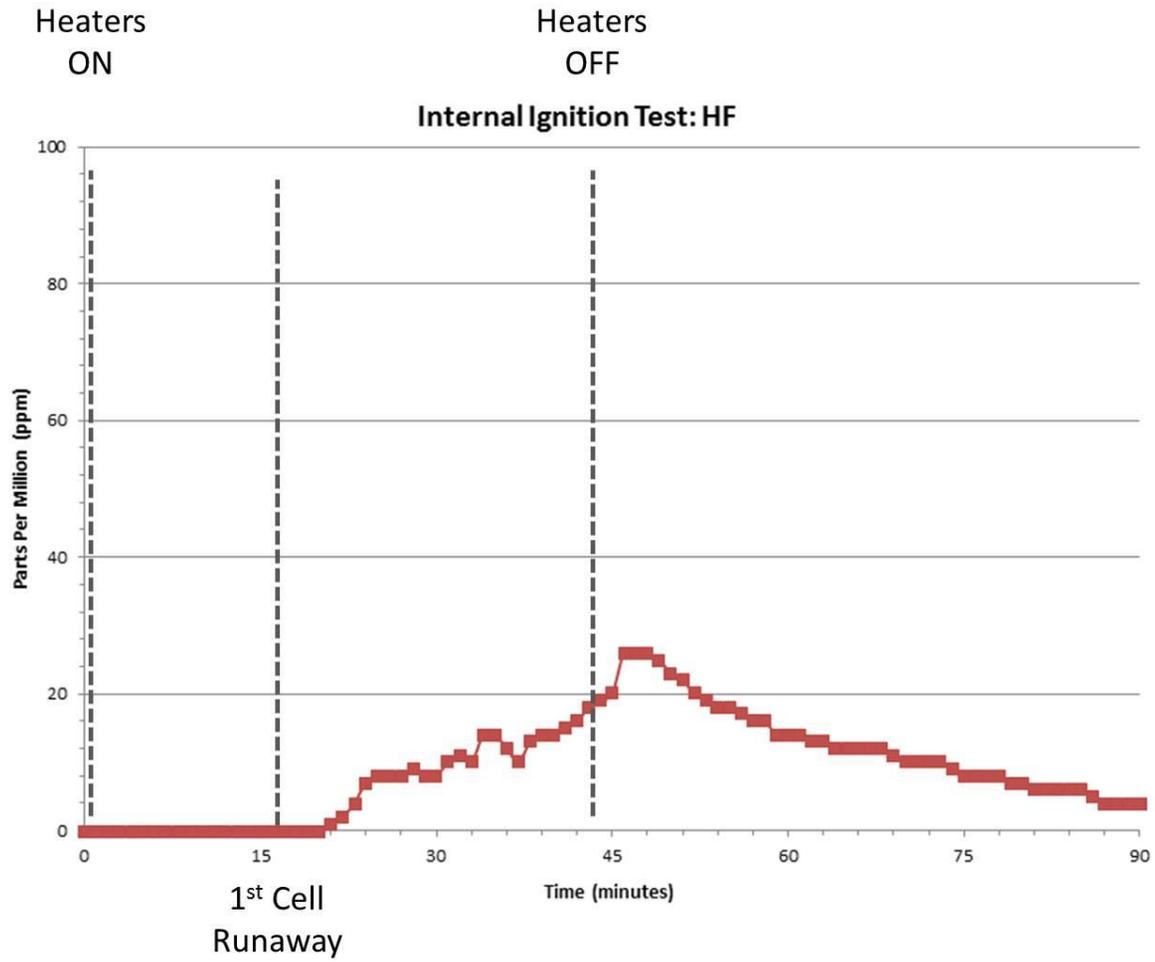
Figure 55 HF detected at the exhaust vent
